Pit or Below-Grade Tank Registration or Closure

Operator: Dugan Production Corp Telephone: (505)325-1821 e-mail address:
Address: P.O. Box 420, Farmington, New Mexico 87401
Facility or well name: Holly #1 API #: 30-045-25149 U/L or Qtr/Qtr L Sec 16 T 24N R 9W
County: San Juan Latitude 36.31190 Longitude 107.80016 NAD: 1927 ☐ 1983 ☐ Surface Owner Federal ☐ State ☒ Private ☐ Indian ☐

FIELD REPORT: PIT CLOSURE VERIFICATION

LOCATION: NAME: HOLLY WELL #: 1 TYPE: ABANDON #1
QUAD/UNIT: L SEC: 16 TWP: 24N RNG: 9W PM: NM CNTY: SJ ST: NM
QTR/FOOTAGE: 1860 FSL x 990 FWL CONTRACTOR: DPC

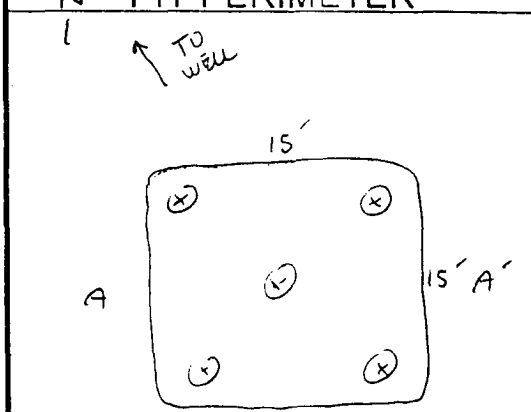
PIT PERIMETER

12' x 12' x 3'± deep unlined abandoned pit, center located 48 feet South 36° East of well PxA marker.

FIELD NOTES & REMARKS: PIT LOCATED APPROXIMATELY 48 FT. S 36E FROM WELLHEAD.
DEPTH TO GROUNDWATER: >100 NEAREST WATER SOURCE: >1000 NEAREST SURFACE WATER: >1000
NMOCD RANKING SCORE: 0 NMOCD TPH CLOSURE STD: 5000 PPM

SOIL TYPE: SAND / (SILTY SAND) / SILT / SILTY CLAY / CLAY / GRAVEL / OTHER
SOIL COLOR: PALE TAN
COHESION (ALL OTHERS): NON COHESIVE / (SLIGHTLY COHESIVE) / COHESIVE / HIGHLY COHESIVE
CONSISTENCY (NON COHESIVE SOILS): LOOSE / (FIRM) / DENSE / VERY DENSE
PLASTICITY (CLAYS): NON PLASTIC / SLIGHTLY PLASTIC / COHESIVE / MEDIUM PLASTIC / HIGHLY PLASTIC
DENSITY (COHESIVE CLAYS & SILTS): SOFT / FIRM / STIFF / VERY STIFF / HARD
MOISTURE: DRY / (SLIGHTLY MOIST) / MOIST / WET / SATURATED / SUPER SATURATED
DISCOLORATION/STAINING OBSERVED: (YES) / NO EXPLANATION -
HC ODOR DETECTED: (YES) / NO EXPLANATION -
SAMPLE TYPE: GRAB / (COMPOSITE) - # OF PTS. 5
ADDITIONAL COMMENTS: PxA well. 12'x12'x3' Deep Unlined Pit.
USE BACKHOE TO Remove IMPACTED SOILS.

Use backhoe to remove impacted pit contents to dimension of 15' x 15' x 10' ± and landfarm soils on location.

Collect 5-point composite soil sample from excavated pit for laboratory testing.

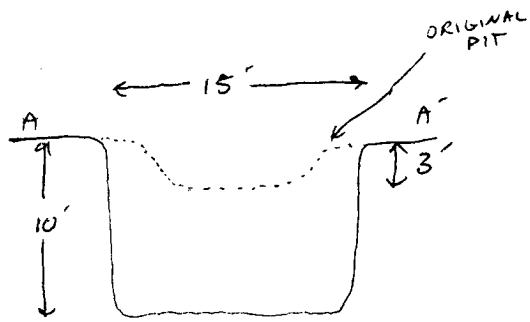
PIT PROFILE

EXCAVATION APPROX. 15 FT. x 15 FT. x 10 FT. DEEP. CUBIC YARDAGE: 67±
DISPOSAL FACILITY: ONSITE REMEDIATION METHOD: LF
LAND USE: RANGE - STATE LEASE: LG-1035 FORMATION: PxA

SAMPLE ID	FIELD HEADSPACE (ppm)
1 @	
2 @	
3 @	
4 @	
5 @	
5-Point @ 10'	27
