Pit or Below-Grade Tank Registration or Closure

FIELD REPORT: PIT CLOSURE VERIFICATION

LOCATION: NAME: WAC WELL #: 1 TYPE: SEP

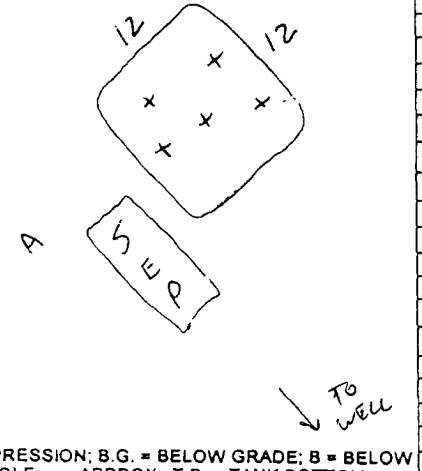
PIT PERIMETER

FIELD NOTES & REMARKS: PIT LOCATED APPROXIMATELY 75 FT. N48W FROM WELLHEAD.

DISCOLORATION/STAINING OBSERVED: (YES) NO EXPLANATION - Gray stain on surface

HC ODOR DETECTED: (YES) NO EXPLANATION - MINOR

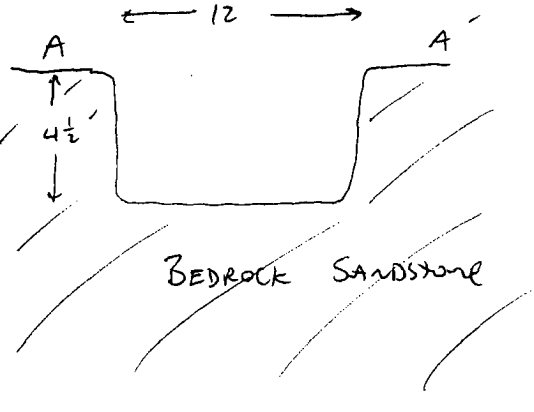
PIT PROFILE

ADDITIONAL COMMENTS: 12'x12'x3' Deep Unlined Pit, Excavated into Bedrock Sandstone. HC Stain on Surface. Excavate Soft Sandstone to Crystalline Sandstone @ 4½'
