Pit or Below-Grade Tank Registration or Closure

Operator: BP AMERICA PROD. CO. Telephone: (505)-326-9200 e-mail address:
Address: 200 ENERGY COURT. FARMINGTON. NM 87410
Facility or well name: ATLANTIC D COM M LS #14 API #: 30-045- 20905 U/L or Qtr/Qtr J Sec 32 T 31N R 10W
County: SAN JUAN Latitude 36.85214 Longitude 107.90235 NAD: 1927 ☐ 1983 ☒ Surface Owner Federal ☐ State ☒ Private ☐ Indian ☐

FIELD REPORT: PIT CLOSURE VERIFICATION

LOCATION: NAME: ATLANTIC D COM M LS WELL #: 14 TYPE: SEP
QUAD/UNIT: J SEC: 32 TWP: 31N RNG: 10W PM: NM CNTY: SJ ST: NM
QTR/FOOTAGE: 1540 FSL x 1630 FEL NWSE CONTRACTOR: P+S (MAMU)

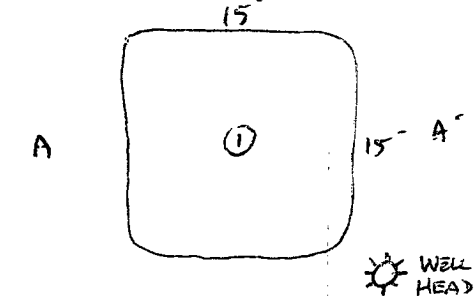
PIT PERIMETER

FIELD NOTES & REMARKS: PIT LOCATED APPROXIMATELY 21 FT. N 78W FROM WELLHEAD.
DEPTH TO GROUNDWATER: >100 NEAREST WATER SOURCE: >1000 NEAREST SURFACE WATER: >1000
NMOCD RANKING SCORE: 0 NMOCD TPH CLOSURE STD: 5000 PPM

SOIL TYPE: SAND / (SILTY SAND) / SILT / SILTY CLAY / CLAY / GRAVEL / OTHER BEDROCK Claystone @ 7' BG
SOIL COLOR: TAN (Surface - 7') Blue @ 7'
COHESION (ALL OTHERS): NON COHESIVE / (SLIGHTLY COHESIVE) / COHESIVE / HIGHLY COHESIVE
CONSISTENCY (NON COHESIVE SOILS): LOOSE / (FIRM) / DENSE / VERY DENSE
PLASTICITY (CLAYS): NON PLASTIC / SLIGHTLY PLASTIC / COHESIVE / MEDIUM PLASTIC / HIGHLY PLASTIC
DENSITY (COHESIVE CLAYS & SILTS): SOFT / FIRM / STIFF / VERY STIFF / HARD
MOISTURE: DRY / (SLIGHTLY MOIST) / MOIST / WET / SATURATED / SUPER SATURATED
DISCOLORATION/STAINING OBSERVED: (YES) / NO EXPLANATION - Great Streaking
HC ODOR DETECTED: (YES) / NO EXPLANATION - Moderate
SAMPLE TYPE: (GRAB) / COMPOSITE - # OF PTS. —
ADDITIONAL COMMENTS: 12' x 12' x 8' Deep Earthen Pit. Use Backhoe to Remove impacted Soils in Pit area to Claystone surface @ 7' BG.

EXCAVATION APPROX. 15 FT. x 15 FT. x 7 FT. DEEP. CUBIC YARDAGE: 42 ±
DISPOSAL FACILITY: BP CROUCH MESA L.F. REMEDIATION METHOD: EXCAVATE
LAND USE: RANGE - STATE LEASE: STATE FORMATION: PC

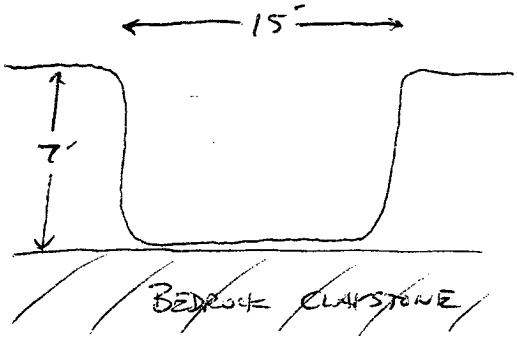
PIT PROFILE

SAMPLE ID	FIELD HEADSPACE (ppm)
1 @ 7'	290
2 @	
3 @	
4 @	
5 @

SAMPLE ID	ANALYSIS	TIME
1 @ 7'	TPH / BTEX	1610
	PASSED
