Pit or Below-Grade Tank Registration or Closure

Operator: Dugan Production Corp Telephone: (505)325-1821 e-mail address:
Address: P.O. Box 420, Farmington, New Mexico 87401
Facility or well name: Bronze Medal No. 1 API #: 30-045-26435 U/L or Qtr/Qtr D Sec 3 T 23N R 10W
County: San Juan Latitude 36.26175 Longitude 107.88846 NAD: 1927 ☐ 1983 ☐ Surface Owner Federal ☒ State ☐ Private ☐ Indian ☐

FIELD REPORT: PIT CLOSURE VERIFICATION

LOCATION: NAME: BRONZE MEDAL WELL #: 1 TYPE: SEP
QUAD/UNIT: D SEC: 3 TWP: 23N RNG: 10 W PM: NM CNTY: SJ ST: NM
QTR/FOOTAGE: 490 FNL x 970 FWL CONTRACTOR: R.W. Miller

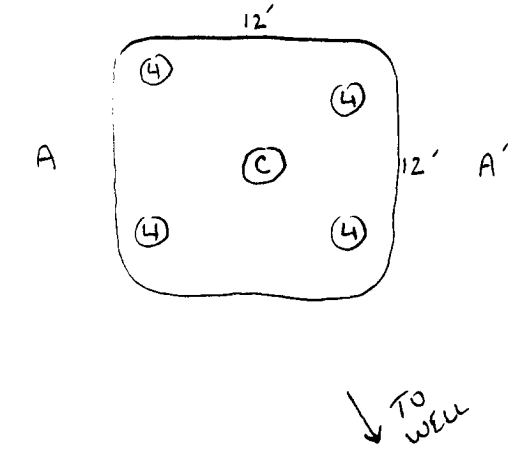
PIT PERIMETER

FIELD NOTES & REMARKS: PIT LOCATED APPROXIMATELY 66 FT. N35W FROM WELLHEAD.
DEPTH TO GROUNDWATER: >100 NEAREST WATER SOURCE: >1000 NEAREST SURFACE WATER: >1000
NMOCD RANKING SCORE: 0 NMOCD TPH CLOSURE STD: 5000 PPM

SOIL TYPE: (SAND / SILTY SAND) / SILT / SILTY CLAY / CLAY / GRAVEL / (OTHER) CLAYSTONE @ 9'
SOIL COLOR: LITE TAN
COHESION (ALL OTHERS): (NON COHESIVE) / SLIGHTLY COHESIVE / COHESIVE / HIGHLY COHESIVE
CONSISTENCY (NON COHESIVE SOILS): (LOOSE) / FIRM / DENSE / VERY DENSE
PLASTICITY (CLAYS): NON PLASTIC / SLIGHTLY PLASTIC / COHESIVE / MEDIUM PLASTIC / HIGHLY PLASTIC
DENSITY (COHESIVE CLAYS & SILTS): SOFT / FIRM / STIFF / VERY STIFF / HARD
MOISTURE: DRY / (SLIGHTLY MOIST) / MOIST / WET / SATURATED / SUPER SATURATED
DISCOLORATION/STAINING OBSERVED: (YES) / NO EXPLANATION - FROM PIT BASE TO 9' - GRAY STREAKING
HC ODOR DETECTED: (YES) / NO EXPLANATION - MODERATE TO 9'
SAMPLE TYPE: GRAB / COMPOSITE - # OF PTS. ____
ADDITIONAL COMMENTS: 12'x12'x4' ± Deep Unlined Pit. USE BACKHOE TO DIG INTO PIT & COLLECT SAMPLES.

Propose to fill pit with clean fill and close in place as is.

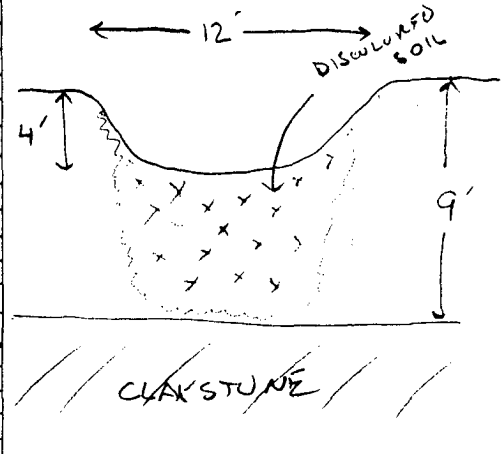
PIT PROFILE

SAMPLE ID	FIELD HEADSPACE (ppm)
1 @	
2 @	
3 @	
4 @	
5 @	
(4) @ 10'	81
(C) @ 10'	96
