Pit or Below-Grade Tank Registration or Closure

Operator: BP AMERICA PROD. CO. Telephone: (505)-326-9200 e-mail address:
Address: 200 ENERGY COURT. FARMINGTON. NM 87410
Facility or well name: MANSFIELD #1A API #: 30-045- 22026 U/L or Qtr/Qtr A Sec 19 T 30N R 9W
County: SAN JUAN Latitude 36.80225 Longitude 107.81525 NAD: 1927 ☐ 1983 ☒ Surface Owner Federal ☒ State ☐ Private ☐ Indian ☐

FIELD REPORT: PIT CLOSURE VERIFICATION

LOCATION: NAME: MANSFIELD WELL #: 1A TYPE: DEMT
QUAD/UNIT: A SEC: 19 TWP: 30N RNG: 9W PM: NM CNTY: SJ ST: NM
QTR/FOOTAGE: 815 FNL x 850 FEL NE/NE CONTRACTOR: PxS (Tremie)

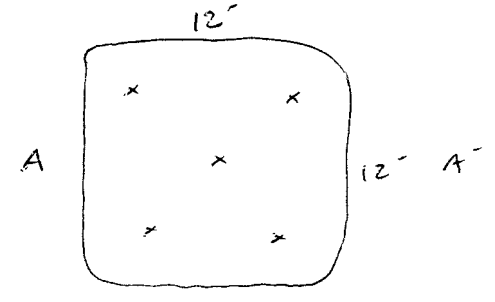
PIT PERIMETER

FIELD NOTES & REMARKS: PIT LOCATED APPROXIMATELY 93 FT. S 20W FROM WELLHEAD.

SOIL TYPE. (SAND) / SILTY SAND / SILT / SILTY CLAY / CLAY / GRAVEL / OTHER
SOIL COLOR: Lite Tan
COHESION (ALL OTHERS): (NON COHESIVE) / SLIGHTLY COHESIVE / COHESIVE / HIGHLY COHESIVE
CONSISTENCY (NON COHESIVE SOILS): (LOOSE) / FIRM / DENSE / VERY DENSE
PLASTICITY (CLAYS): NON PLASTIC / SLIGHTLY PLASTIC / COHESIVE / MEDIUM PLASTIC / HIGHLY PLASTIC
DENSITY (COHESIVE CLAYS & SILTS): SOFT / FIRM / STIFF / VERY STIFF / HARD
MOISTURE: DRY / (SLIGHTLY MOIST) / MOIST / WET / SATURATED / SUPER SATURATED
DISCOLORATION/STAINING OBSERVED: YES (NO) EXPLANATION -
HC ODOR DETECTED: YES / (NO) EXPLANATION -
SAMPLE TYPE GRAB / (COMPOSITE) # OF PTS. 5
ADDITIONAL COMMENTS: 12'x12'x3' Deep Dehy Pit (Abandon) - Previously w/ 21 Steel Tank - collect 5-Point Composite w/ Backhoe

CLOSED
