Pit or Below-Grade Tank Registration or Closure

Operator: BP AMERICA PROD. CO. Telephone: (505)-326-9200 e-mail address:
Address: 200 ENERGY COURT, FARMINGTON, NM 87410
Facility or well name: CHAVEZ GC A #1A API #: 30-045- 22302 U/L or Qtr/Qtr P Sec 3 T 29N R 9W
County: SAN JUAN Latitude 36.74858 Longitude 107.76009 NAD: 1927 ☐ 1983 ☒ Surface Owner Federal ☒ State ☐ Private ☐ Indian ☐

FIELD REPORT: PIT CLOSURE VERIFICATION

LOCATION: NAME: CHAVEZ GC A WELL #: 1A TYPE: SEPARATOR

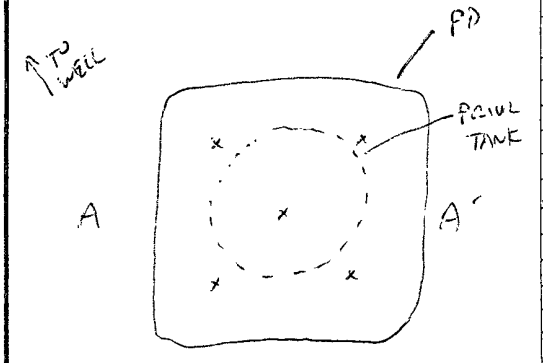
PIT PERIMETER

FIELD NOTES & REMARKS: PIT LOCATED APPROXIMATELY 99 FT. S33E FROM WELLHEAD.

ADDITIONAL COMMENTS: 18'x12'x6' Deep Pit (EXCAVATED INTO SANDSTONE) w/ 95 BBL steel Pit tank Used Backhoe to Fill tank & Scrape S.S. surface.

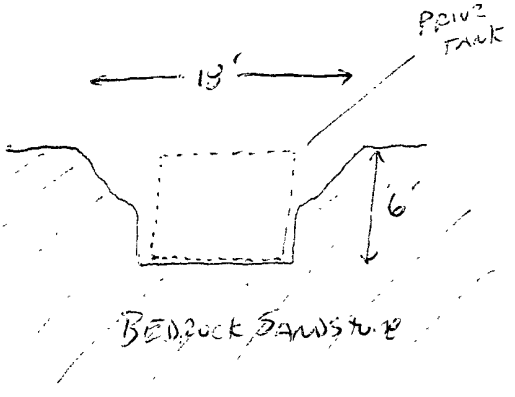
PIT PROFILE

BEDROCK BOTTOM

SAMPLE ID	FIELD HEADSPACE (ppm)
1 @	
2 @	
3 @	
4 @	
5 @	
5-POINT	
COMPOSITE	
@ 6'
