Meter Number:93649
Location Name:FARMING E #1E
Location:TN-24 RG-06
SC-02 UL-I
1 - State
NMOCD Zone:OUTSIDE
Hazard Ranking Score:00

RATIONALE FOR RISK-BASED CLOSURE OF PRODUCTION PITS LOCATED OUTSIDE OF THE VULNERABLE ZONE IN THE SAN JUAN BASIN

FIELD PIT SITE ASSESSMENT FORM

FIELD PIT REMEDIATION/CLOSURE FORM

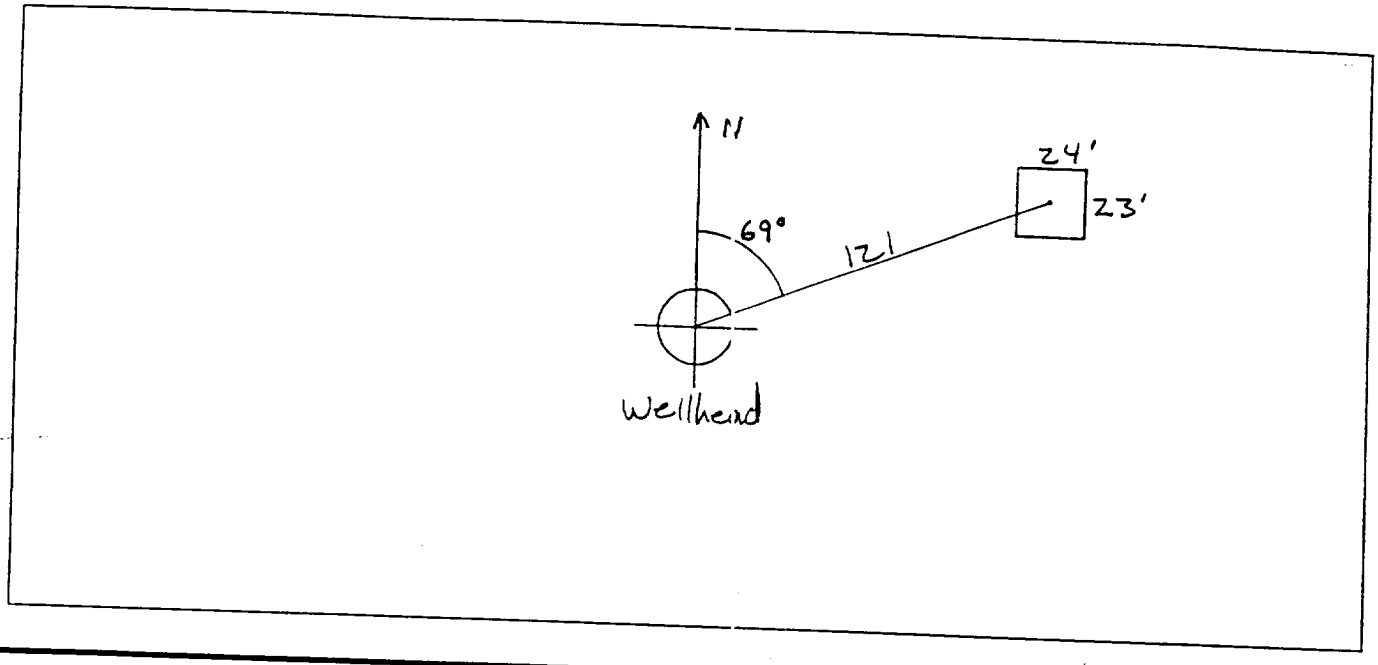
ORIGINAL PIT LOCATION

Remarks : Redline - outside VZ. Topo VZ - outside
Two pits - water & oil in drip pit

Original Pit : a) Degrees from North 69 Footage from Wellhead 121

b) Length : 24 Width : 23 Depth : 4

oil & water in pit ~1000 gal
