Meter Number:72433
Location Name:SAN JUAN 27-5 UNIT #47 PC
Location:TN-27 RG-05
SC-18 UL-K
2 - Federal
NMOCD Zone:OUTSIDE
Hazard Ranking Score:00

RATIONALE FOR RISK-BASED CLOSURE OF PRODUCTION PITS LOCATED OUTSIDE OF THE VULNERABLE ZONE IN THE SAN JUAN BASIN

FIELD PIT SITE ASSESSMENT FORM

FIELD PIT REMEDIATION/CLOSURE FORM

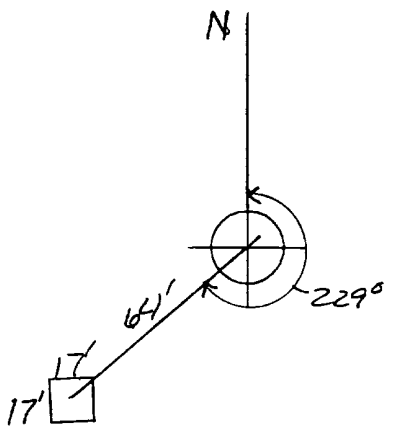
ORIGINAL PIT LOCATION

Remarks : 2 PITS ON LOCATION, ONE PIT TO BE CLOSED

Original Pit : a) Degrees from North 229° Footage from Wellhead 64'

b) Length : 17' Width : 17' Depth : 3'
