RATIONALE FOR RISK-BASED CLOSURE OF PRODUCTION PITS LOCATED OUTSIDE OF THE VULNERABLE ZONE IN THE SAN JUAN BASIN

FIELD PIT SITE ASSESSMENT FORM

Meter: 72411 Location: San Juan 28-7 Unit #95 PC

FIELD PIT REMEDIATION/CLOSURE FORM

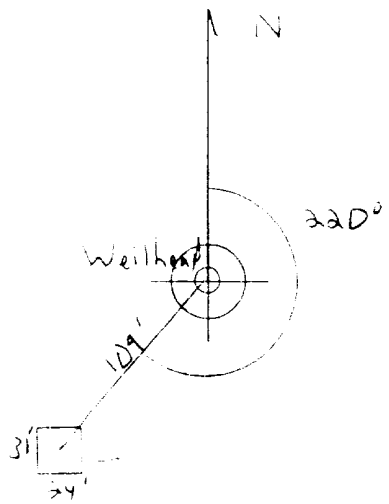
ORIGINAL PIT LOCATION

Original Pit : a) Degrees from North 220° Footage from Wellhead 109'

b) Length : 31' Width : 24' Depth : 5'
