Meter Number:87329
Location Name:SAN JUAN 28-7 UNIT #153
Location:TN-27 RG-07
SC-20 UL-A
2 - Federal
NMOCD Zone:OUTSIDE
Hazard Ranking Score:00

RATIONALE FOR RISK-BASED CLOSURE OF PRODUCTION PITS LOCATED OUTSIDE OF THE VULNERABLE ZONE IN THE SAN JUAN BASIN

FIELD PIT SITE ASSESSMENT FORM

FIELD PIT REMEDIATION/CLOSURE FORM

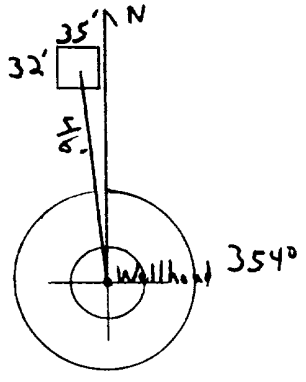
ORIGINAL PIT LOCATION

Remarks : Redline & Vuln - Outside 1 pit. Will Close. Pit Dry. Dehy still on pit. Dehy not taken over by operator as confirmed by Blanco Office

Original Pit : a) Degrees from North 354° Footage from Wellhead 46'

b) Length : 35' Width : 32' Depth : 5'
