Meter Number:75736
Location Name:NEWSOM A-6
Location:TN-26 RG-08
SC-15 UL-J
2 - Federal
NMOCD Zone:OUTSIDE
Hazard Ranking Score:00

RATIONALE FOR RISK-BASED CLOSURE OF PRODUCTION PITS LOCATED OUTSIDE OF THE VULNERABLE ZONE IN THE SAN JUAN BASIN

FIELD PIT SITE ASSESSMENT FORM

FIELD PIT REMEDIATION/CLOSURE FORM

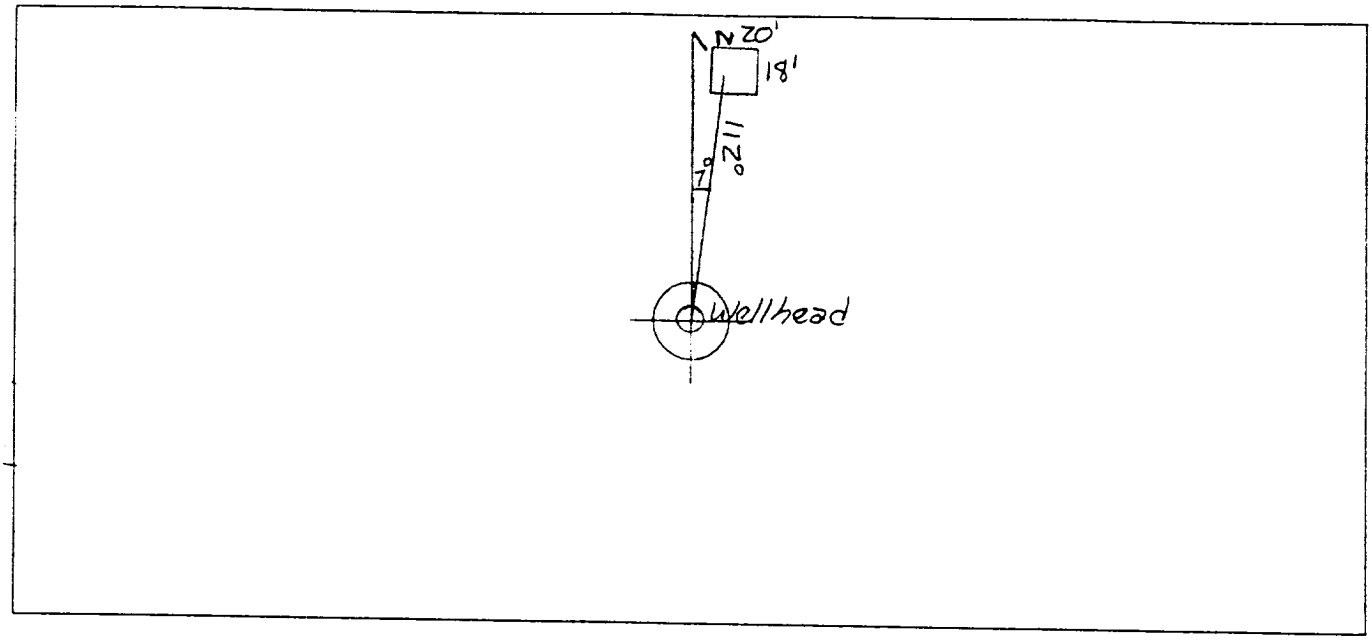
Remarks : Redline Book - Outside Vulnerable Zone Topo - Outside
Two pits on site, location drip pit is dry, will close one pit.

Original Pit : a) Degrees from North 7° Footage from Wellhead 112'

b) Length : 20' Width : 18' Depth : 2'
