Meter Number:73516
Location Name:SAN JUAN 28-5 #54
Location:TN-28 RG-05
SC-20 UL-M
2 - Federal
NMOCD Zone:OUTSIDE
Hazard Ranking Score:00

RATIONALE FOR RISK-BASED CLOSURE OF PRODUCTION PITS LOCATED OUTSIDE OF THE VULNERABLE ZONE IN THE SAN JUAN BASIN

FIELD PIT SITE ASSESSMENT FORM

FIELD PIT REMEDIATION/CLOSURE FORM

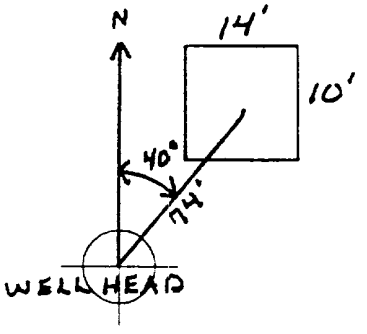
ORIGINAL PIT LOCATION

Original Pit : a) Degrees from North 40° Footage from Wellhead 74'

b) Length : 14' Width : 10' Depth : 2'
