Meter Number:75468 75469
Location Name:LARGO FED 1 DK & MV
Location:TN-27 RG-08
SC-34 UL-L
2 - Federal
NMOCD Zone:OUTSIDE
Hazard Ranking Score:00

RATIONALE FOR RISK-BASED CLOSURE OF PRODUCTION PITS LOCATED OUTSIDE OF THE VULNERABLE ZONE IN THE SAN JUAN BASIN

FIELD PIT SITE ASSESSMENT FORM

FIELD PIT REMEDIATION/CLOSURE FORM

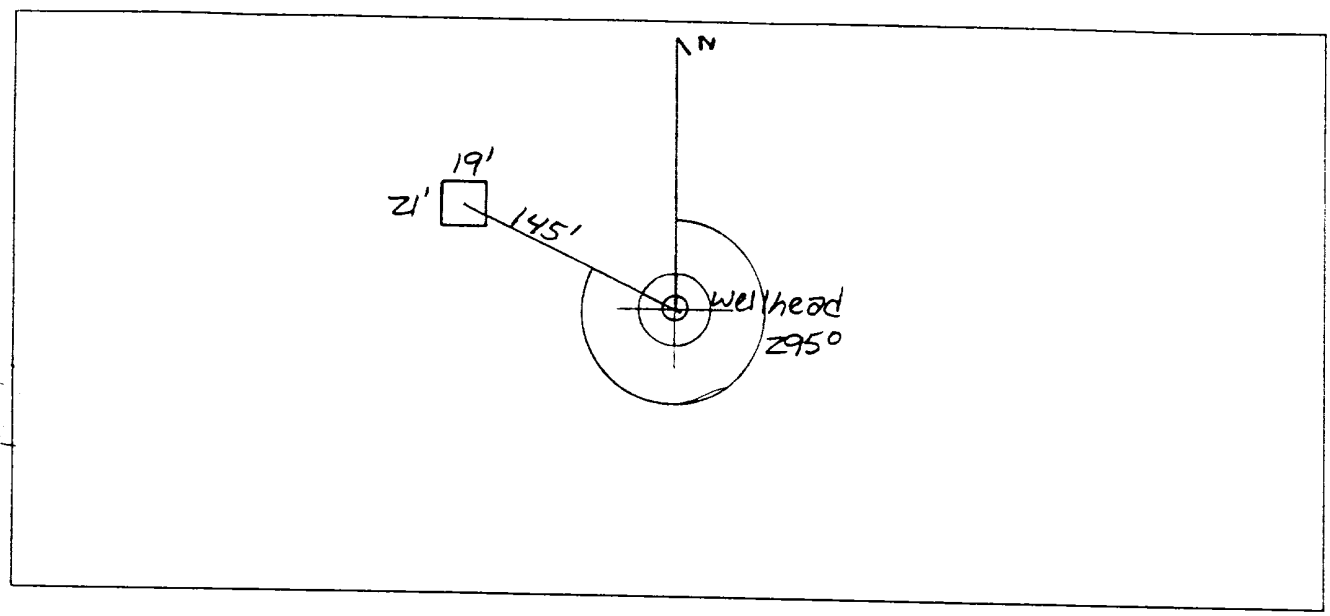
Remarks : Redline Book - Outside Vulnerable Zone Topo - Outside
Three pits on-site, location drip pit is dry. Will close one pit.

Original Pit : a) Degrees from North 295° Footage from Wellhead 145'

b) Length : 21' Width : 19' Depth : 5'
