Meter Number:93384
Location Name:MARTIN GAS COM G #1E
Location:TN-27 RG-10
SC-14 UL-J
2 - Federal
NMOCD Zone:OUTSIDE
Hazard Ranking Score:00

RATIONALE FOR RISK-BASED CLOSURE OF PRODUCTION PITS LOCATED OUTSIDE OF THE VULNERABLE ZONE IN THE SAN JUAN BASIN

FIELD PIT SITE ASSESSMENT FORM

FIELD PIT REMEDIATION/CLOSURE FORM

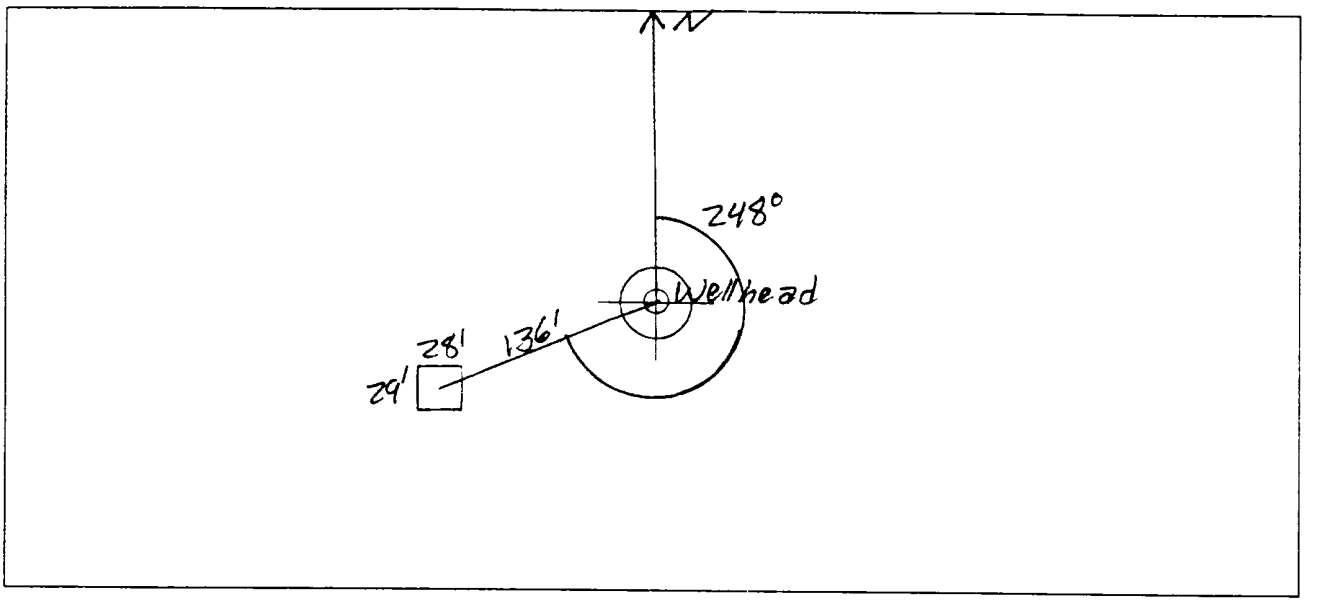
ORIGINAL PIT LOCATION

Remarks : Redline book: Outside, Vulnerable Zone Topo: Outside
Three pits, location drip pit is dry. Will close one pit.
PUSH IN

Original Pit : a) Degrees from North 248° Footage from Wellhead 136'

b) Length : 29' Width : 28' Depth : 5'
