Meter Number:93480
Location Name:MARTIN GAS COM E #1E
Location:TN-27 RG-10
SC-15 UL-C
2 - Federal
NMOCD Zone:OUTSIDE
Hazard Ranking Score:00

RATIONALE FOR RISK-BASED CLOSURE OF PRODUCTION PITS LOCATED OUTSIDE OF THE VULNERABLE ZONE IN THE SAN JUAN BASIN

FIELD PIT SITE ASSESSMENT FORM

FIELD PIT REMEDIATION/CLOSURE FORM

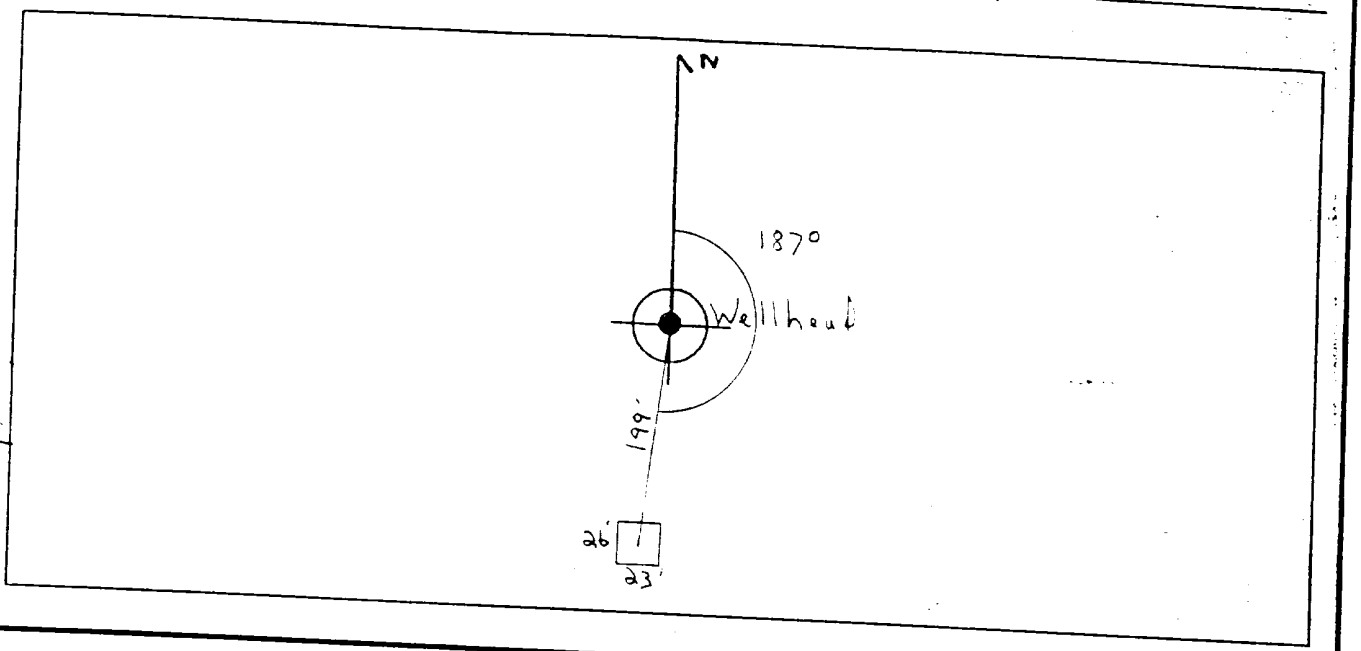
Remarks : Redline Book - Outside Vulnerable Zone Topo - Outside
2 pits. Will close 1. Pit dry

Original Pit : a) Degrees from North 187° Footage from Wellhead 199'

b) Length : 26' Width : 23' Depth : 6'
