RATIONALE FOR RISK-BASED CLOSURE OF PRODUCTION PITS LOCATED OUTSIDE OF THE VULNERABLE ZONE IN THE SAN JUAN BASIN

FIELD PIT SITE ASSESSMENT FORM

Meter: 71403 Location: SAN JUAN 29-5 #14
Operator #: _____ Operator Name: PHILLIPS P/L District: BLOOMFIELD
Coordinates: Letter: G Section 27 Township: 29 Range: 5
Or Latitude _____ Longitude _____
Pit Type: Dehydrator X Location Drip: ___ Line Drip: ___ Other: _____
Site Assessment Date: 2.24.95 Area: 10 Run: 71

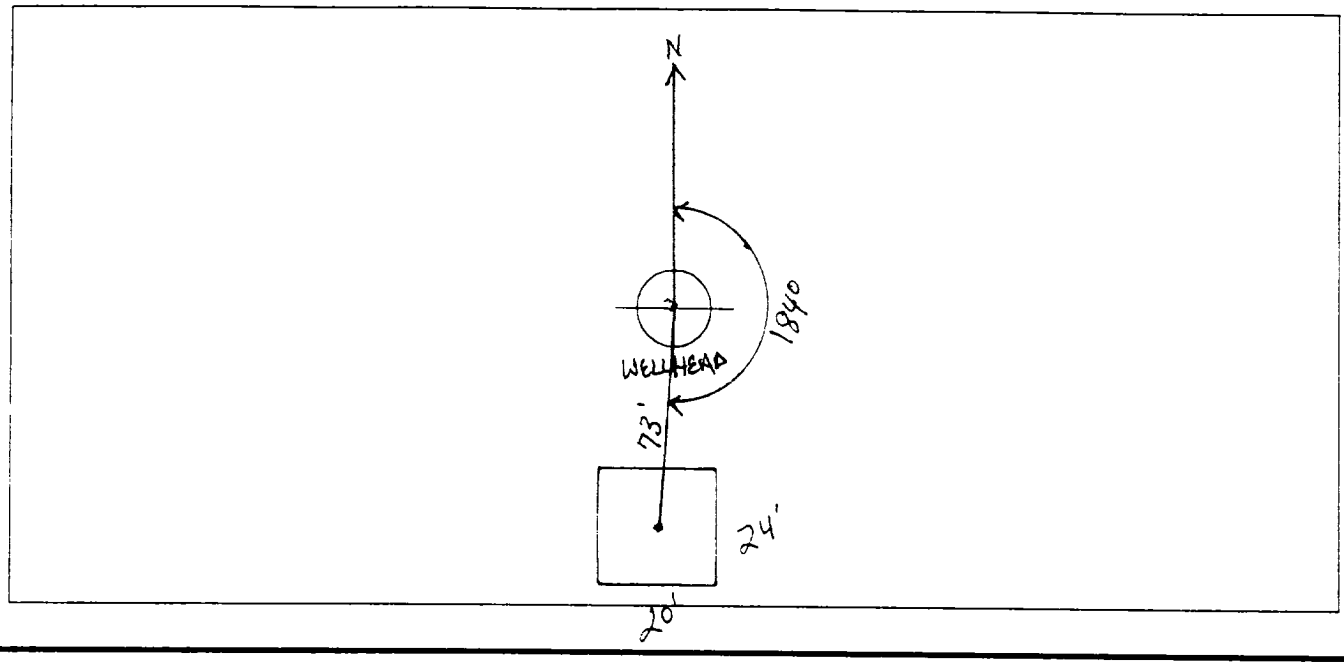
ORIGINAL PIT LOCATION

Original Pit : a) Degrees from North 184° Footage from Wellhead 73'

b) Length : 24' Width : 20' Depth : 3'
