Meter Number:70840
Location Name:SAN JUAN 29-6 #11-7
Location:TN-29 RG-06
SC-07 UL-M
4 - Fee
NMOCD Zone:OUTSIDE
Hazard Ranking Score:00

RATIONALE FOR RISK-BASED CLOSURE OF PRODUCTION PITS LOCATED OUTSIDE OF THE VULNERABLE ZONE IN THE SAN JUAN BASIN

FIELD PIT SITE ASSESSMENT FORM

FIELD PIT REMEDIATION/CLOSURE FORM

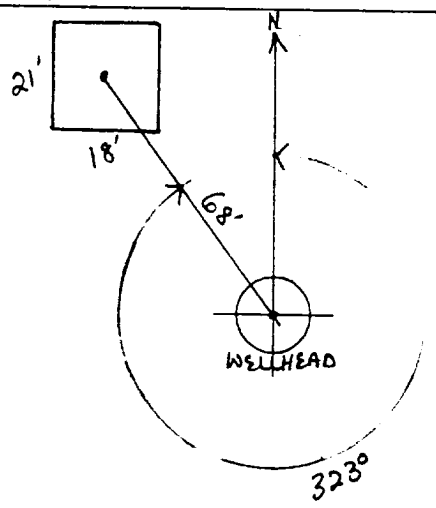
ORIGINAL PIT LOCATION

Original Pit : a) Degrees from North 323° Footage from Wellhead 68'

b) Length : 21' Width : 18' Depth : 3'
