Meter Number:90968
Location Name:HUGHES #6
Location:TN-29 RG-08
SC-29 UL-C
2 - Federal
NMOCD Zone:OUTSIDE
Hazard Ranking Score:00

RATIONALE FOR RISK-BASED CLOSURE OF PRODUCTION PITS LOCATED OUTSIDE OF THE VULNERABLE ZONE IN THE SAN JUAN BASIN

FIELD PIT SITE ASSESSMENT FORM

FIELD PIT REMEDIATION/CLOSURE FORM

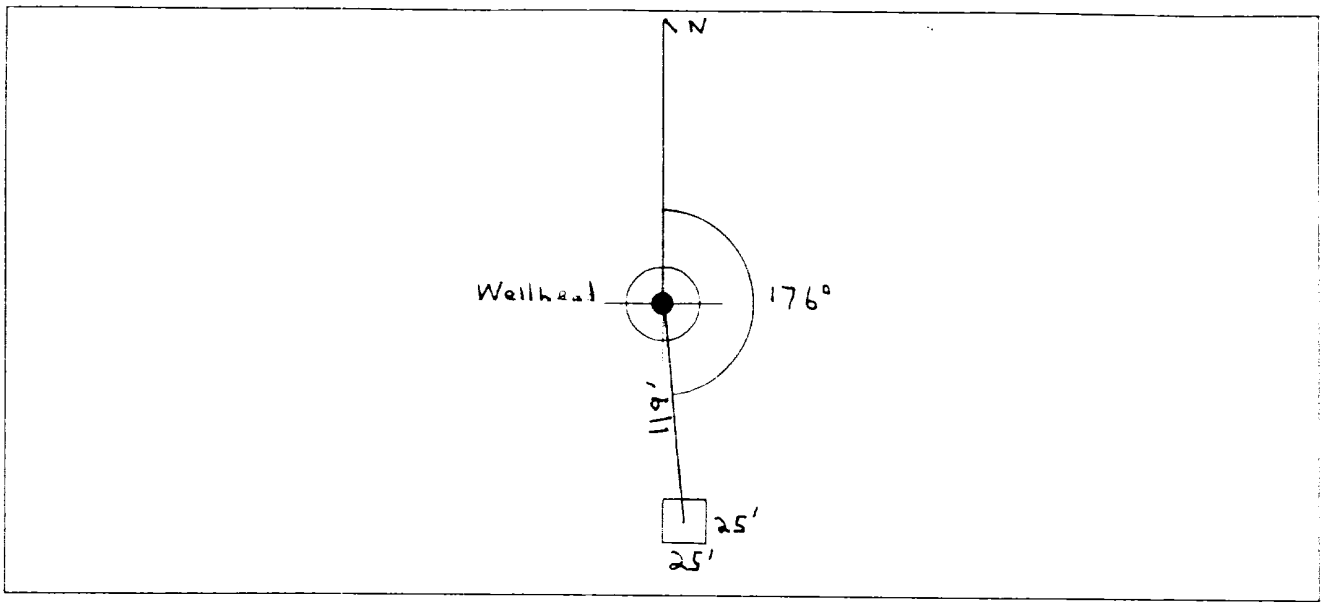
Remarks : Redline & Vulnerable Zone Tops - Outside 3 pits. Will close 1. Pit Dry

Original Pit : a) Degrees from North 176° Footage from Wellhead 119'

b) Length : 25' Width : 25' Depth : 4'
