Meter Number:89612
Location Name:CHAVEZ GAS COM A #1A
Location:TN-29 RG-09
SC-03 UL-P
2 - Federal
NMOCD Zone:OUTSIDE
Hazard Ranking Score:00

RATIONALE FOR RISK-BASED CLOSURE OF PRODUCTION PITS LOCATED OUTSIDE OF THE VULNERABLE ZONE IN THE SAN JUAN BASIN

FIELD PIT SITE ASSESSMENT FORM

FIEL_ PIT REMEDIATION/CLOSU_E FORM

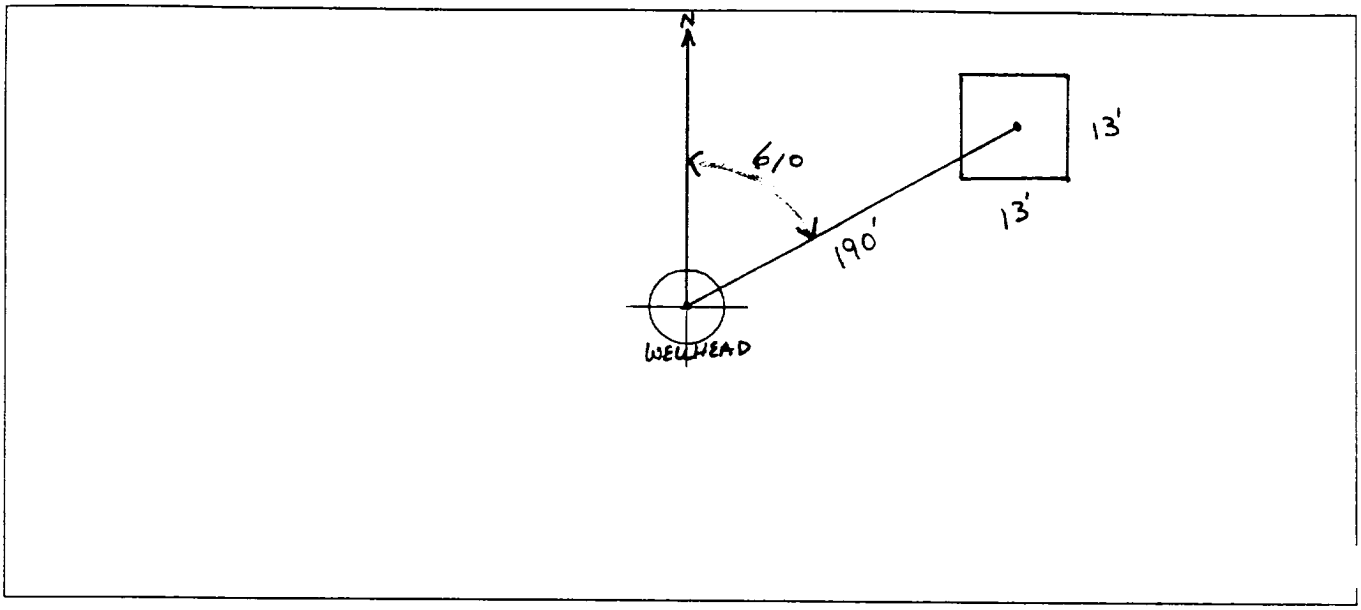
ORIGINAL PIT LOCATION

Original Pit : a) Degrees from North 61° Footage from Wellhead 190'

b) Length : 13' Width : 13' Depth : 2'
