ENVIROTECH Inc.

FIELD REPORT: SITE ASSESSMENT

JOB No: 93163
PAGE No: 1 of 1

LOCATION: LEASE SAN JUAN 30-5 WELL: # 83 DK QD: 950' FWL, 1480' FSL (L)
SEC: 23 TWP: 30 N RNG: 5 W PM: NM CNTY: R.A. ST: NM PIT: SEP.

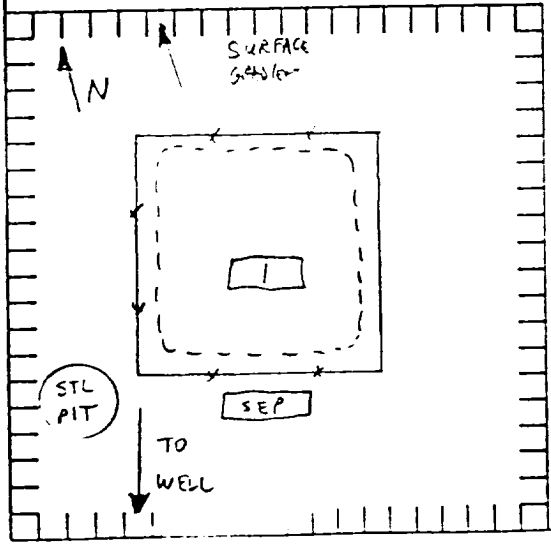
SITE DIAGRAM

FIELD NOTES & REMARKS: PIT IS LOCATED APPROX. 55 FEET N. 15° E. OF WELLHEAD
CLOSURE STD: < 1000 ppm TPH
T1: MOIST, BROWN/YELLOW, POORLY GRADED SAND. NO ODOR.
