Meter Number:75529
Location Name:D.J. Simmons #7 PC
Location:TN-29 RG-09
SC-25 UL-H
2 - Federal
NMOCD Zone:OUTSIDE
Hazard Ranking Score:00

RATIONALE FOR RISK-BASED CLOSURE OF PRODUCTION PITS LOCATED OUTSIDE OF THE VULNERABLE ZONE IN THE SAN JUAN BASIN

FIELD PIT SITE ASSESSMENT FORM

FIELD PIT REMEDIATION/CLOSURE FORM

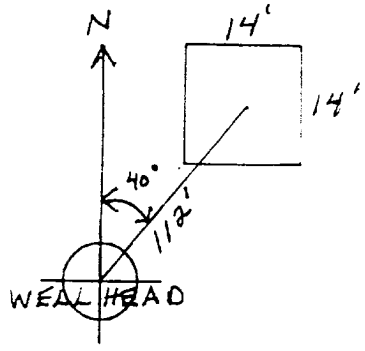
ORIGINAL PIT LOCATION

Original Pit : a) Degrees from North 40° Footage from Wellhead 112'

b) Length : 14' Width : 14' Depth : 3'
