PIT REMEDIATION AND CLOSURE REPORT

Operator: PNM Gas Services (Burlington) **Telephone:** 324-3764

Facility or Well Name: Grenier B #3E

Location: Unit J Sec 5 T 29N R 10W County San Juan

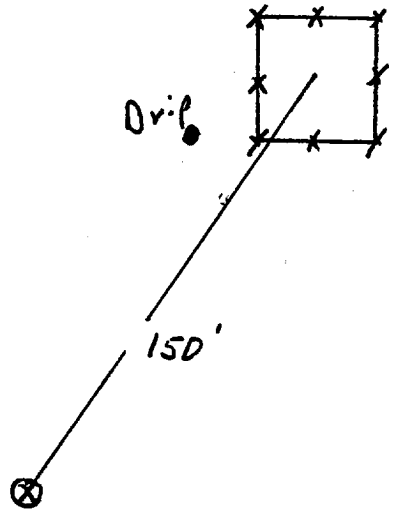
Site diagram:

Excavated contaminated soil to a pit size of 8' X 10' X 4' and landfarmed soil onsite within a bermed area at a depth of 6" to 12". Soil was aerated by disking/plowing until soil met regulatory levels.

***Sandstone encountered at 4'. See attached risk analysis form.

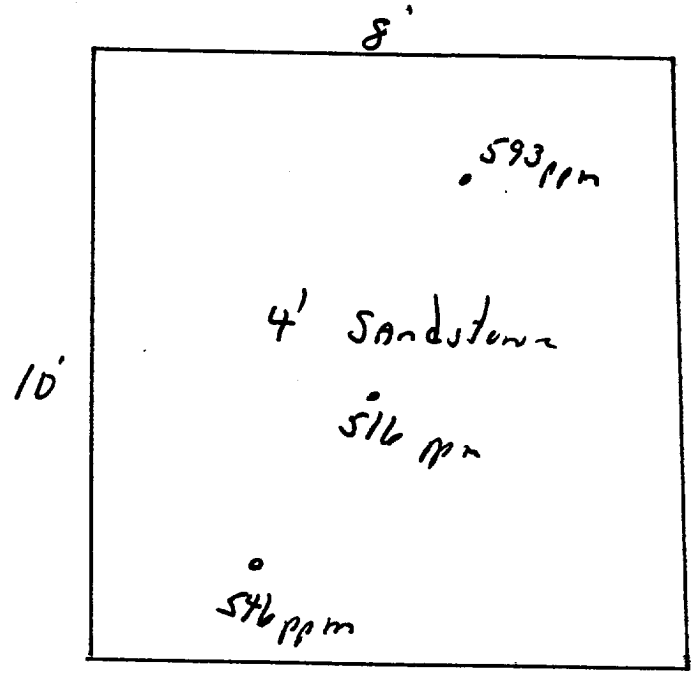
End of excavation:

Sample Location 3 pt. composite - bottom.
Sample depth 4'
Sample date 06/16/1999 Sample time 9:00:00 AM

Benzene (ppm) < 0.5
Total BTEX (ppm) 57.4 ***
Field headspace (ppm)
TPH (ppm) 710.00 Method 8015B

Headspace: 21.6 ppm (walls)

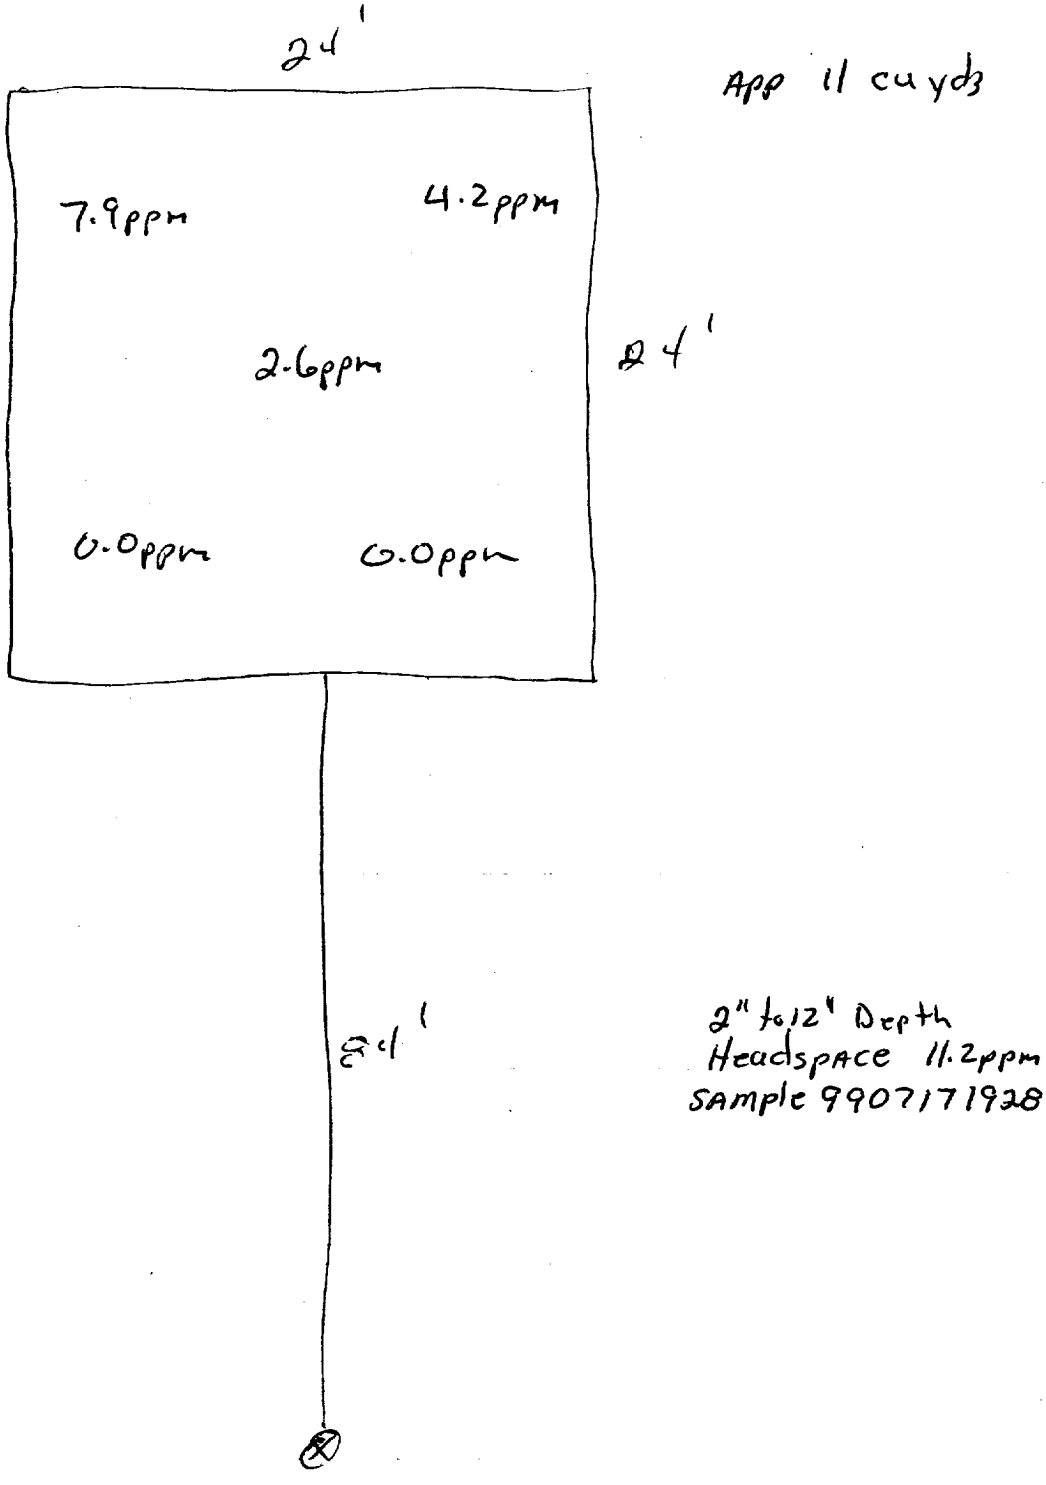
Landfarm drawing

App 11 cu yds

2" to 12" Depth
Headspace 11.2ppm
Sample 9907171928
