Meter Number:72440
Location Name:NEW MEXICO COM B#1
Location:TN-30 RG-10
SC-36 UL-D
1 - State
NMOCD Zone:OUTSIDE
Hazard Ranking Score:00

RATIONALE FOR RISK-BASED CLOSURE OF PRODUCTION PITS LOCATED OUTSIDE OF THE VULNERABLE ZONE IN THE SAN JUAN BASIN

FIELD PIT SITE ASSESSMENT FORM

FIEL PIT REMEDIATION/CLOSU FORM

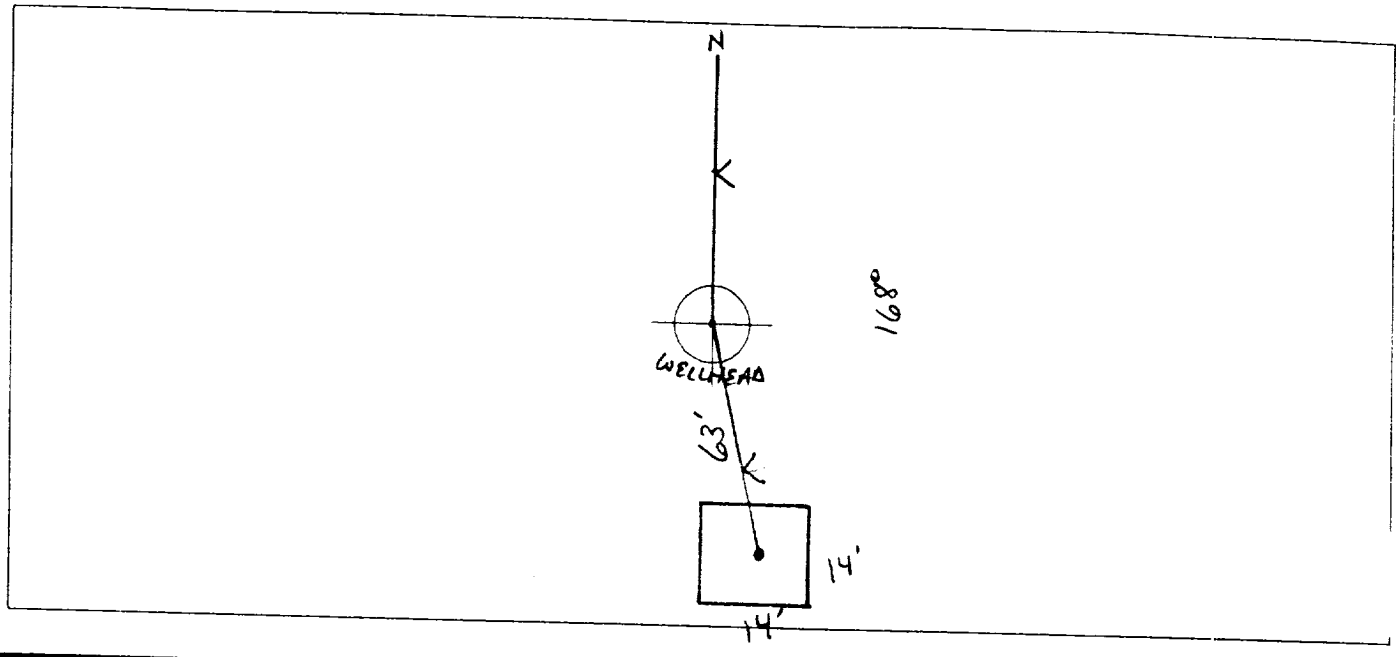
ORIGINAL PIT LOCATION

Remarks : ONLY PIT ON LOCATION. PIT IS DRY.

Original Pit : a) Degrees from North 168° Footage to Wellhead 63'

c) Length : 14' Width : 14' Depth : _____
