Meter Number:72373
Location Name:SAN JUAN 32-8 #21 MV
Location:TN-31 RG-08
SC-15 UL-A
2 - Federal
NMOCD Zone:OUTSIDE
Hazard Ranking Score:00

RATIONALE FOR RISK-BASED CLOSURE OF PRODUCTION PITS LOCATED OUTSIDE OF THE VULNERABLE ZONE IN THE SAN JUAN BASIN

FIELD PIT SITE ASSESSMENT FORM

FIEL PIT REMEDIATION/CLOS E FORM

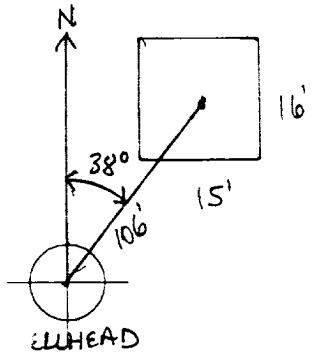
PUSH IN

ORIGINAL PIT LOCATION

Original Pit : a) Degrees from North 38° Footage from Wellhead 106'

b) Length : 16' Width : 15' Depth : 3'
