PIT REMEDIATION AND CLOSURE REPORT

Operator : Devon Energy Corporation Telephone: (505) 324-0033

Facility Or: N. E. Blanco Unit # 202
Well Name

FIELD PIT SITE ASSESSMENT FORM

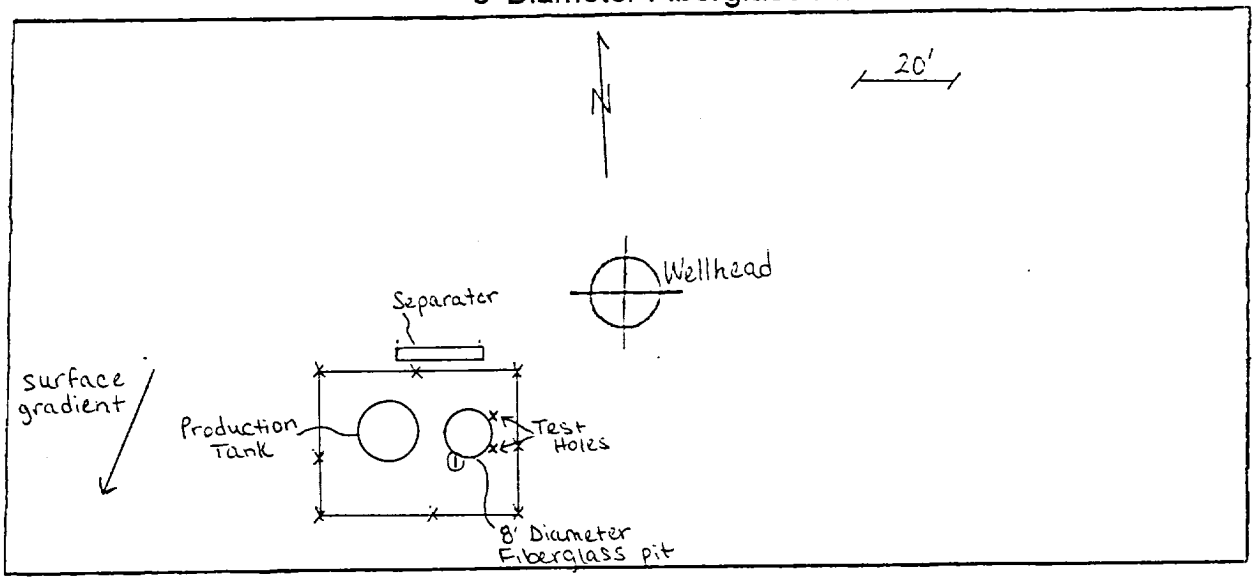
ORIGINAL PIT LOCATION

Original Pit : a) Degrees from North 235 Footage from Wellhead 45'

8' Diameter Fiberglass Pit

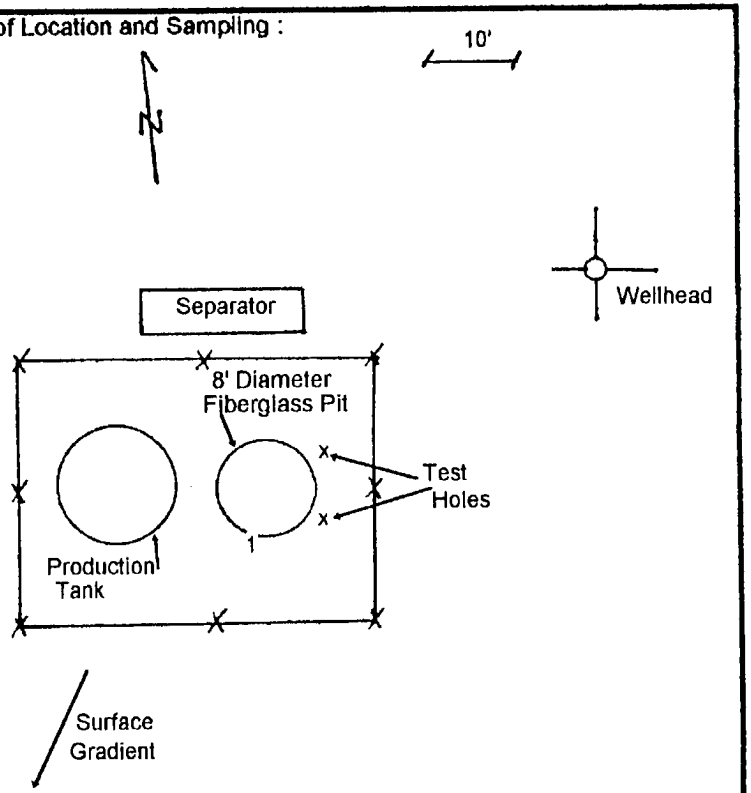
Overview of Location and Sampling :

Sample #	Location	OVM
1	Btm. @ 3'	1.2
2		
3		
4		
5		
6		
7		
8		
9		
10		
11		
12

Comments : Brown sandy clay, moist, no odor
