Meter Number:89278
Location Name:WALKER #1A
Location:TN-31 RG-10
SC-13 UL-P
2 - Federal
NMOCD Zone:OUTSIDE
Hazard Ranking Score:00

RATIONALE FOR RISK-BASED CLOSURE OF PRODUCTION PITS LOCATED OUTSIDE OF THE VULNERABLE ZONE IN THE SAN JUAN BASIN

FIELD PIT SITE ASSESSMENT FORM

FIEL PIT REMEDIATION/CLOSU E FORM

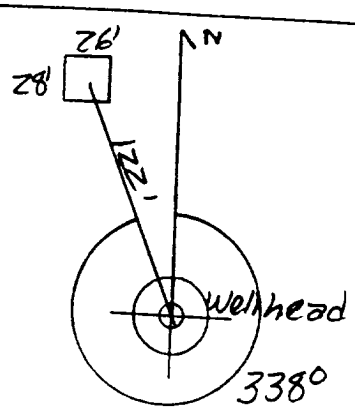
Remarks : Redline Book - Outside Vulnerable Zone Topo - Outside
Four pits, location drip pit has liquid in it, will close one pit.

Original Pit : a) Degrees from North 338° Footage from Wellhead 122'

b) Length : 28' Width : 26' Depth : 4'
