Release Notification

Site Name: DKS Truck Rollover Spill	Site Type: Intersection of HWY 206 and HWY 235
Date Release Discovered: 12/11/2018	API# *(if applicable)*

FIGURE 3
EXCAVATION SOIL SAMPLE LOCATIONS
DKS TRANSPORT TRUCKING ROLLOVER
UNIT G SEC 31 T18S R28E
EDDY COUNTY, NEW MEXICO
DKS TRANSPORT, LLC

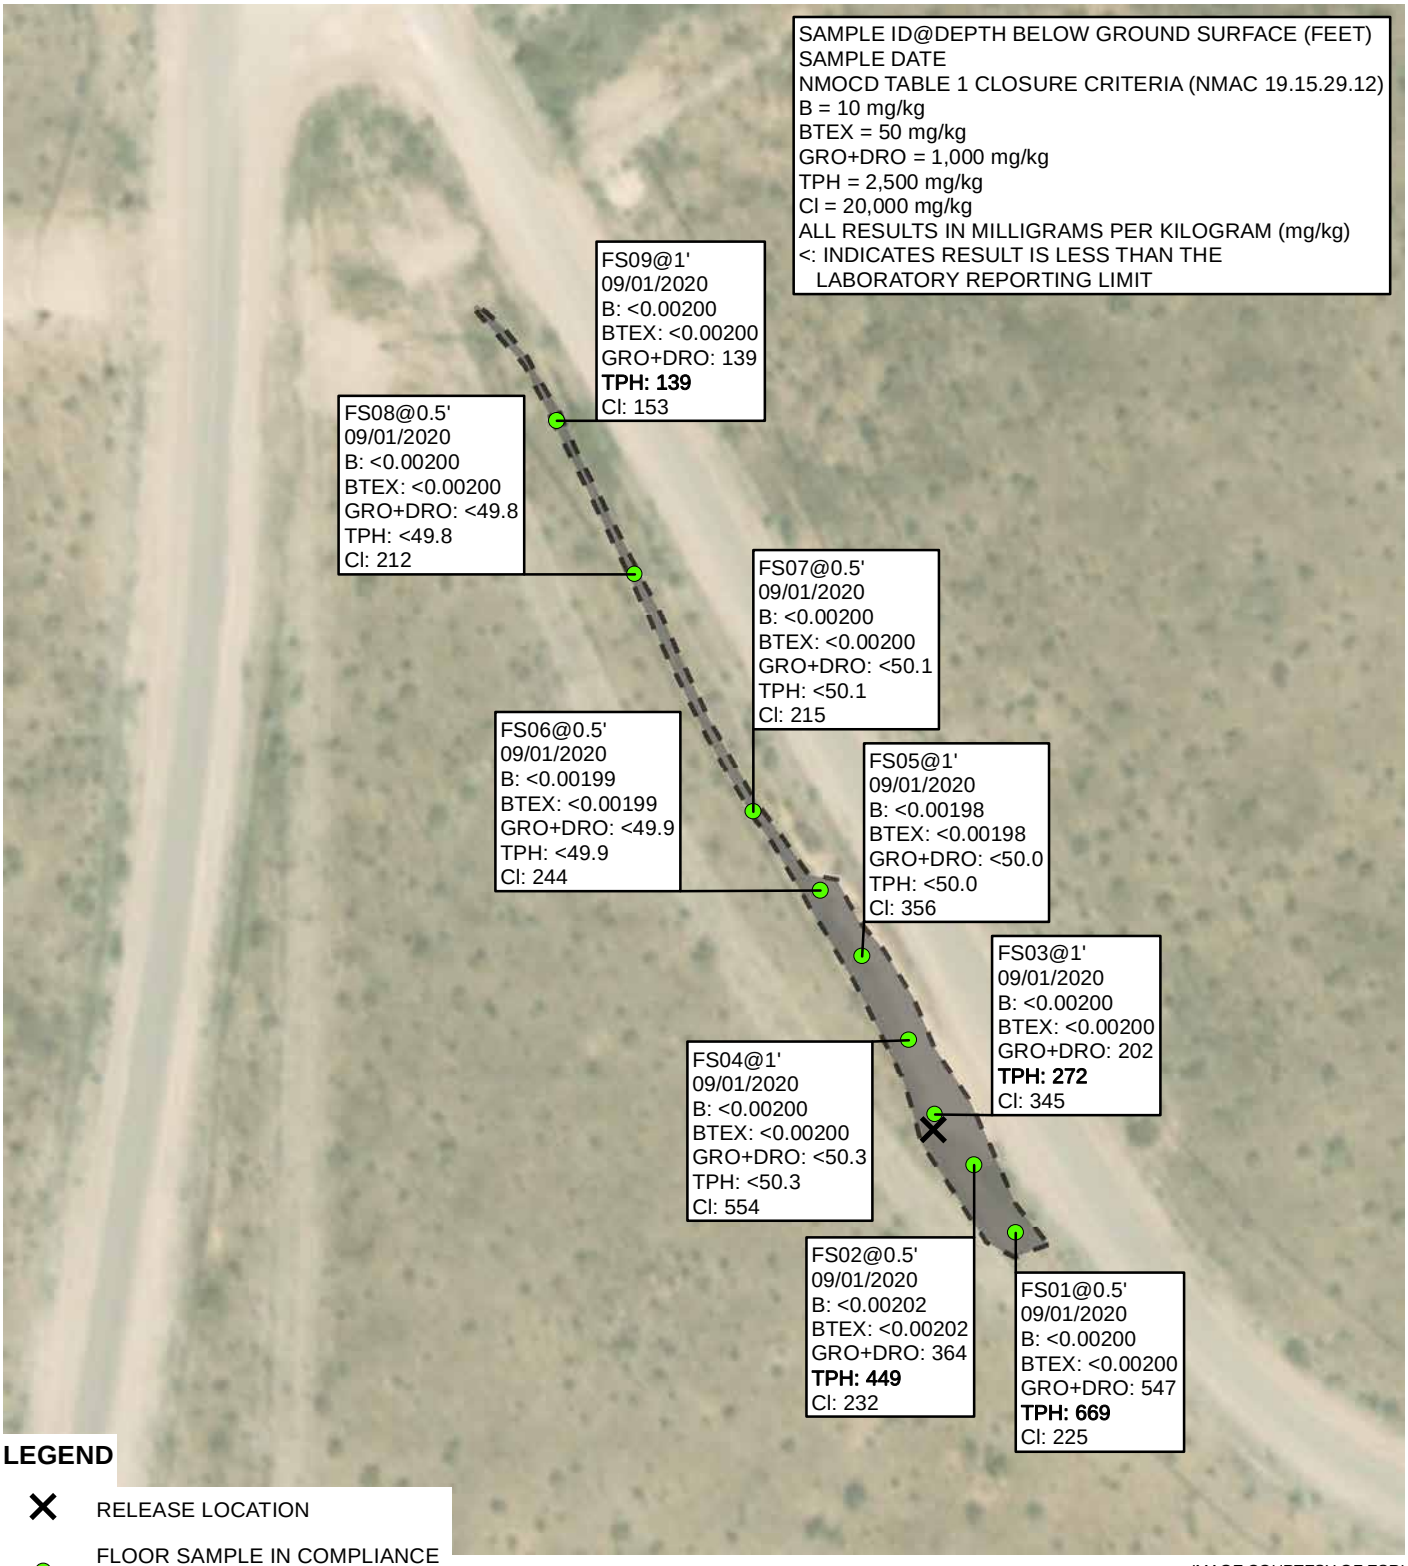
On September 1, 2020, LTE collected 5-point composite soil samples using an EPA-approved Visual Sampling Plan (VSP) from the excavation, which was developed in the Remediation Plan. The VSP is a plan based on statistical sampling theory, which provides a randomized sampling plan representative of the soils that remain in place after the excavation. Based upon the release area, the VSP recommends nine randomly placed, composite samples for laboratory analysis (Attachment 5). The 5-point composite samples were collected by placing five equivalent aliquots of soil into a 1-gallon, resealable plastic bag and homogenizing the samples by thoroughly mixing. A total of nine composite floor soil samples (FS01 through FS09) were collected from the excavation at depths ranging from approximately 0.5 feet bgs to 1.5 feet bgs. The excavation soil samples were collected, handled, and analyzed following the same procedures as described above. The locations of the final extent of the excavation and September 1, 2020 confirmation soil samples are presented on Figure 3.

On August 31, 2020, LTE personnel were at the Site to oversee site assessment and excavation activities. Impacted soil was excavated from the release extent as indicated by field screening activities, laboratory analytical results, and visible staining. Excavation activities were performed

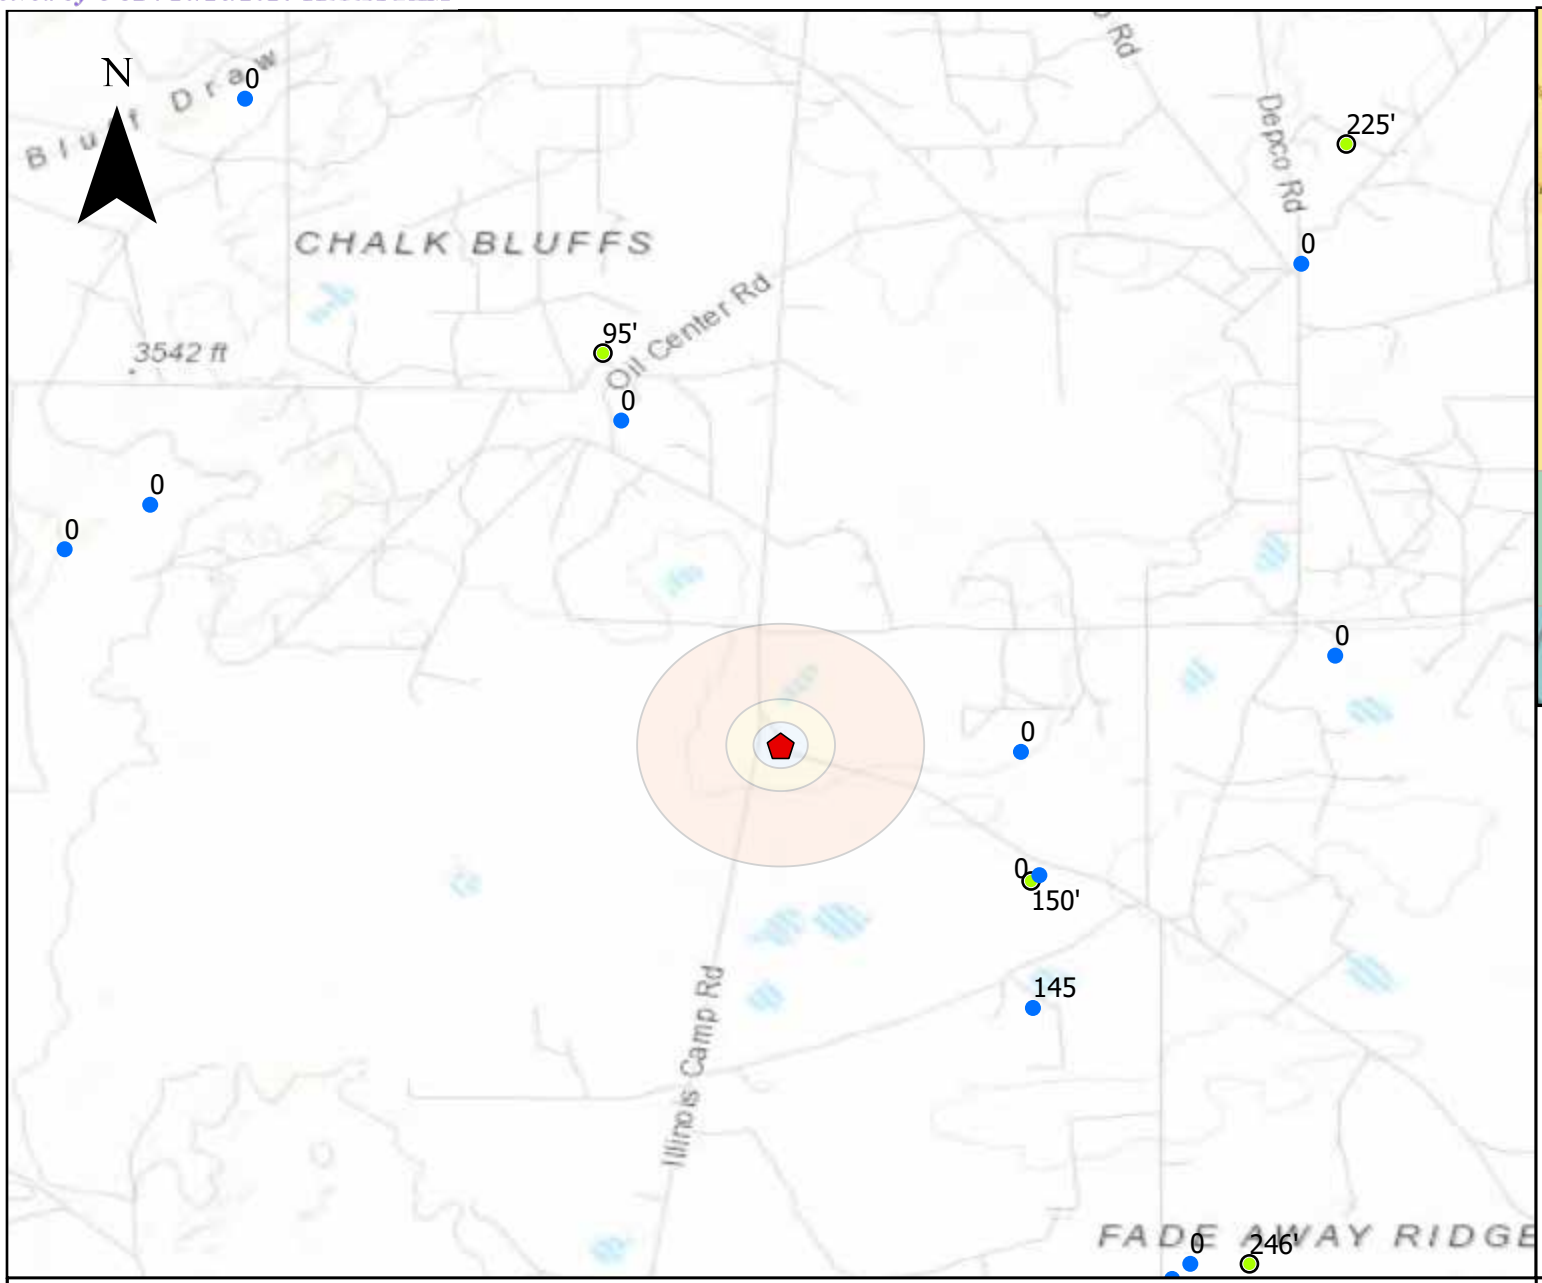
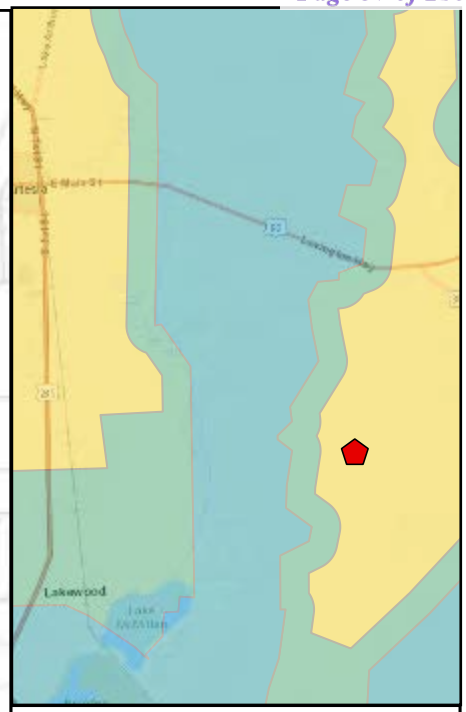
Figure 1

Based upon New Mexico Office of State Engineer (NMOSE) data, depth to groundwater in the area is estimated to be 167 feet below grade surface (bgs). There are no known water sources within ½-mile of the location (NMOSE Online Water Well Database, 2019). The nearest significant watercourse is the Pecos River, located approximately 5.1 miles to the west. Figure 2 illustrates the site with 100-, 200-, and 300-foot radii to indicate that it does not lie within a sensitive area as described in 19.15.29.12.C(4) NMAC. Pertinent well data is attached in Appendix D.

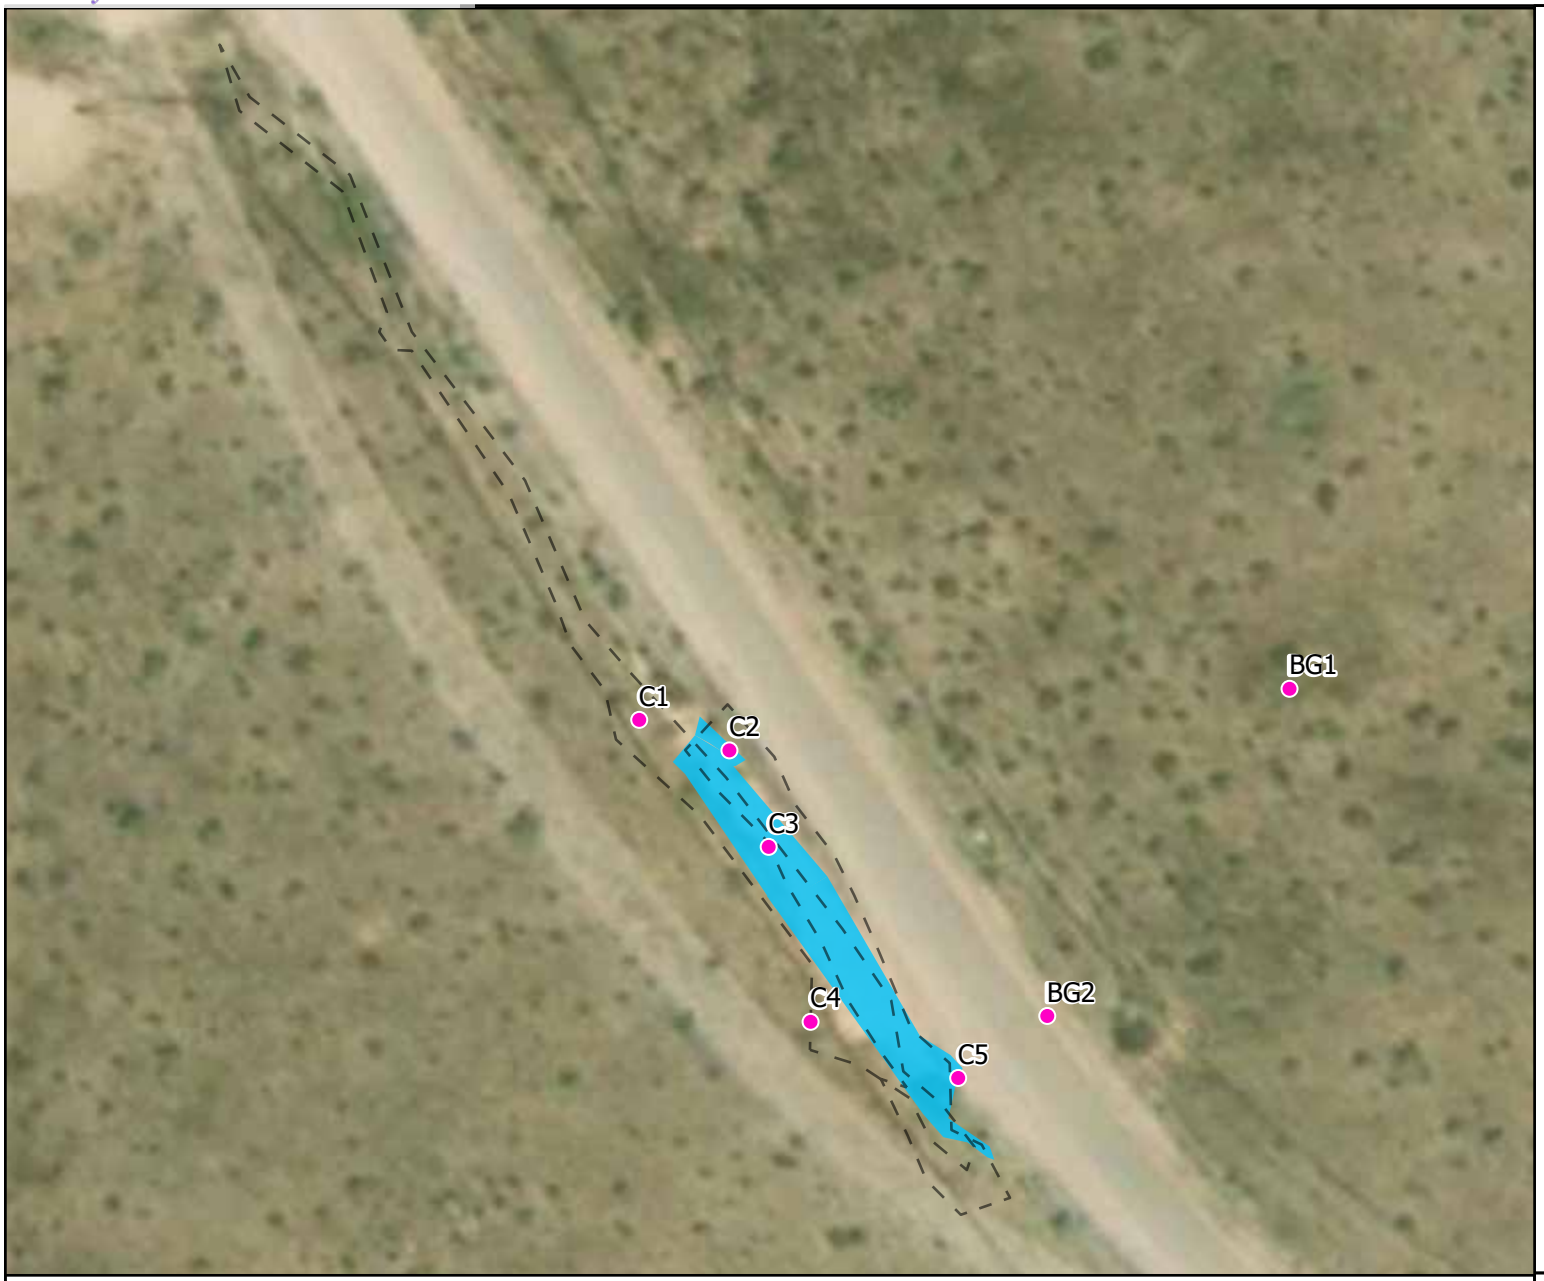
Figure 4

On July 2, 2019, SMA returned to the site to apply an in-situ oxidation product, Cool-Ox® to the southern portion of the site. Composite samples (C1-C5) were collected along the release area prior to application of the Cool-Ox® to establish a baseline for the treatment. At this time, two background samples, BG1 and BG2, were also collected from two different soil types from the opposite side of the adjacent road (Curry Comb Rd/235) in order to determine if high chloride concentrations in the soil are naturally occurring and pre-existing. Sample locations and the area of Cool-Ox® application is shown in Figure 4.
