Pima Environmental Services, LLC (Pima) has conducted a site assessment, soil sampling and has prepared this Closure Report on behalf of Devon Energy Production Company (Devon) for the Regulus 26 Federal #4H. These incidents were assigned NAB1900956626 (2RP-5166) and NRM2015053388 by the New Mexico Oil Conservation Division (NMOCD).

Regulus 26 Federal #4H
API 30-015-40041
Eddy County, NM
Location Map

Appendix E:
Photographic Documentation

Regulus 26 Fed #4H Liner Photos

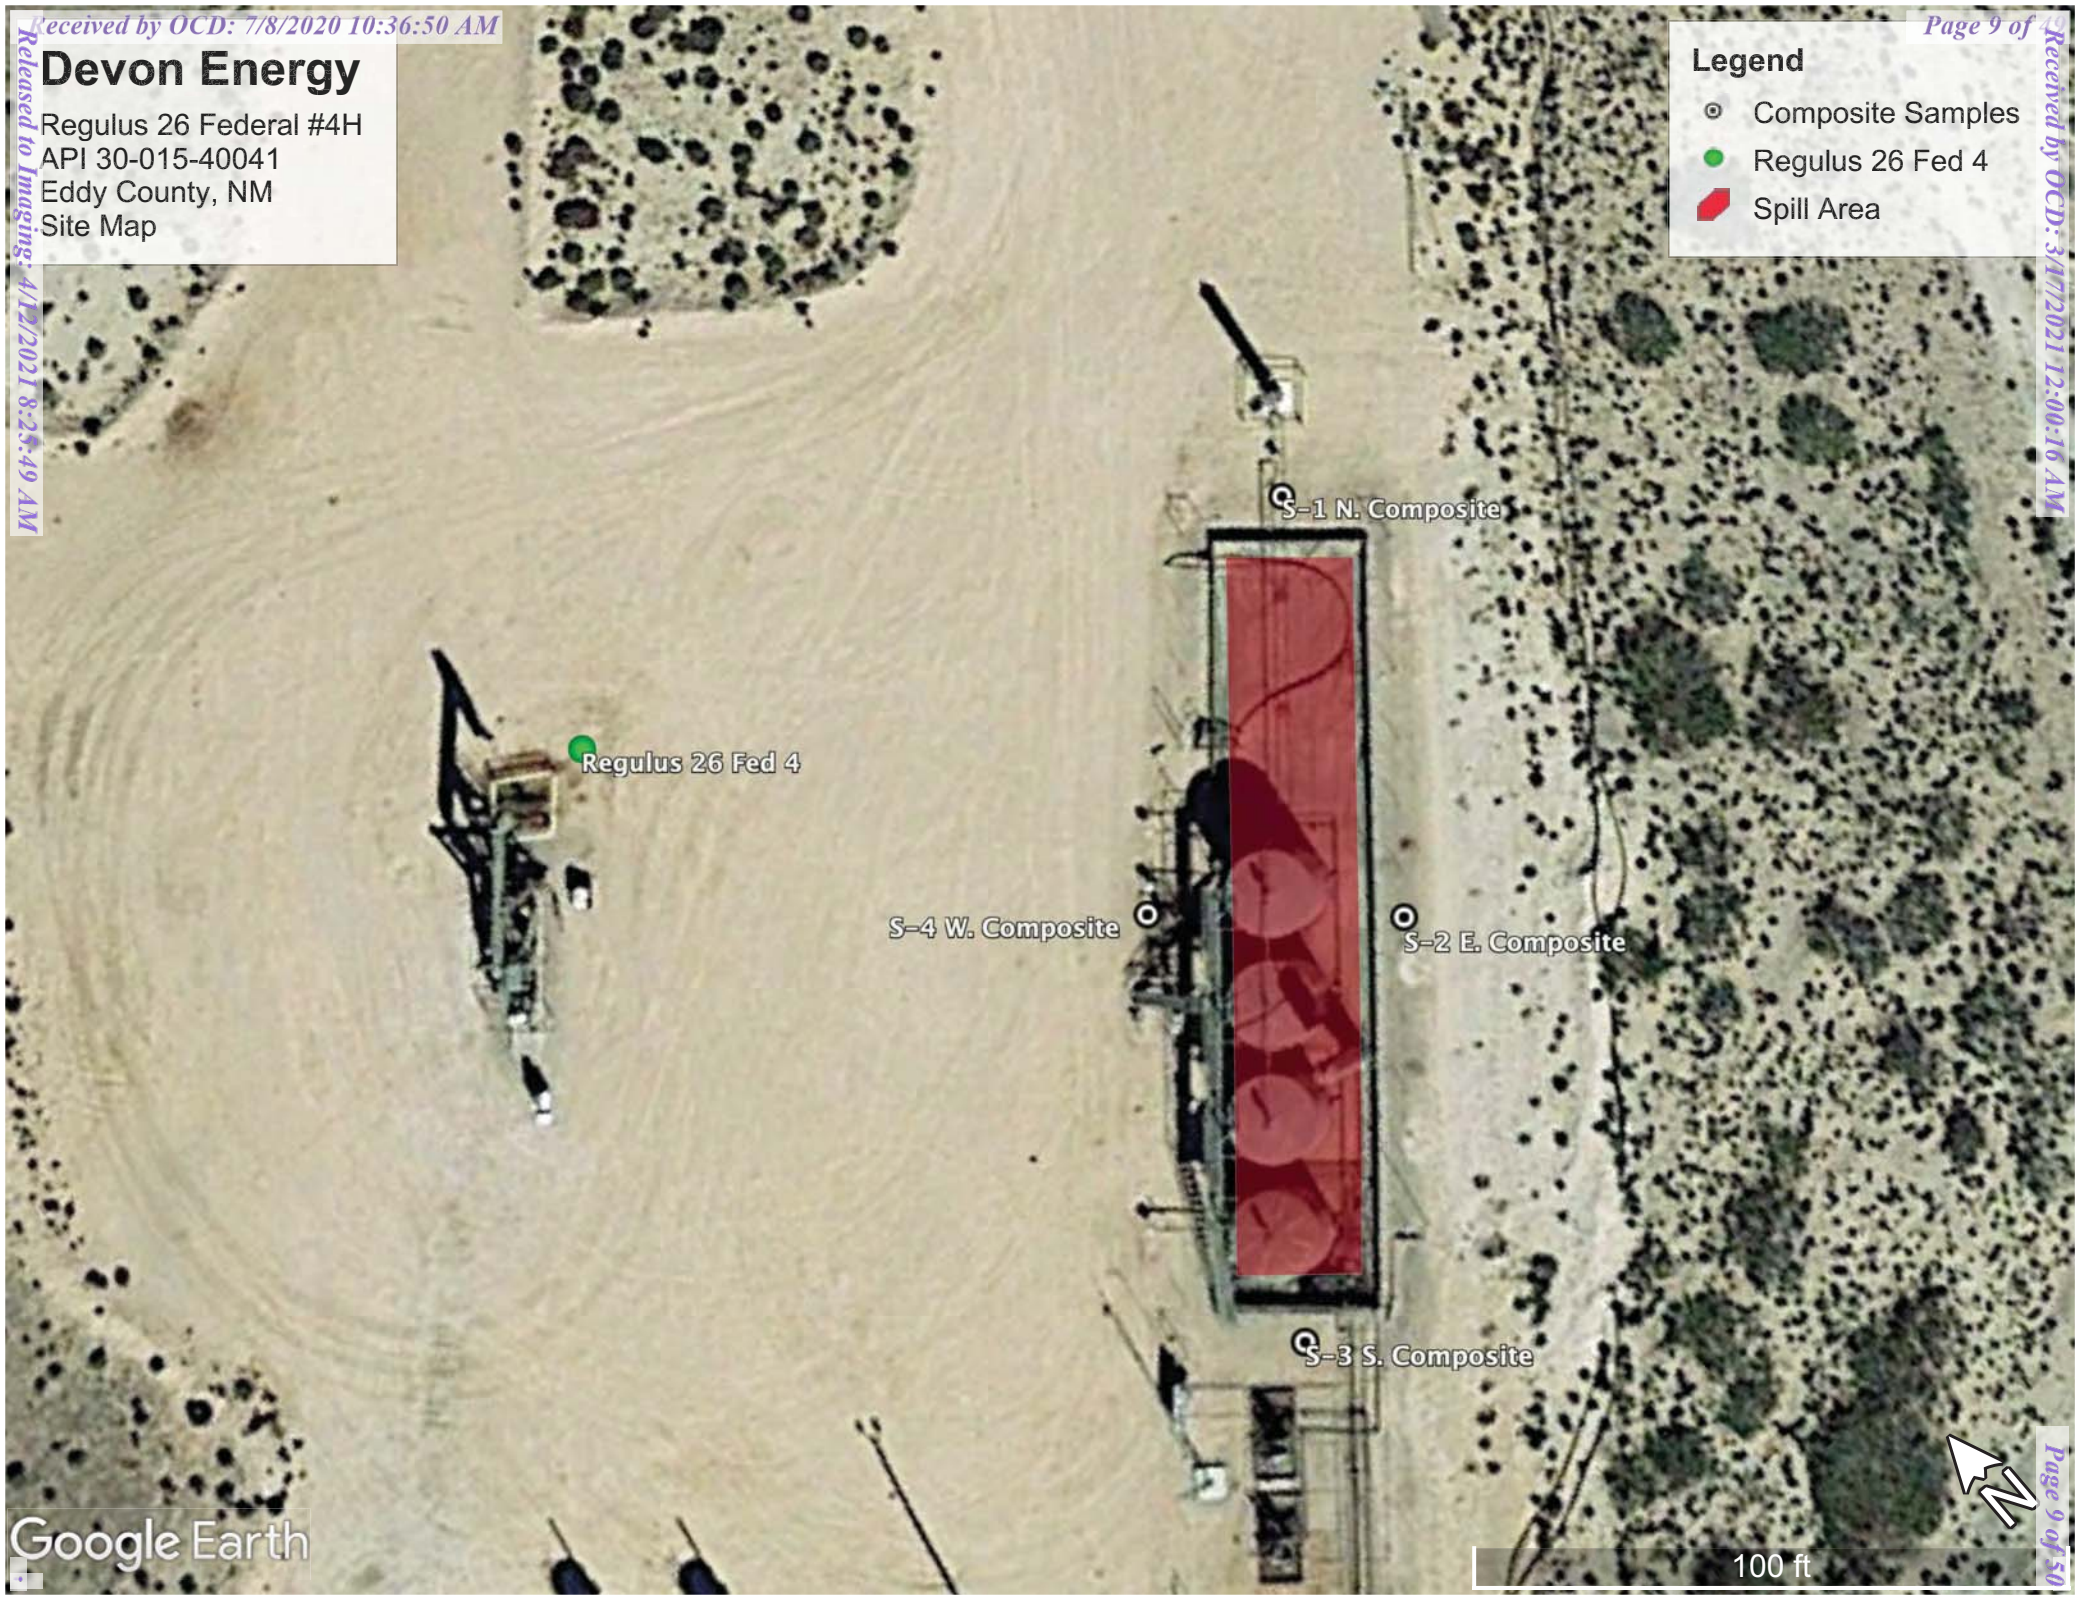
Regulus 26 Federal #4H
API 30-015-40041
Eddy County, NM
Site Map

NRM2015053388: On May 12, 2020, the fill line to the tank developed some holes releasing produced water into the engineered steel and poly-lined containment, resulting in the release of approximately 222 bbls of produced water. The initial response activities were conducted by the operator and included source elimination and site containment and the recovery of approximately 222 bbls of produced water. Figure 4 references a site map illustrating spill area and sample points.

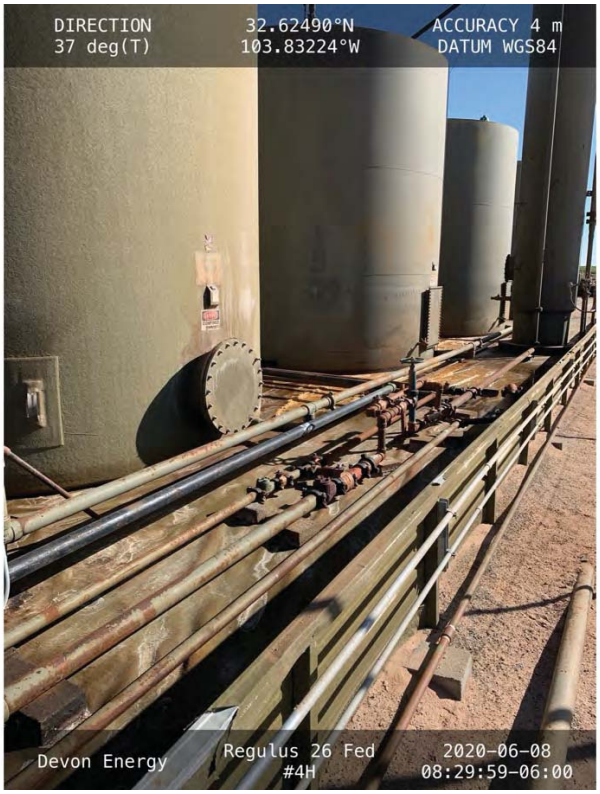
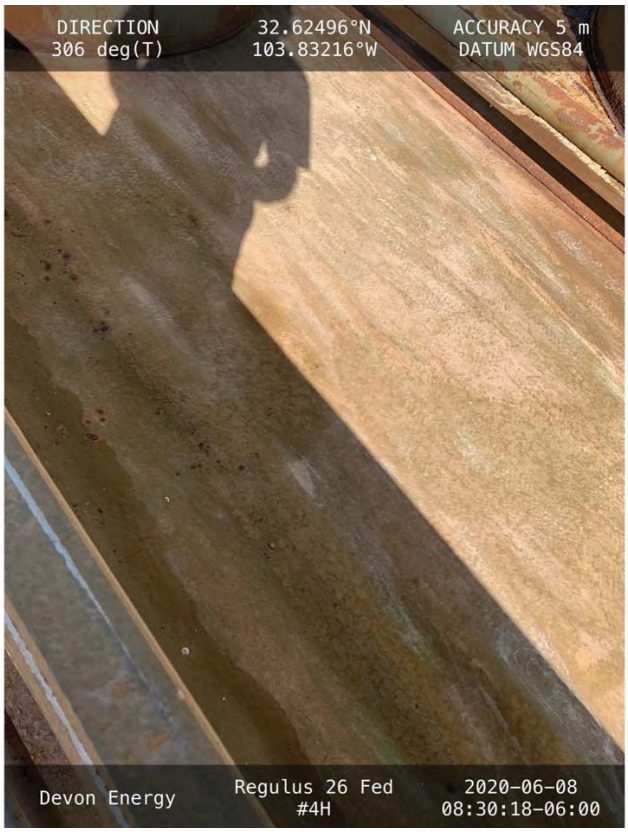
The sample results were below NMOCD Closure Criteria 19.15.29 NMAC; the visual liner inspection shows no evidence that the integrity was compromised. Based on these findings, no remediation activities were needed at this location.
