CLOSURE REPORT

Goodnight Midstream
Dodger Injection Well
Lea County, New Mexico
Unit Letter “F”, Section 4, Township 22 South, Range 36 East
Latitude 32.424203, Longitude -103.273661

NRM2022638776

April 2021

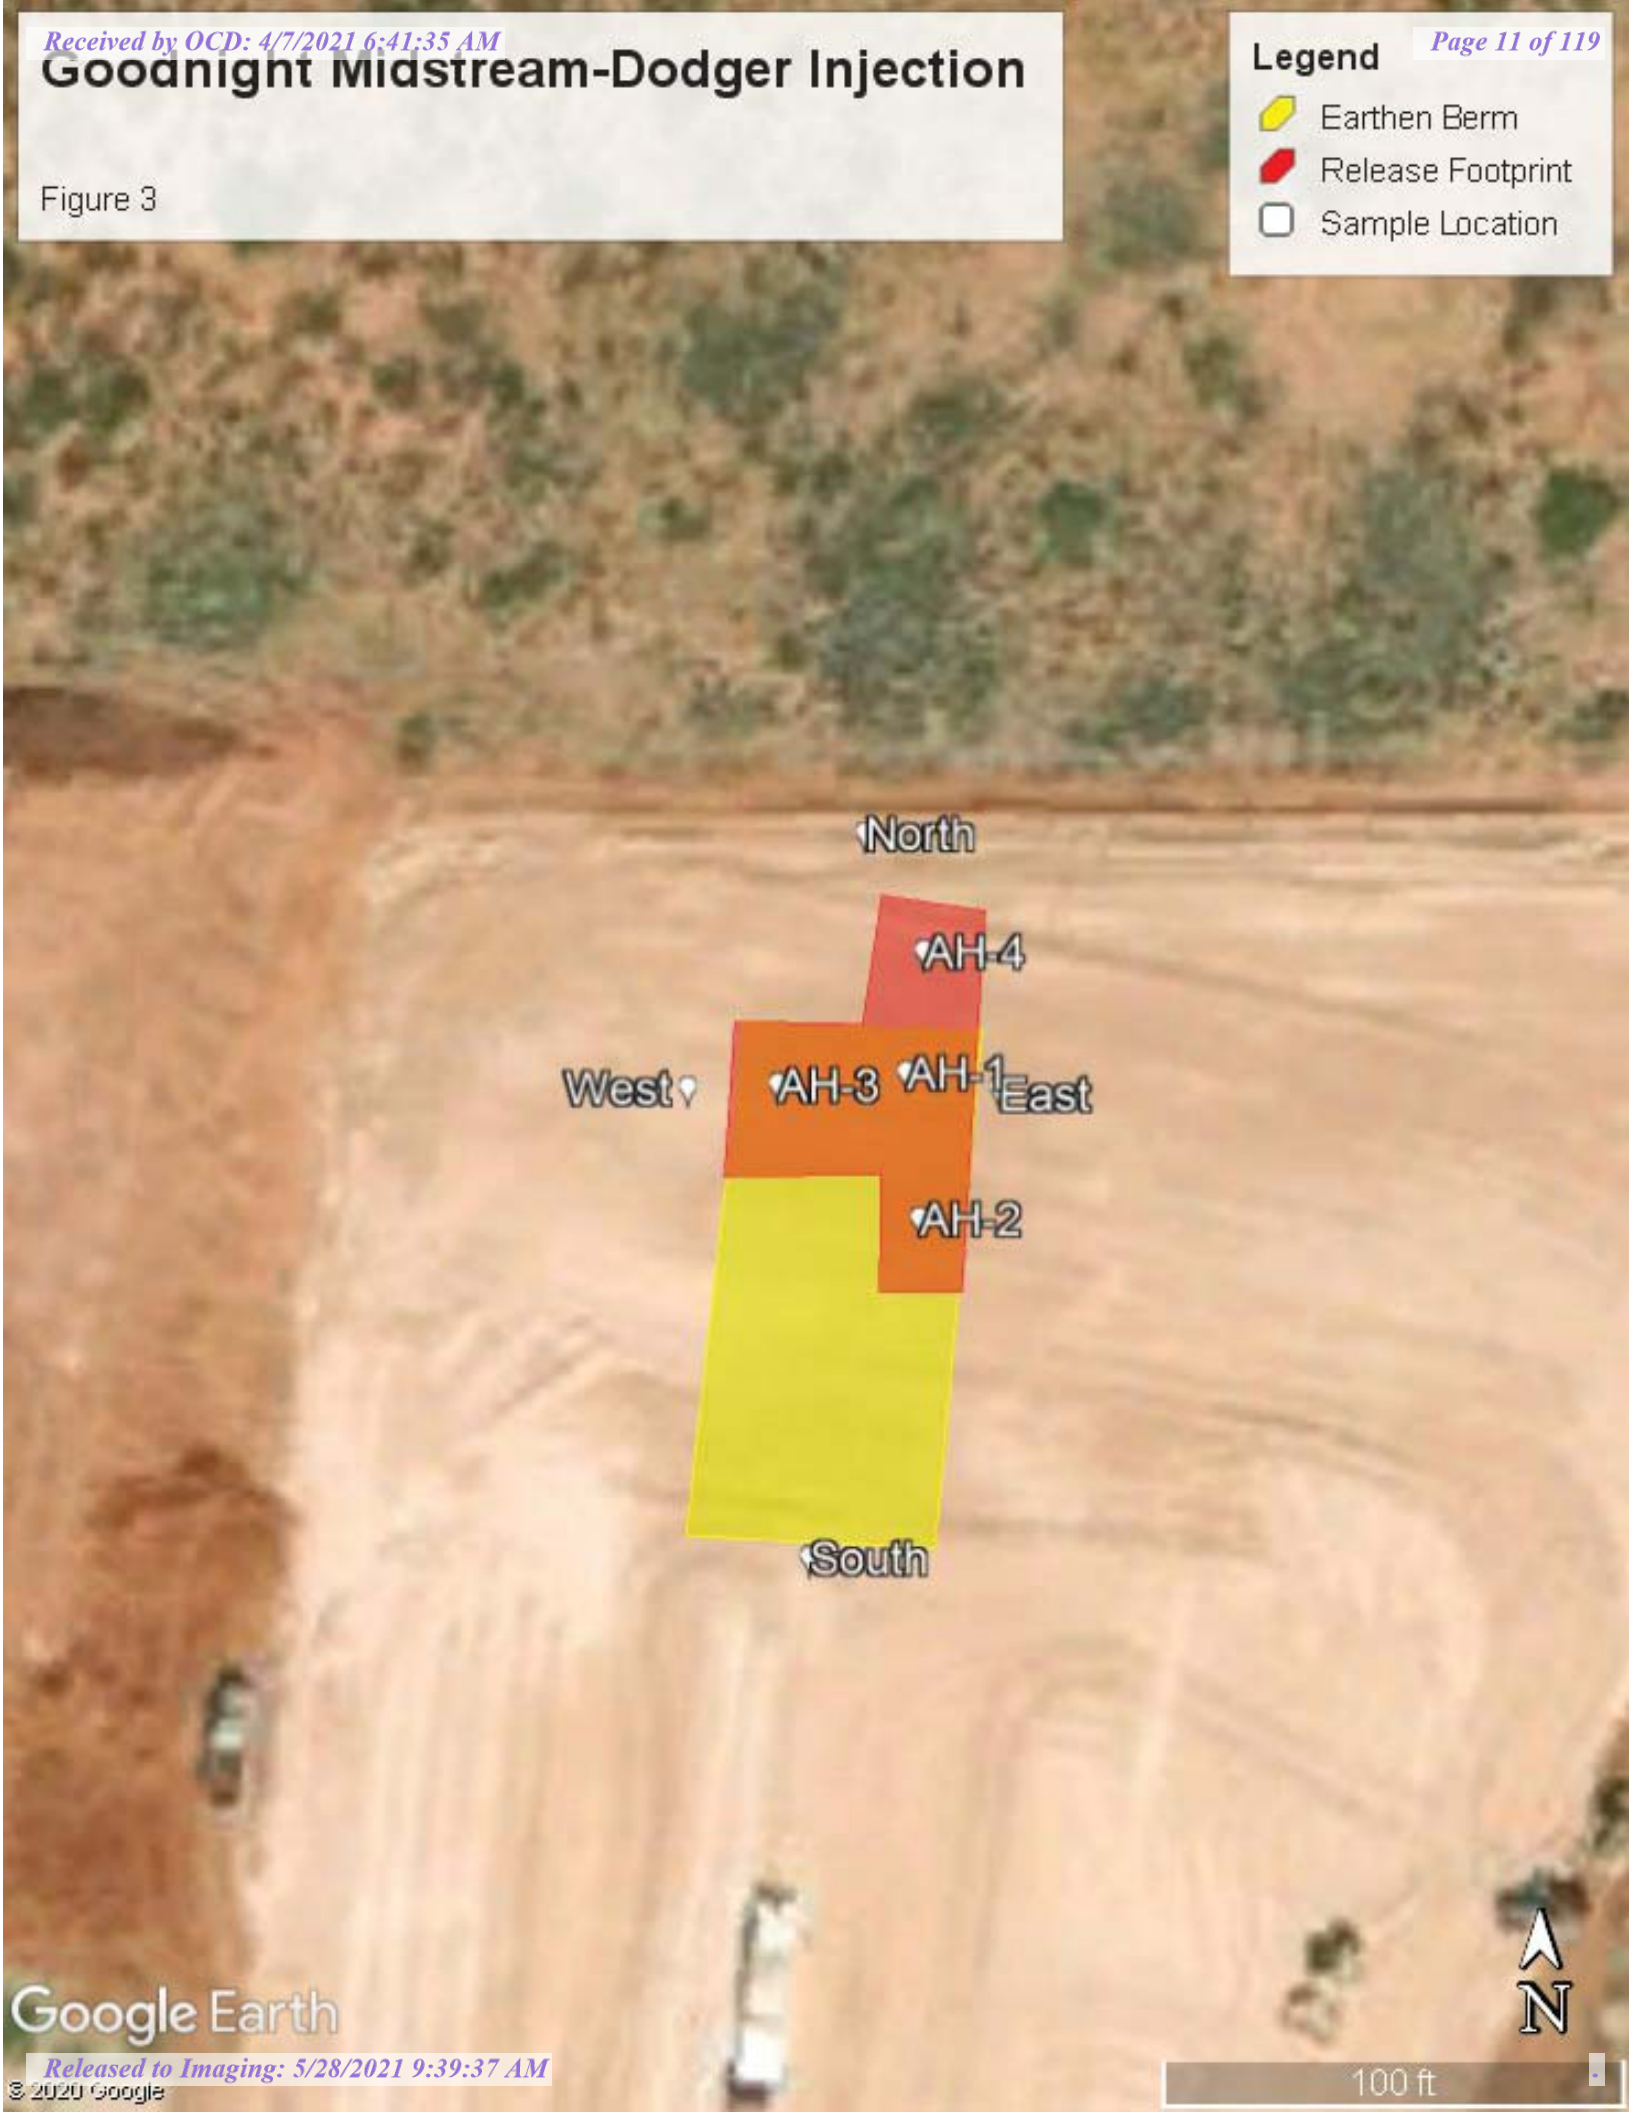
Figure 3 in Appendix A indicates the approximate location of the auger holes installed within and outside the release footprint in relation to pertinent land features.

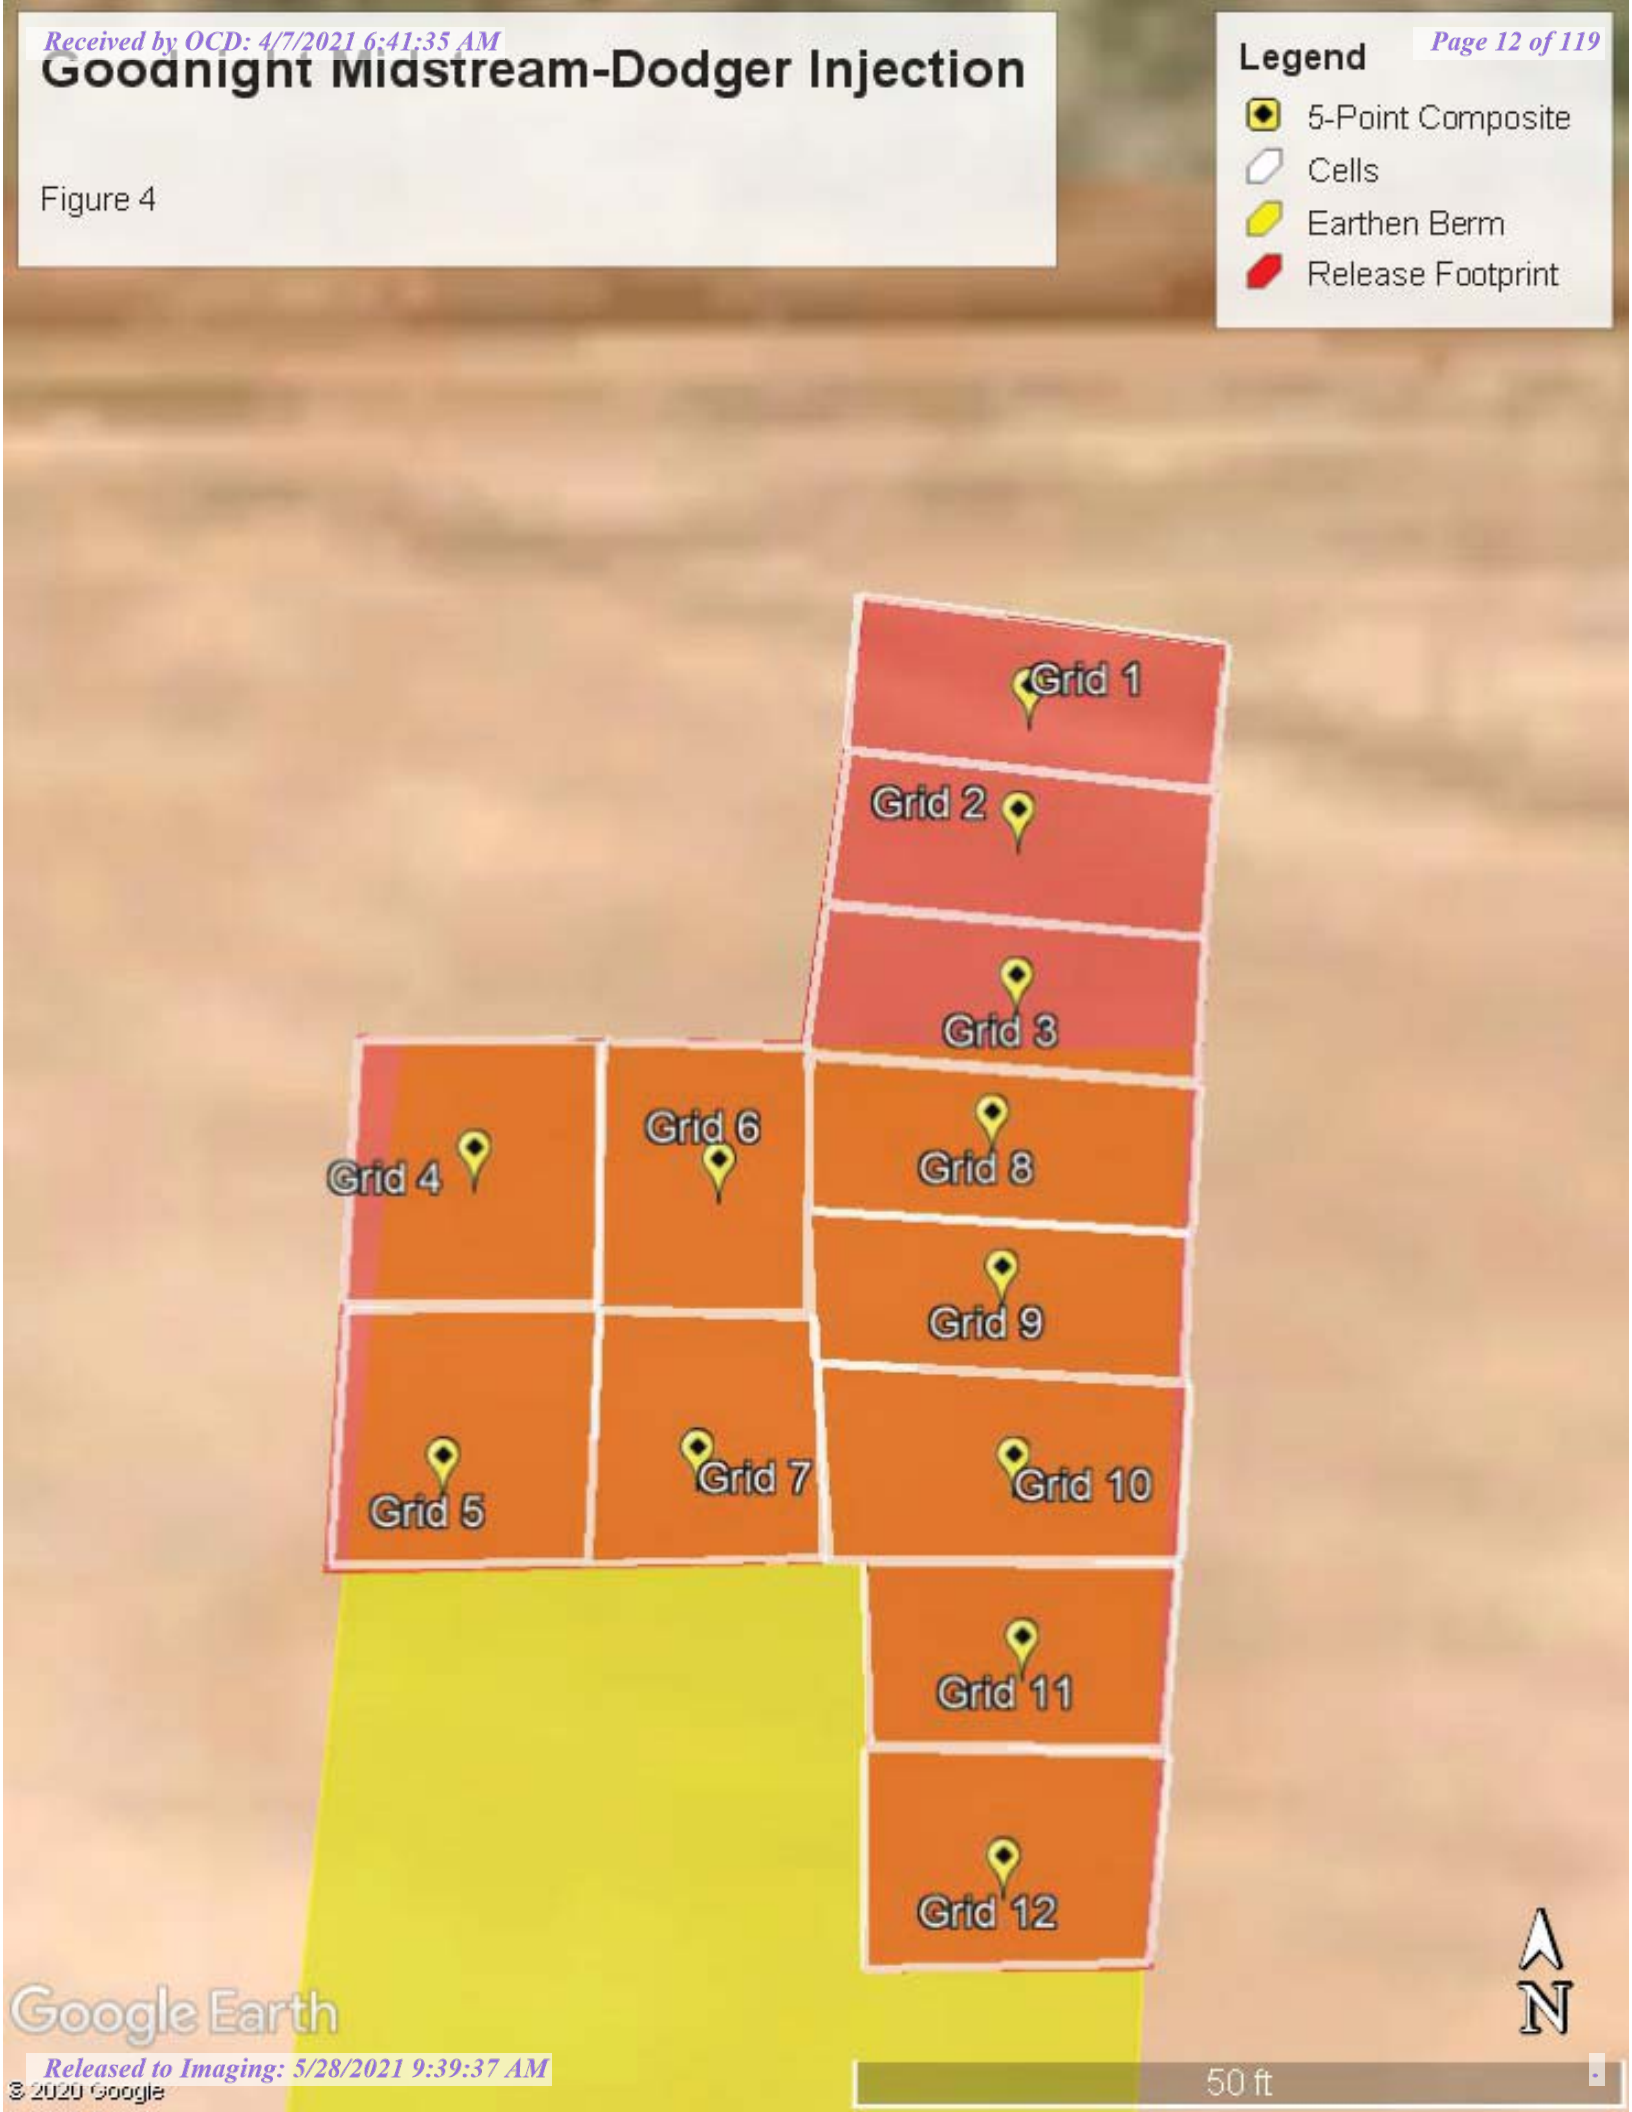
A grid area was designed covering the release footprint comprised of twelve (12) individual 10' X 20' cells equaling 200 sq. ft. each. Twelve (12) 5-point confirmation samples (i.e., composite) were collected. Figure 4 in Appendix A show the grid cells and the approximate sample locations for the March 12, 2021 sampling event.

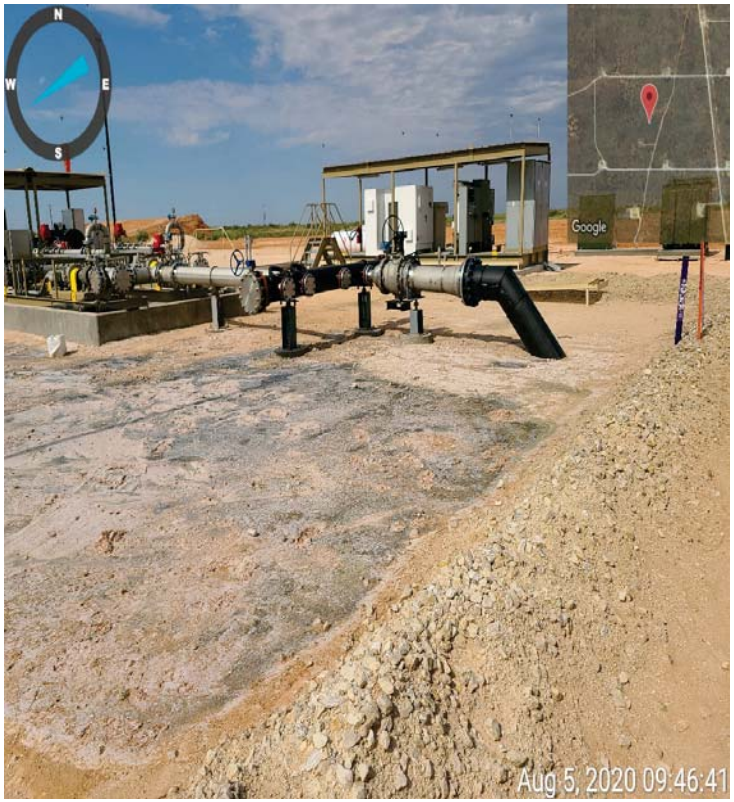
View Southwest – A portion of the spill flow path caused by the fluid release within the release footprint.

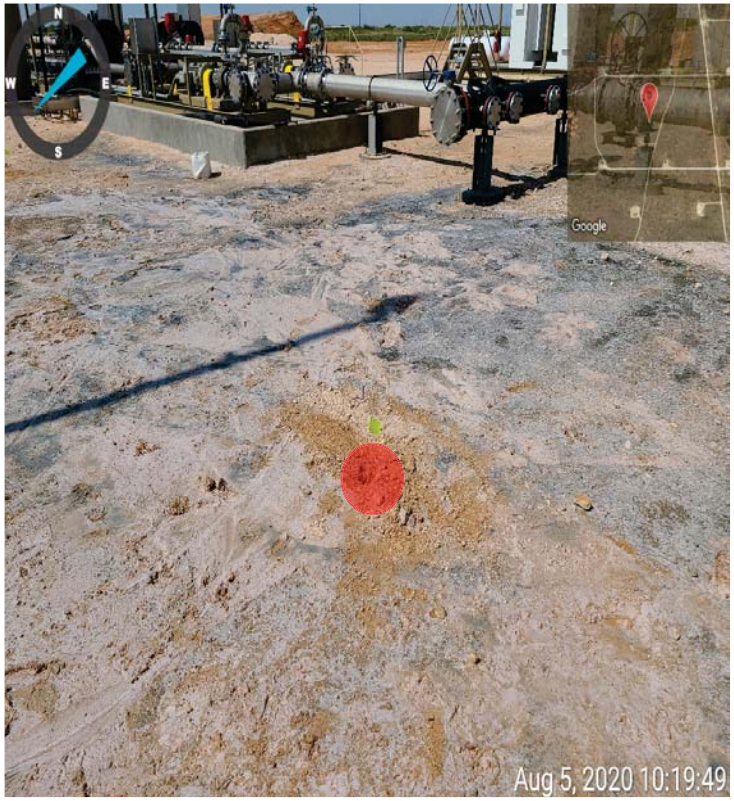
View West – A portion of the spill flow path caused by the fluid release within the release footprint.

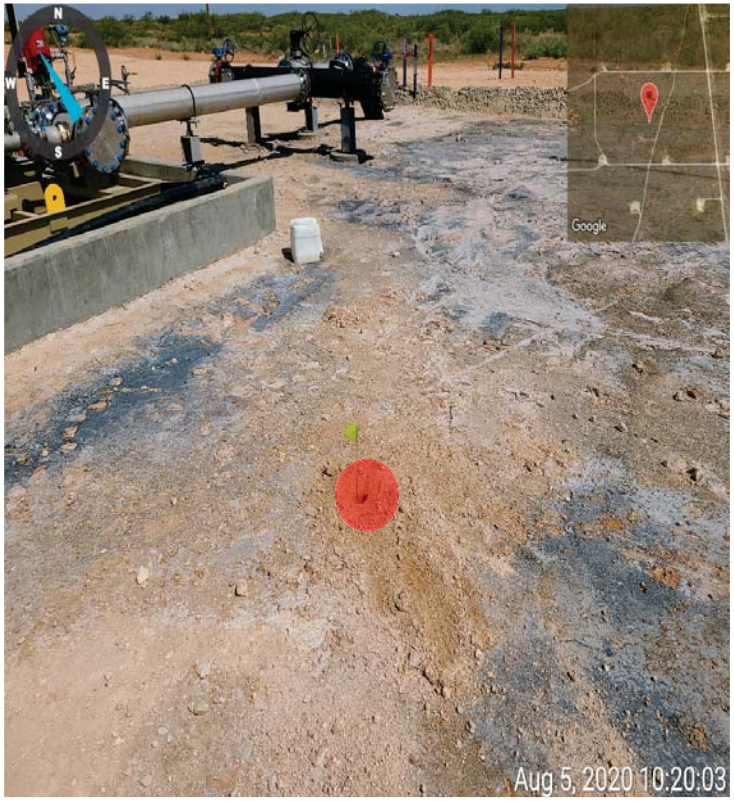
View Southwest – Sample location Auger Hole 1 (red circle) middle of photograph.

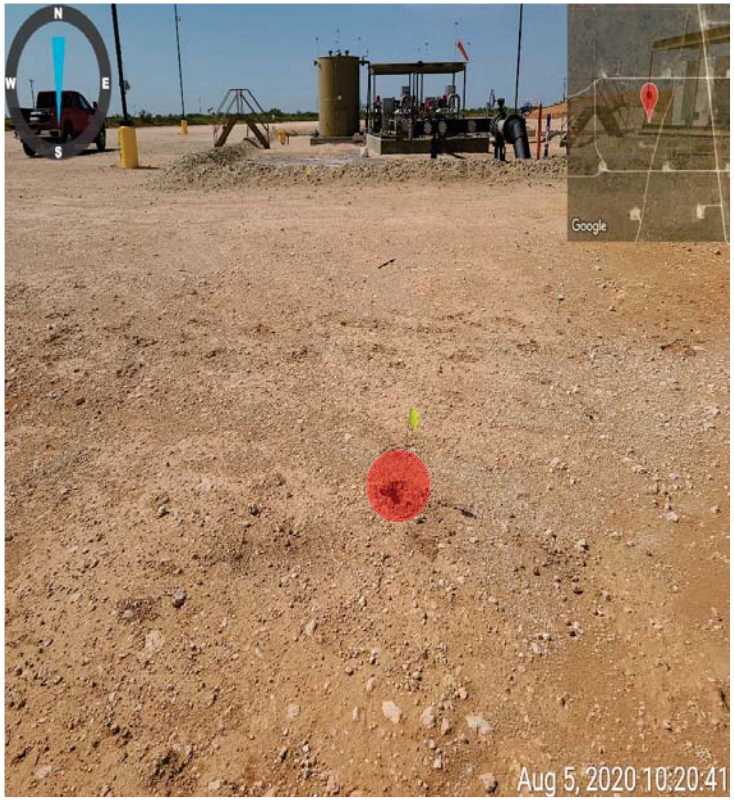
View South – Sample location North (red circle) middle of photograph.

View North– Sample location South (red circle) middle of photograph.

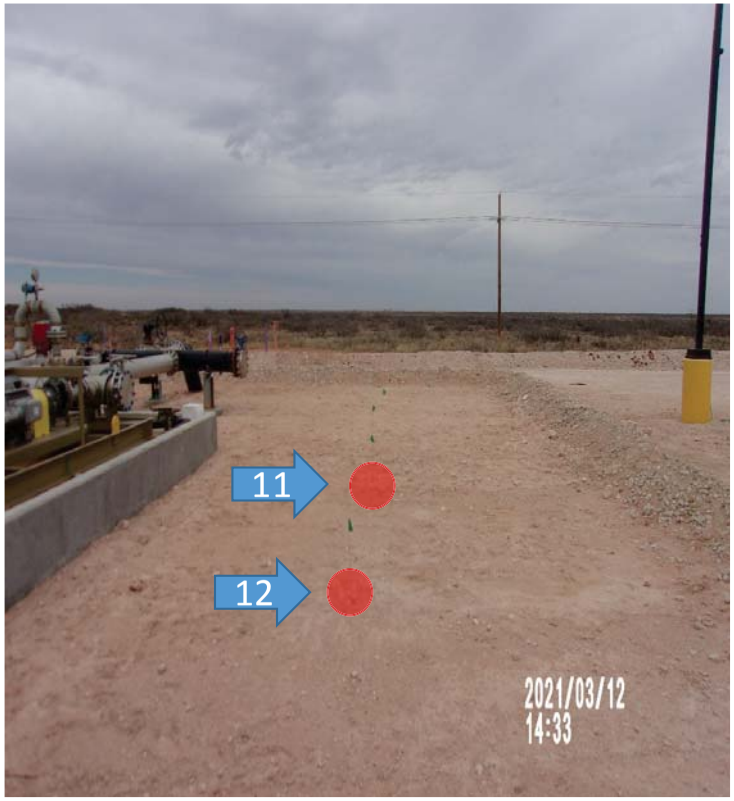
View North – Sample locations Confirmation Sample 12 and Confirmation Sample 11 (red circles) middle of photograph.

View West– Sample locations Confirmation Sample 10, Confirmation Sample 9, and Confirmation Sample 8 (red circles) middle of photograph.

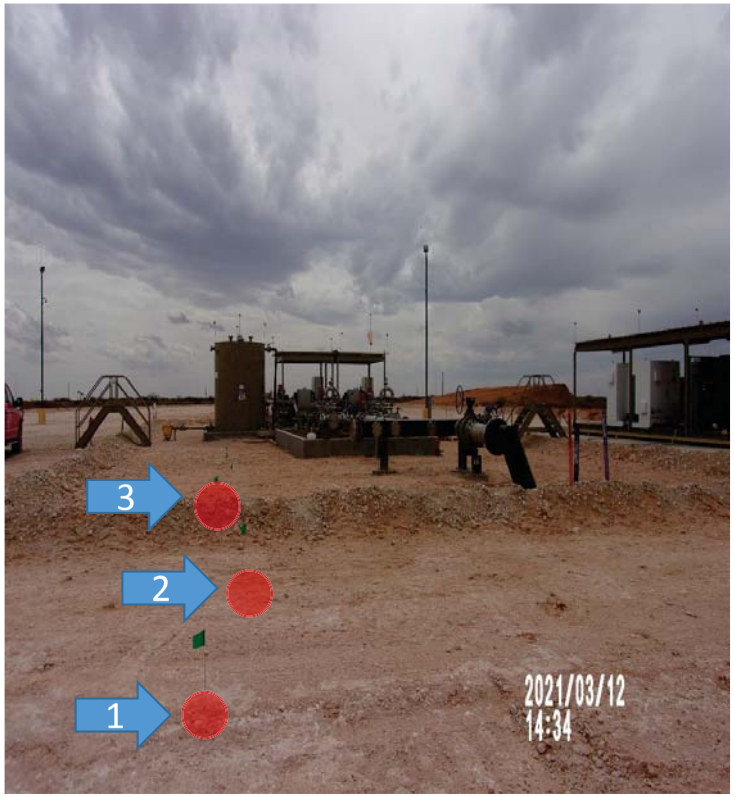
View South – Sample locations Confirmation Sample 1, Confirmation Sample 2, and Confirmation Sample 3 (red circles) left side of photograph.

View South– Sample locations Confirmation Sample 6 and Confirmation Sample 7 (red circles) middle of photograph.
