Re: Vacuum Grayburg San Andres Unit 16
Site Closure Report
Case No. 1RP-3256 & 1RP-2760
Lea County, New Mexico

- Vacuum Grayburg San Andres Unit 16 – Site Closure Report

The submittal was prepared by Arcadis U.S., Inc. (Arcadis) on behalf of Chevron Environmental Management Company (CEMC).

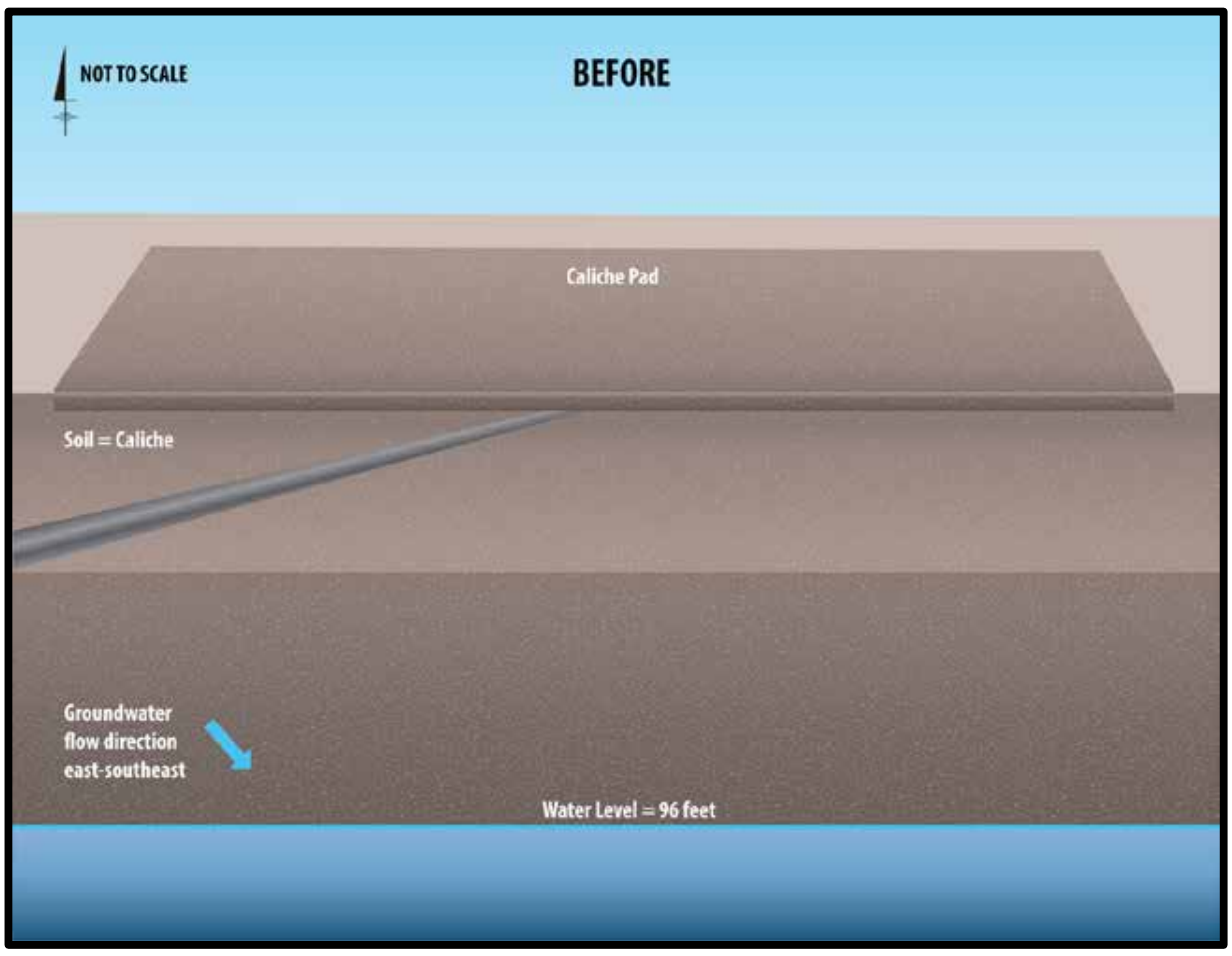
The site is located in the western edge of the Permian Basin with Lovington (the closest town) located approximately 16 miles northeast of the site. Due to the arid climate, the site experiences low precipitation and high evapotranspiration rates. According to information obtained from the NMOSE online database, groundwater near the site is encountered at a depth of approximately 96 feet bgs.

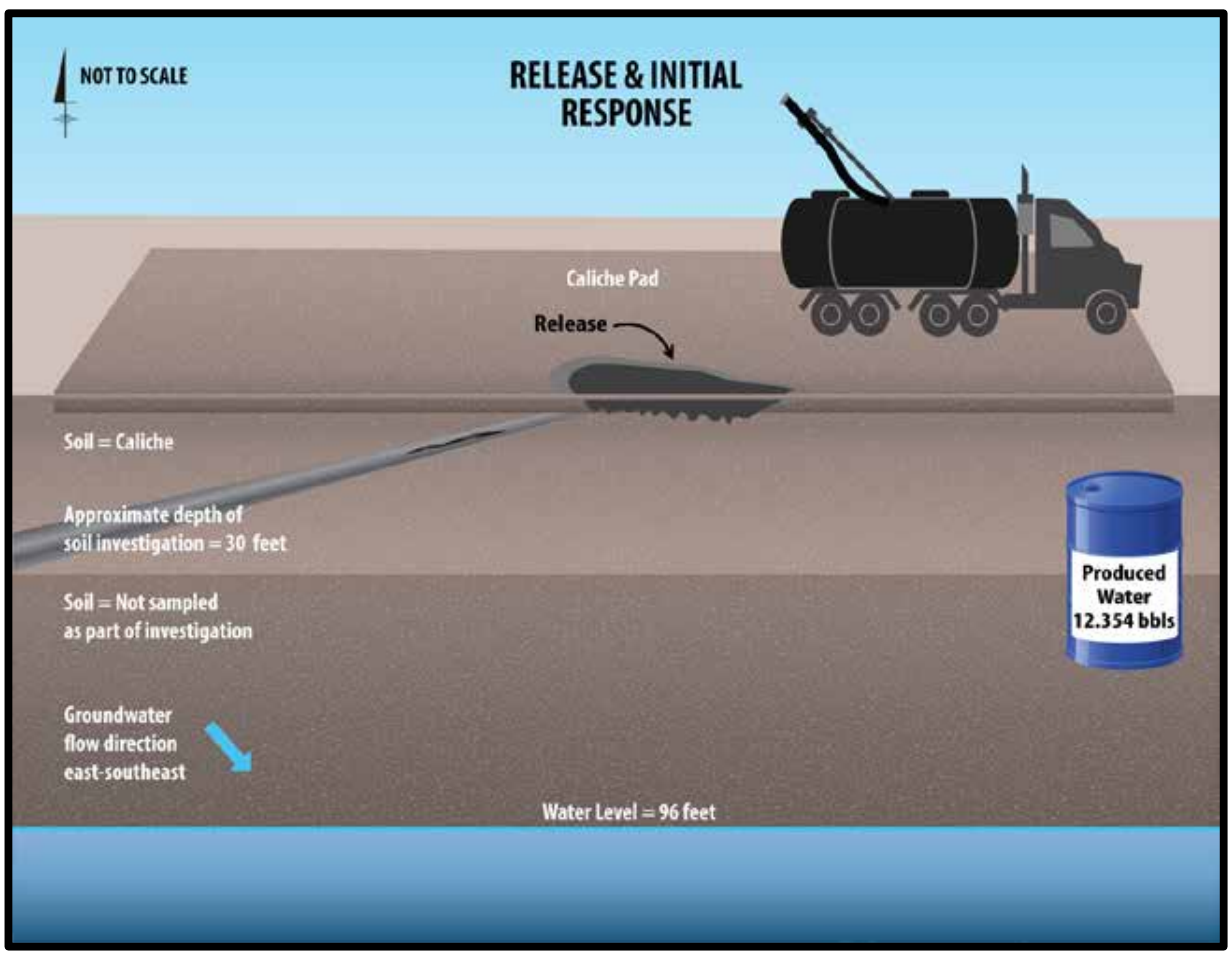
A release of approximately 12.354 bbls of produced water occurred at the site on November 10, 2011 due to a pinhole leak in an underground utility line. Chevron personnel from the MidContinent Business Unit (MCBU) stopped the release and recovered an approximately 12 bbls of fluids using a vacuum truck. Chevron MCBU personnel excavated visually impacted soil in the area to a depth of approximately 2 feet bgs and collected five discrete confirmation soil samples from the base of the excavation. Analyte concentrations in one or more confirmation soil samples were above regulatory criteria, which prompted additional site assessment activities.

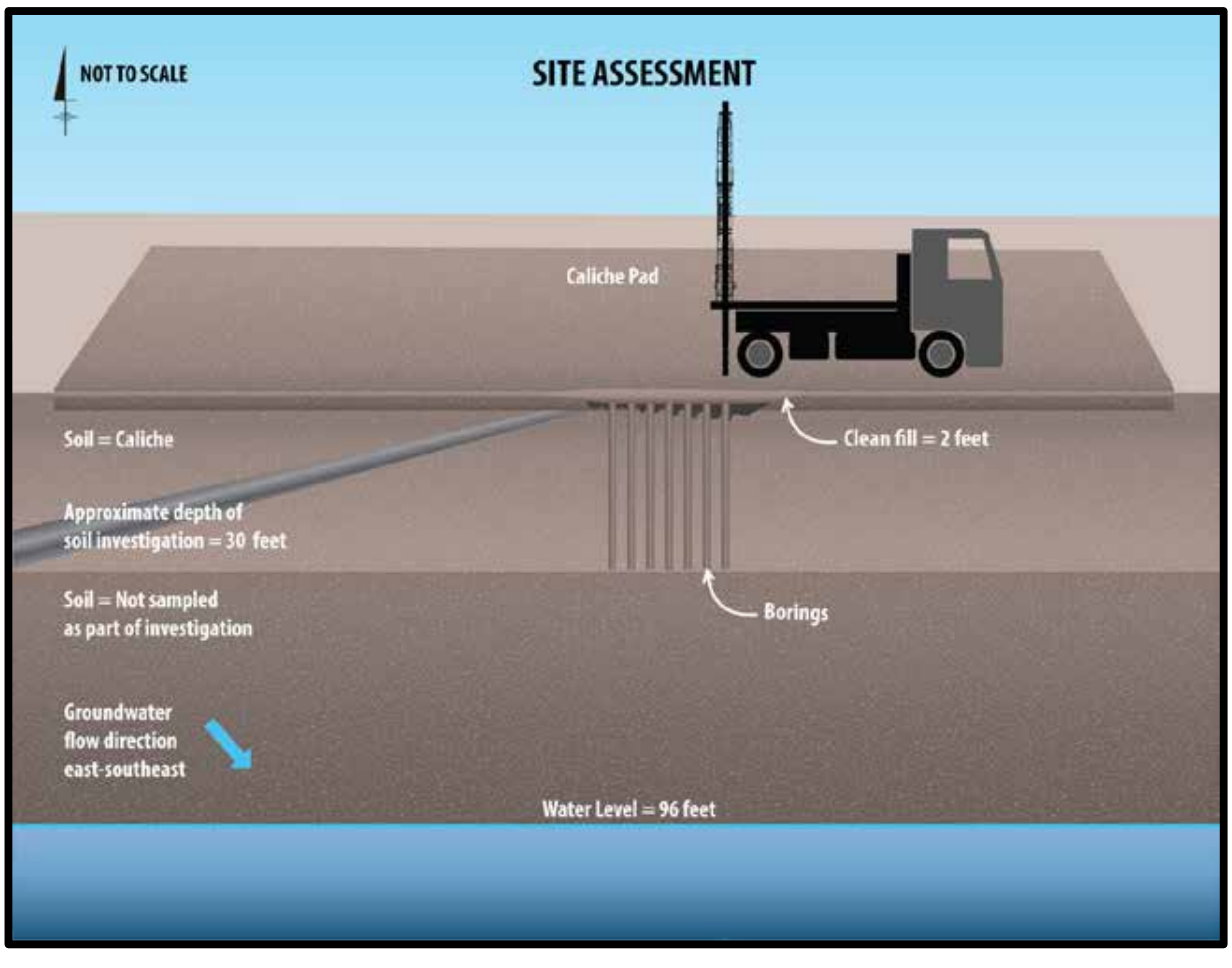
In May 2013, ARCADIS conducted site assessment activities to characterize the lateral and vertical extents of soil impacts at the site. Soil boring locations were selected based on the results of confirmation soil sampling completed at the site in November 2011, locations of pipelines and other equipment at the site, and the extent of the release as documented by Chevron MCBU personnel during the initial response activities. Analyte concentrations in samples collected during the 2013 assessment were reported below site-specific criteria. Site assessment activities demonstrate that remaining soil concentrations associated with the release do not pose significant risk to groundwater resources or other receptors.

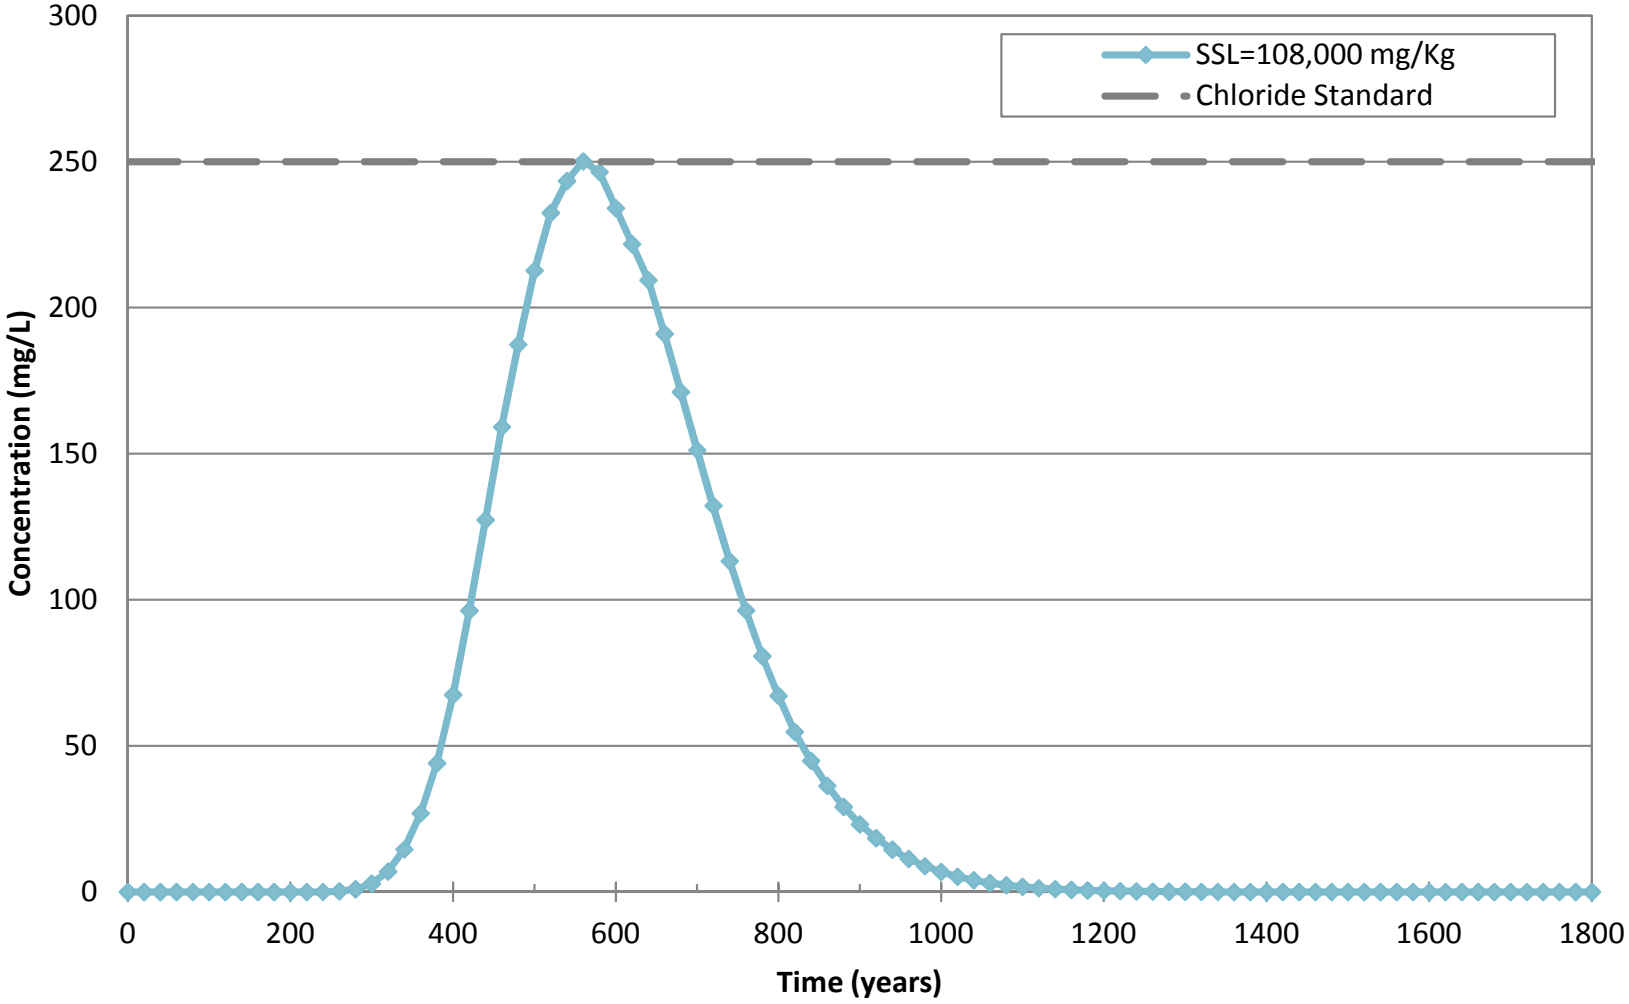
Figure 1
MULTIMED Simulated Chloride Concentration Vs Time in Groundwater
(Source = 20m, Chloride 0-1m, & Depth to Groundwater = 20m)

The predicted groundwater concentrations versus time are illustrated on Figures 1 through 8. The peak arrival times varied between 540 and 860 years. The simulations indicate the site SSLs for the protection of groundwater ranged from 8,525 to 266,100 mg/kg (Table 2) depending on the scenario and are protective of the New Mexico chloride groundwater standard of 250 mg/L.
