Closure

1RP-5636
Closure Report
East Blinebry Drinkard Unit #37
Produced Water Spill
Lea County, New Mexico

LAI Project No. 19-0112-49

December 31, 2020

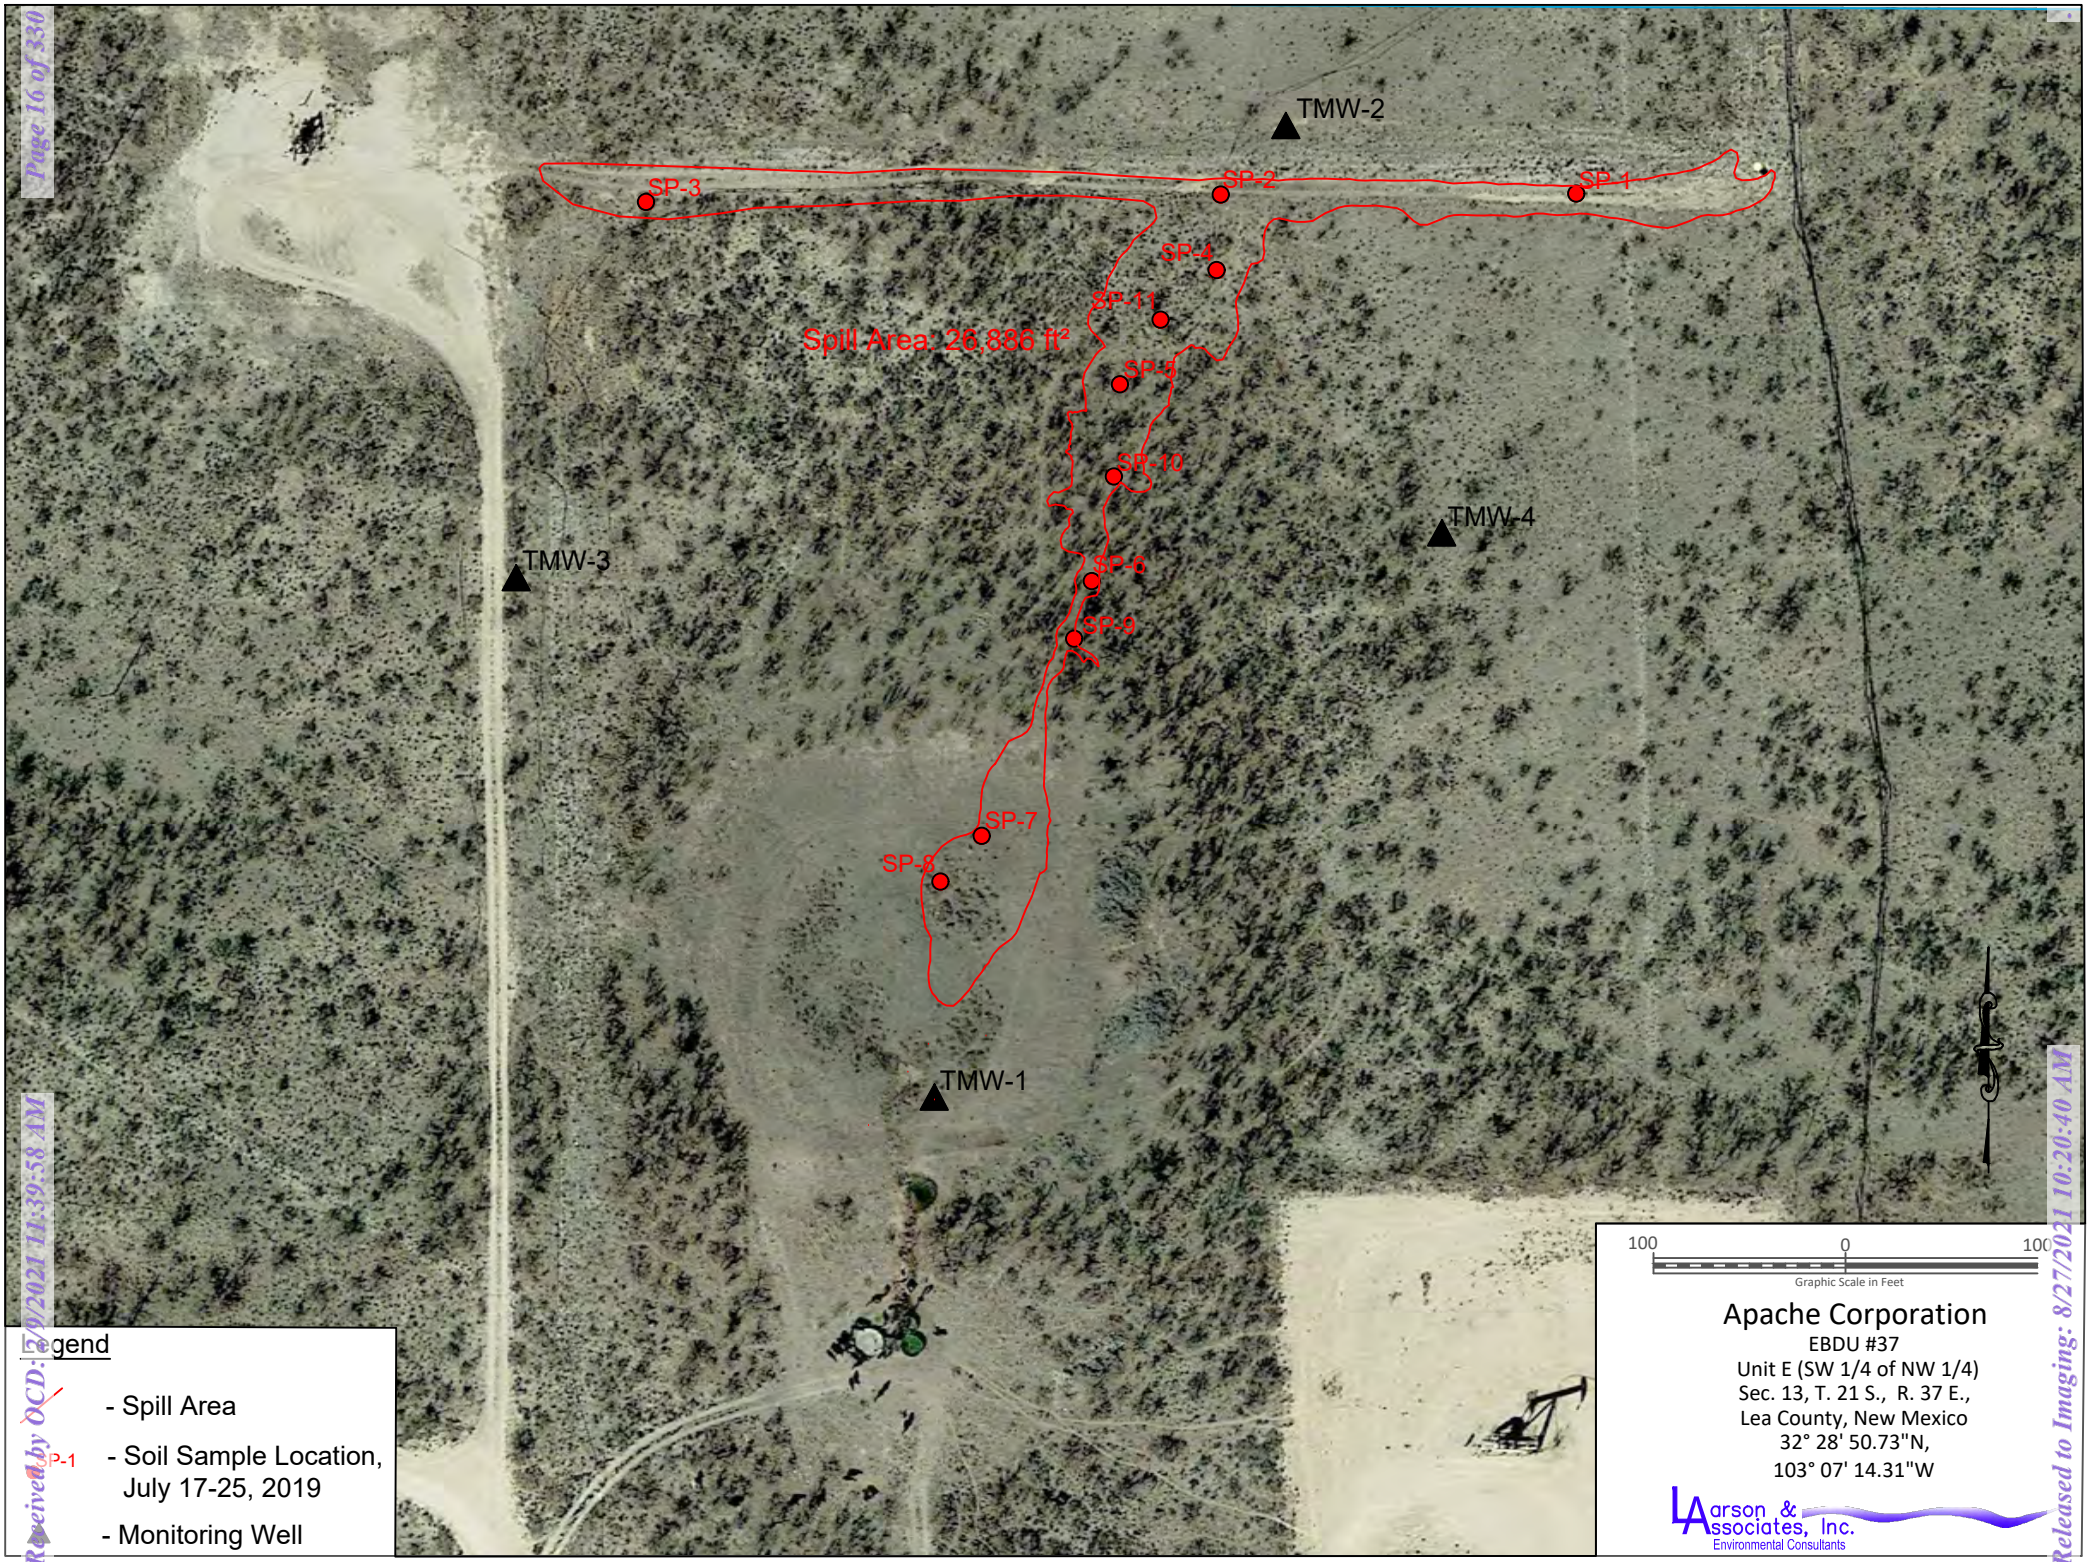
Figure 3 - Site Map Showing Monitoring Well Locations

The monitoring wells were completed with two (2) inch threaded schedule 40 PVC casing and approximately twenty (20) feet 0.01-inch factory slotted screen. The screens were positioned above and below the groundwater level observed during drilling. On September 30, 2020 groundwater was recorded at 57.62 feet bgs in TMW-3 and 57.39 feet bgs in well TMW-4. The wells were developed using an electric submersible pump to remove to sediment disturbed and fresh water introduced during drilling. All monitor wells were surveyed for geodetic position and elevation, including surface elevation and top of casing (TOC) elevation, West Company, a New Mexico licensed professional surveyor (license number 23263). Figure 4 presents a Site drawing showing the monitoring well locations.

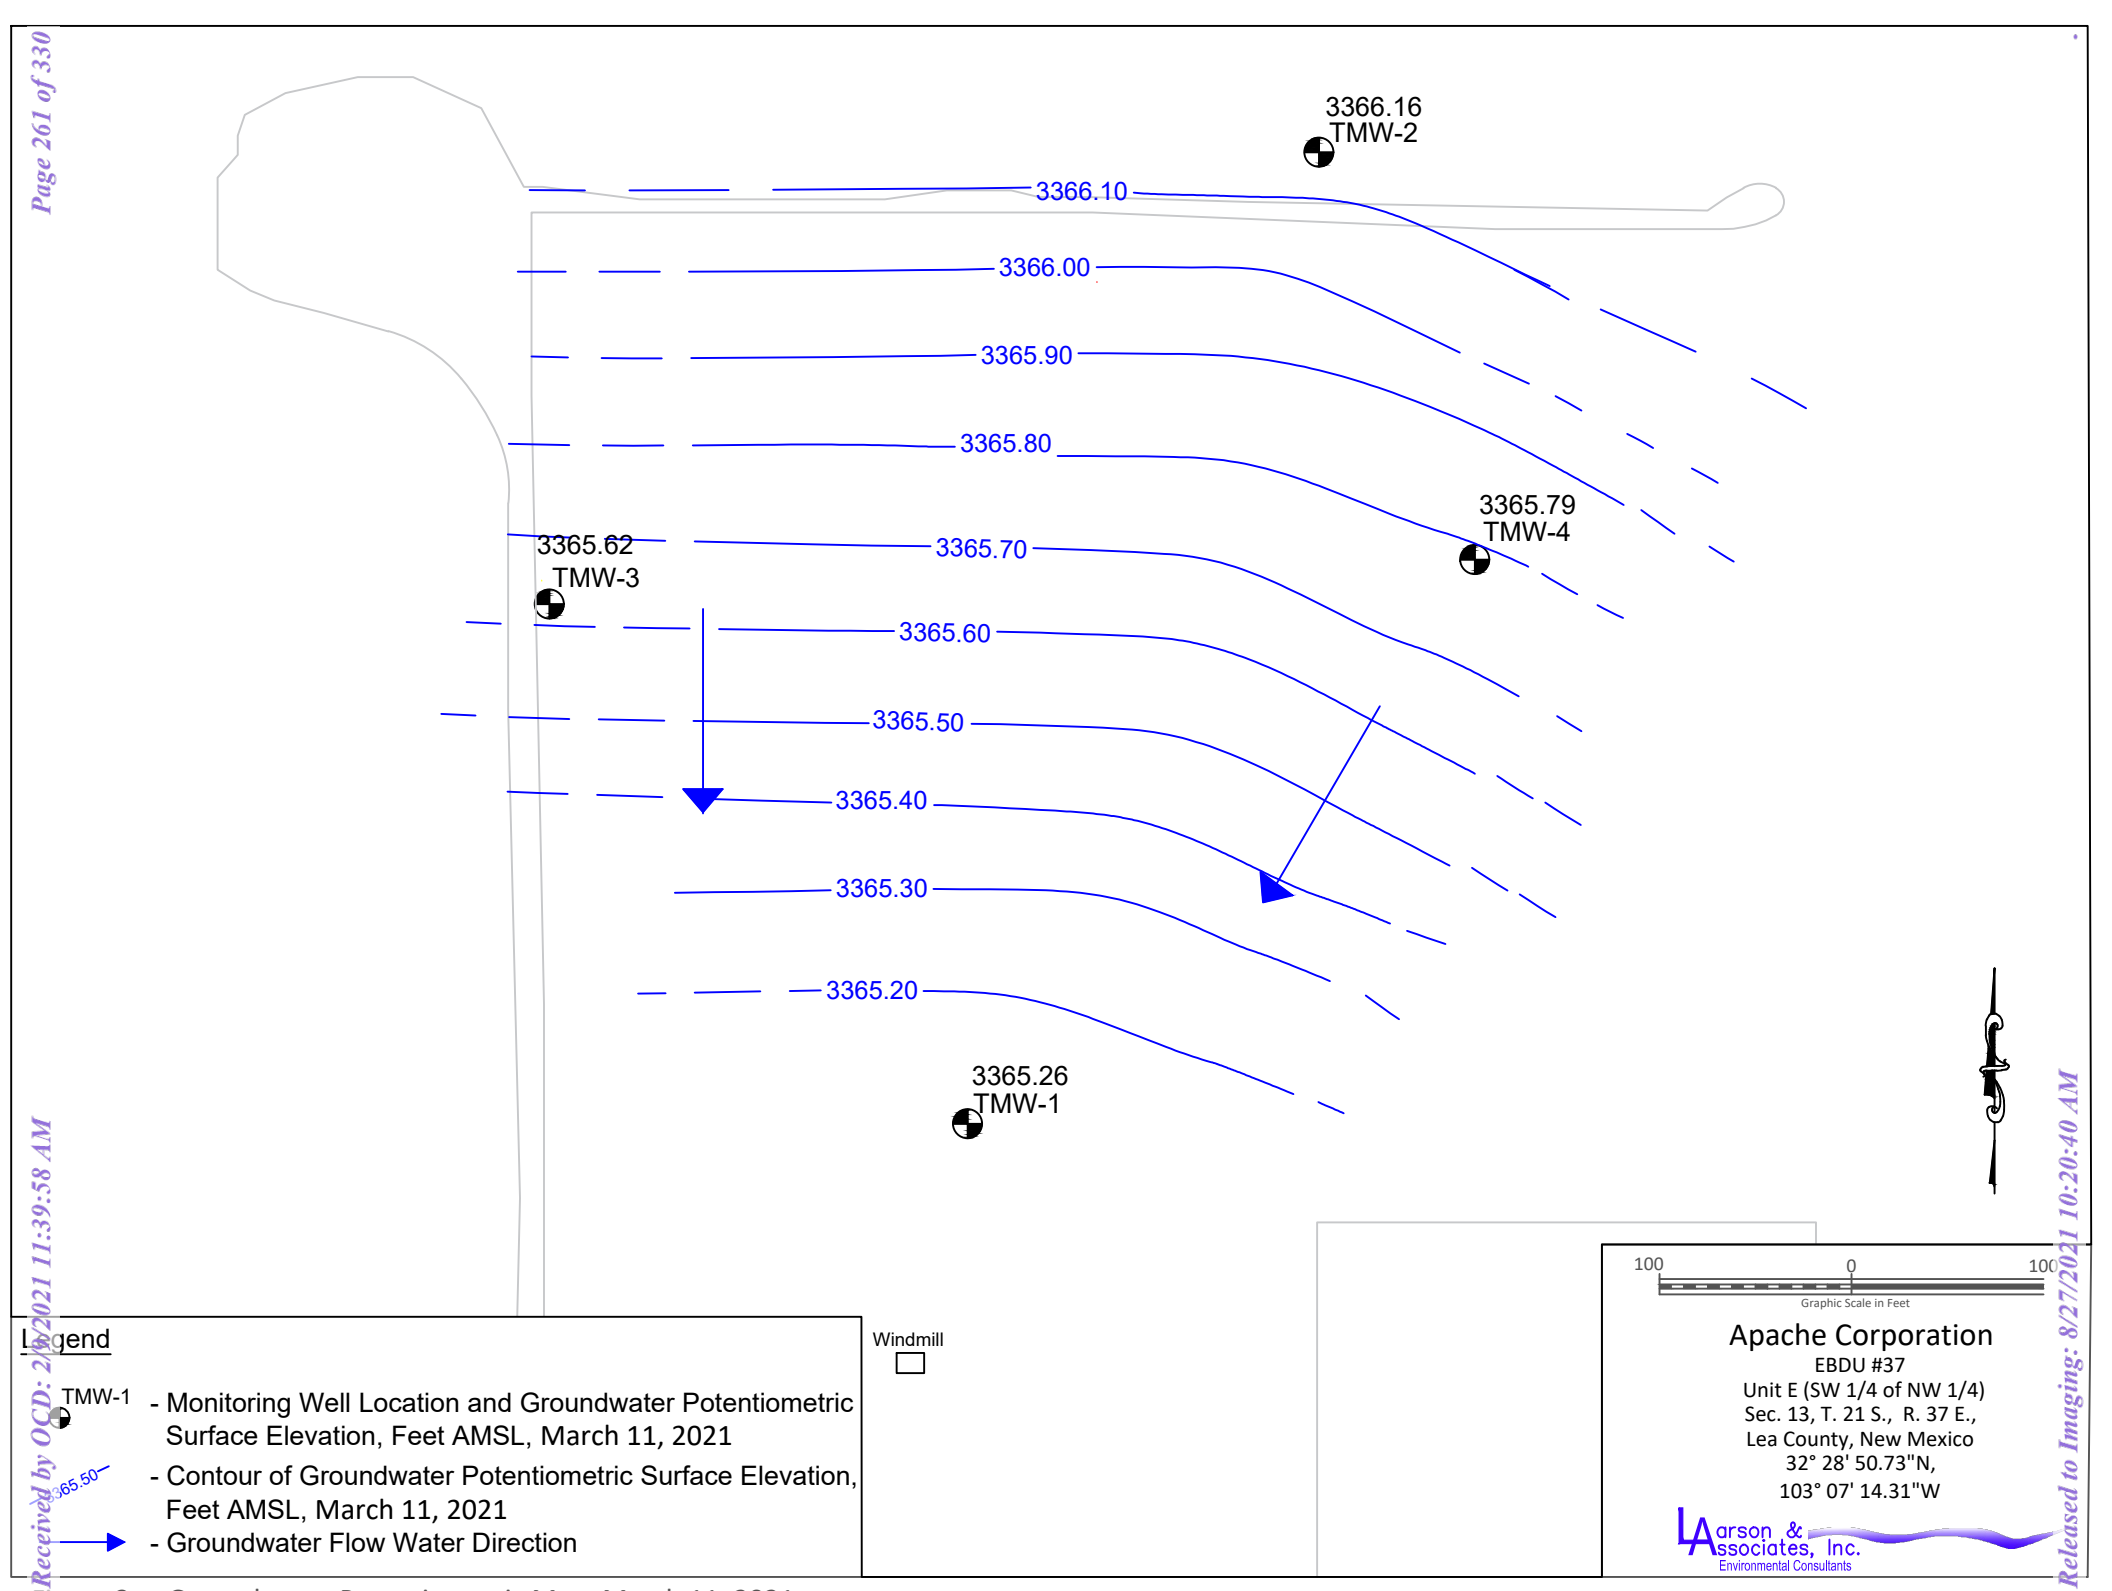
Figure 3a - Groundwater Potentiometric Map, March 11, 2021

No significant changes in potentiometric surface elevation, flow direction, or gradient were observed on March 11, 2021. Figure 3 presents the groundwater potentiometric surface map on March 11, 2021. Table 1 presents monitor well construction and gauging summary.

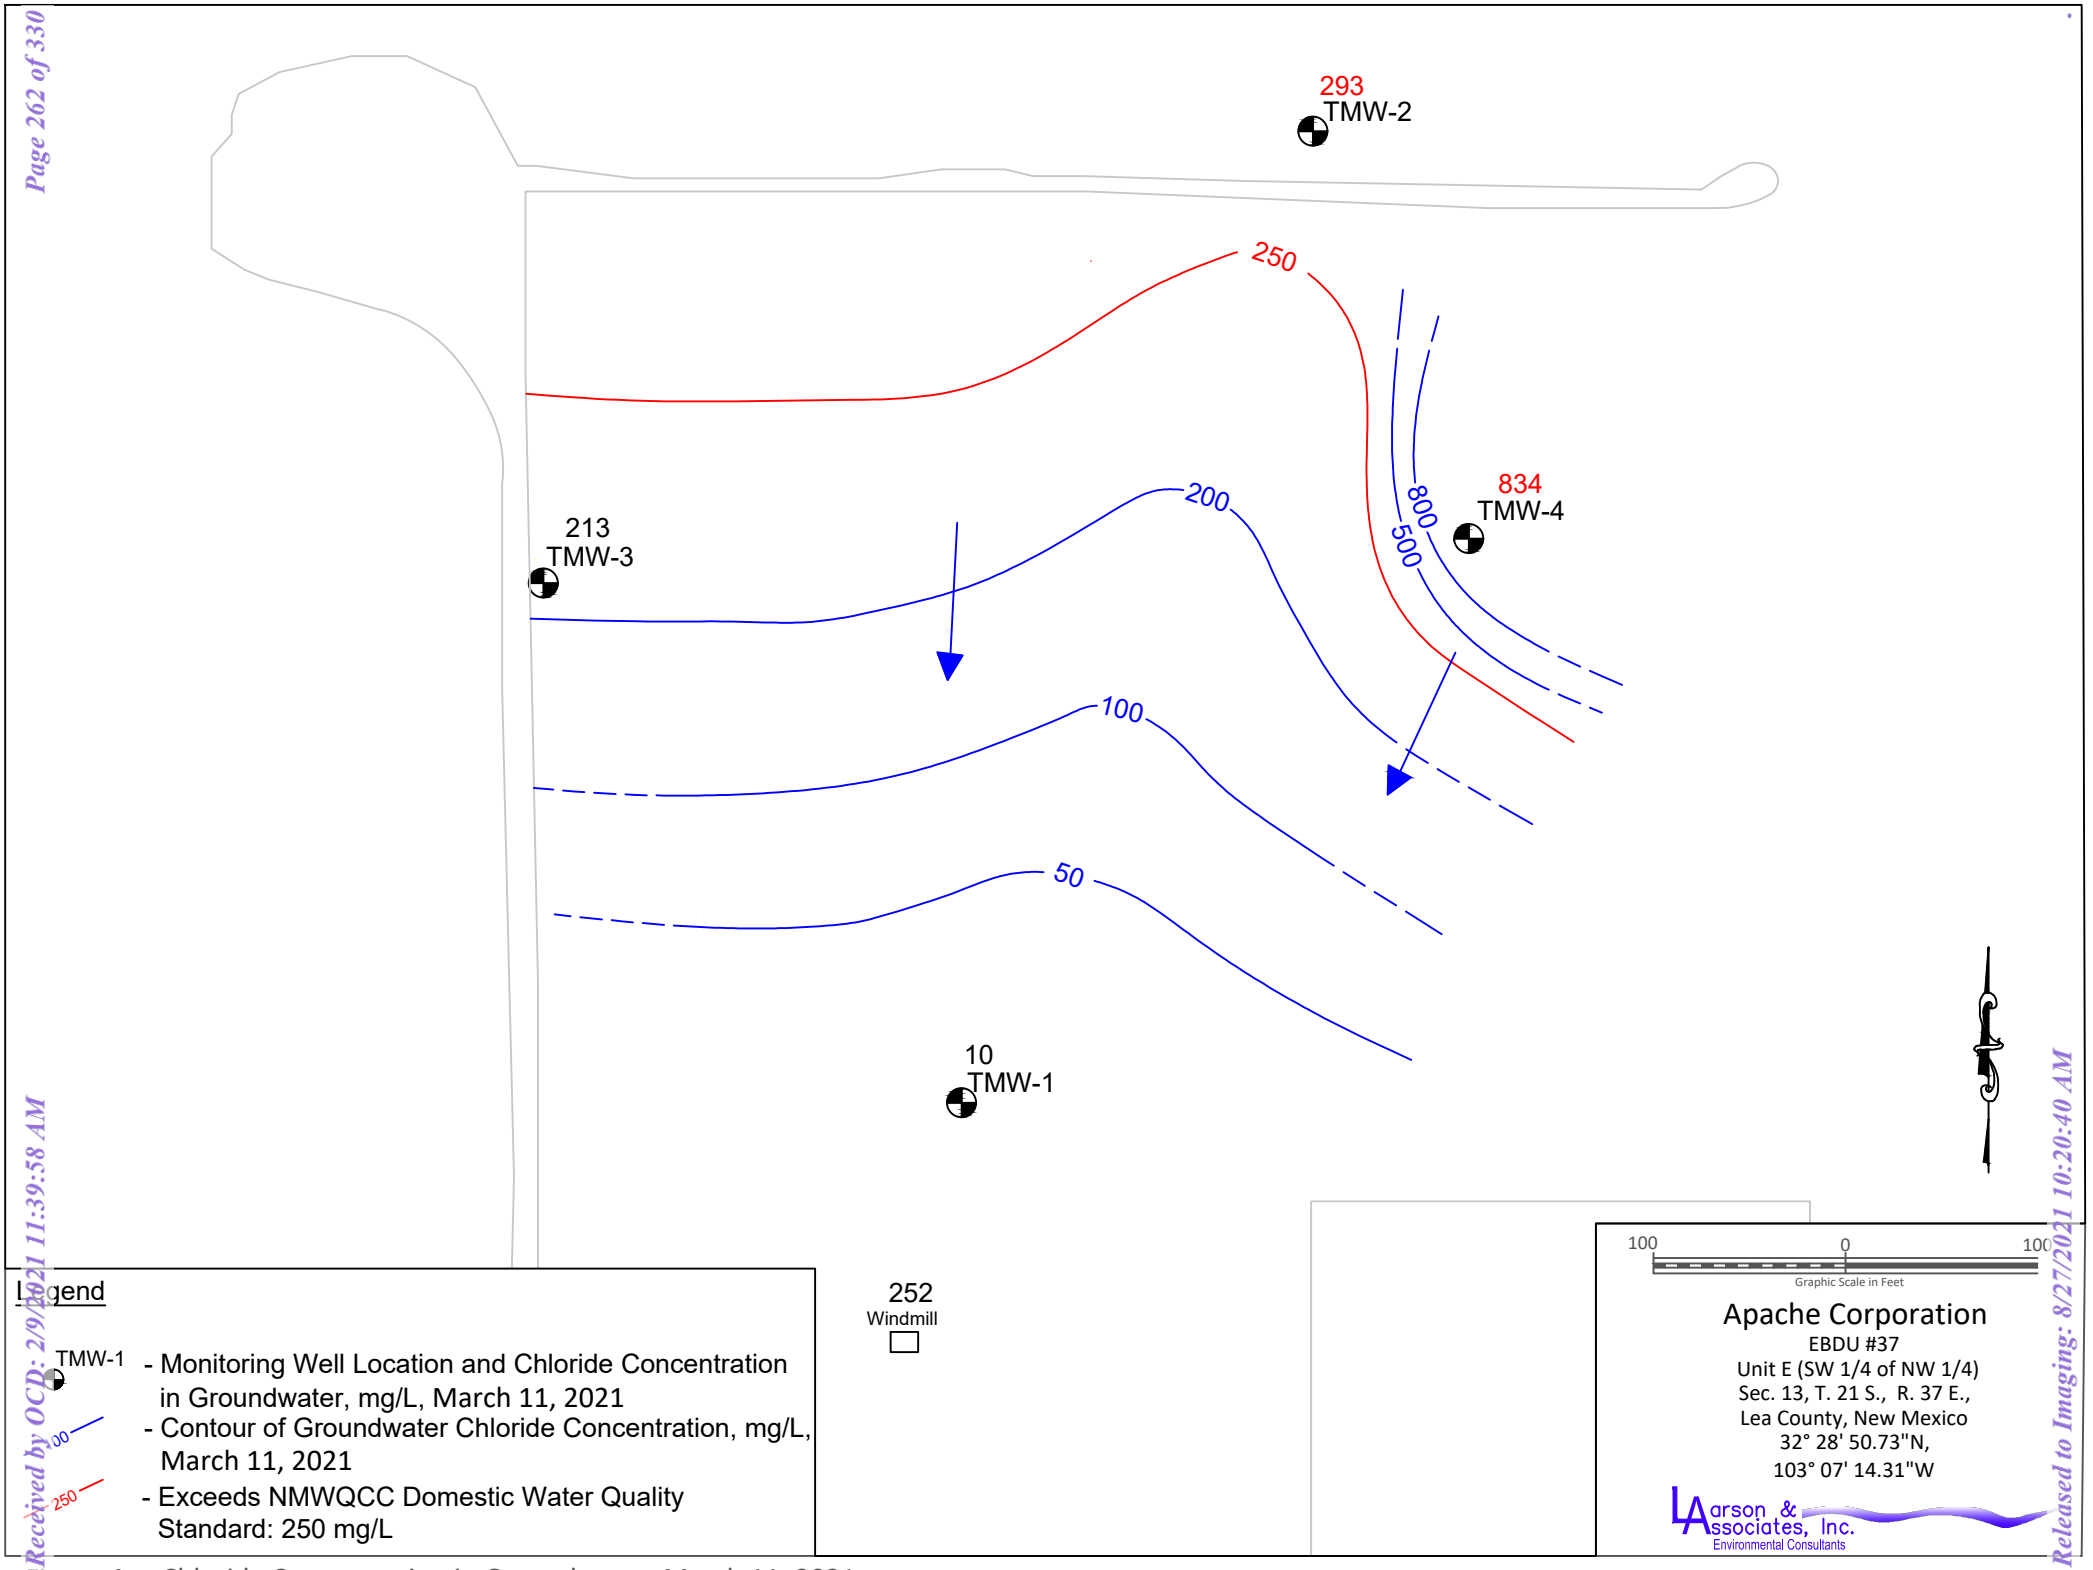
Figure 4a - Chloride Concentration in Groundwater, March 11, 2021

250 - Exceeds NMWQCC Domestic Water Quality Standard: 250 mg/L

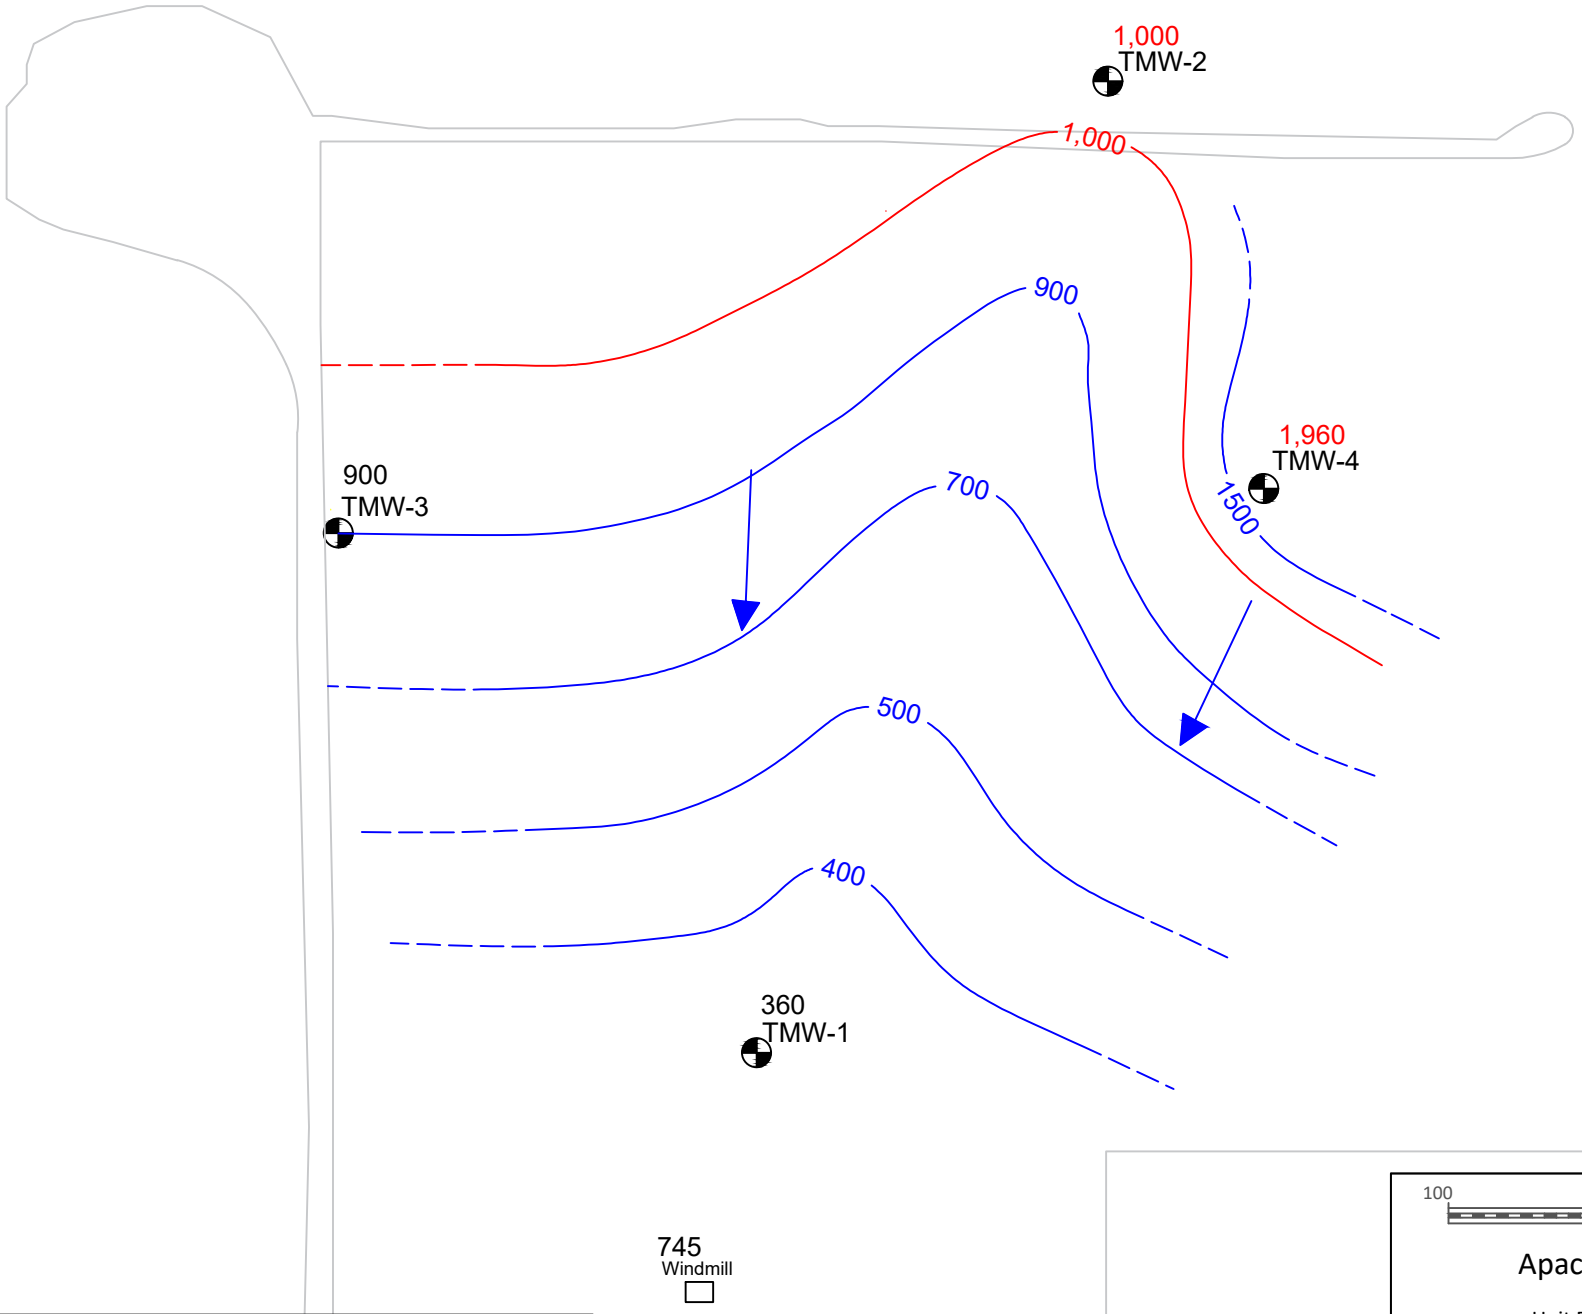
TMW-1 - Monitoring Well Location and TDS Concentration in Groundwater, mg/L, March 11, 2021
