Closure Report
Mercury CTB (02.10.22)
Incident #: NAPP2205928781
Eddy County, New Mexico
Unit N Sec 18 T26S R28E
32.036947°, -104.12051°

Crude Oil Release
Point of Release: Failed Connection
Release Date: 02/10/2022
Volume Released: 94 barrel of Crude Oil
Volume Recovered: 94 barrels of Crude Oil

Re: Closure Report
Mercury CTB (02.10.22)
Concho Operating, LLC
Incident ID NAPP22005928781
Site Location: Unit N, S18, T26S, R28E
(Lat 32.036947º, Long -104.128051º)
Eddy County, New Mexico

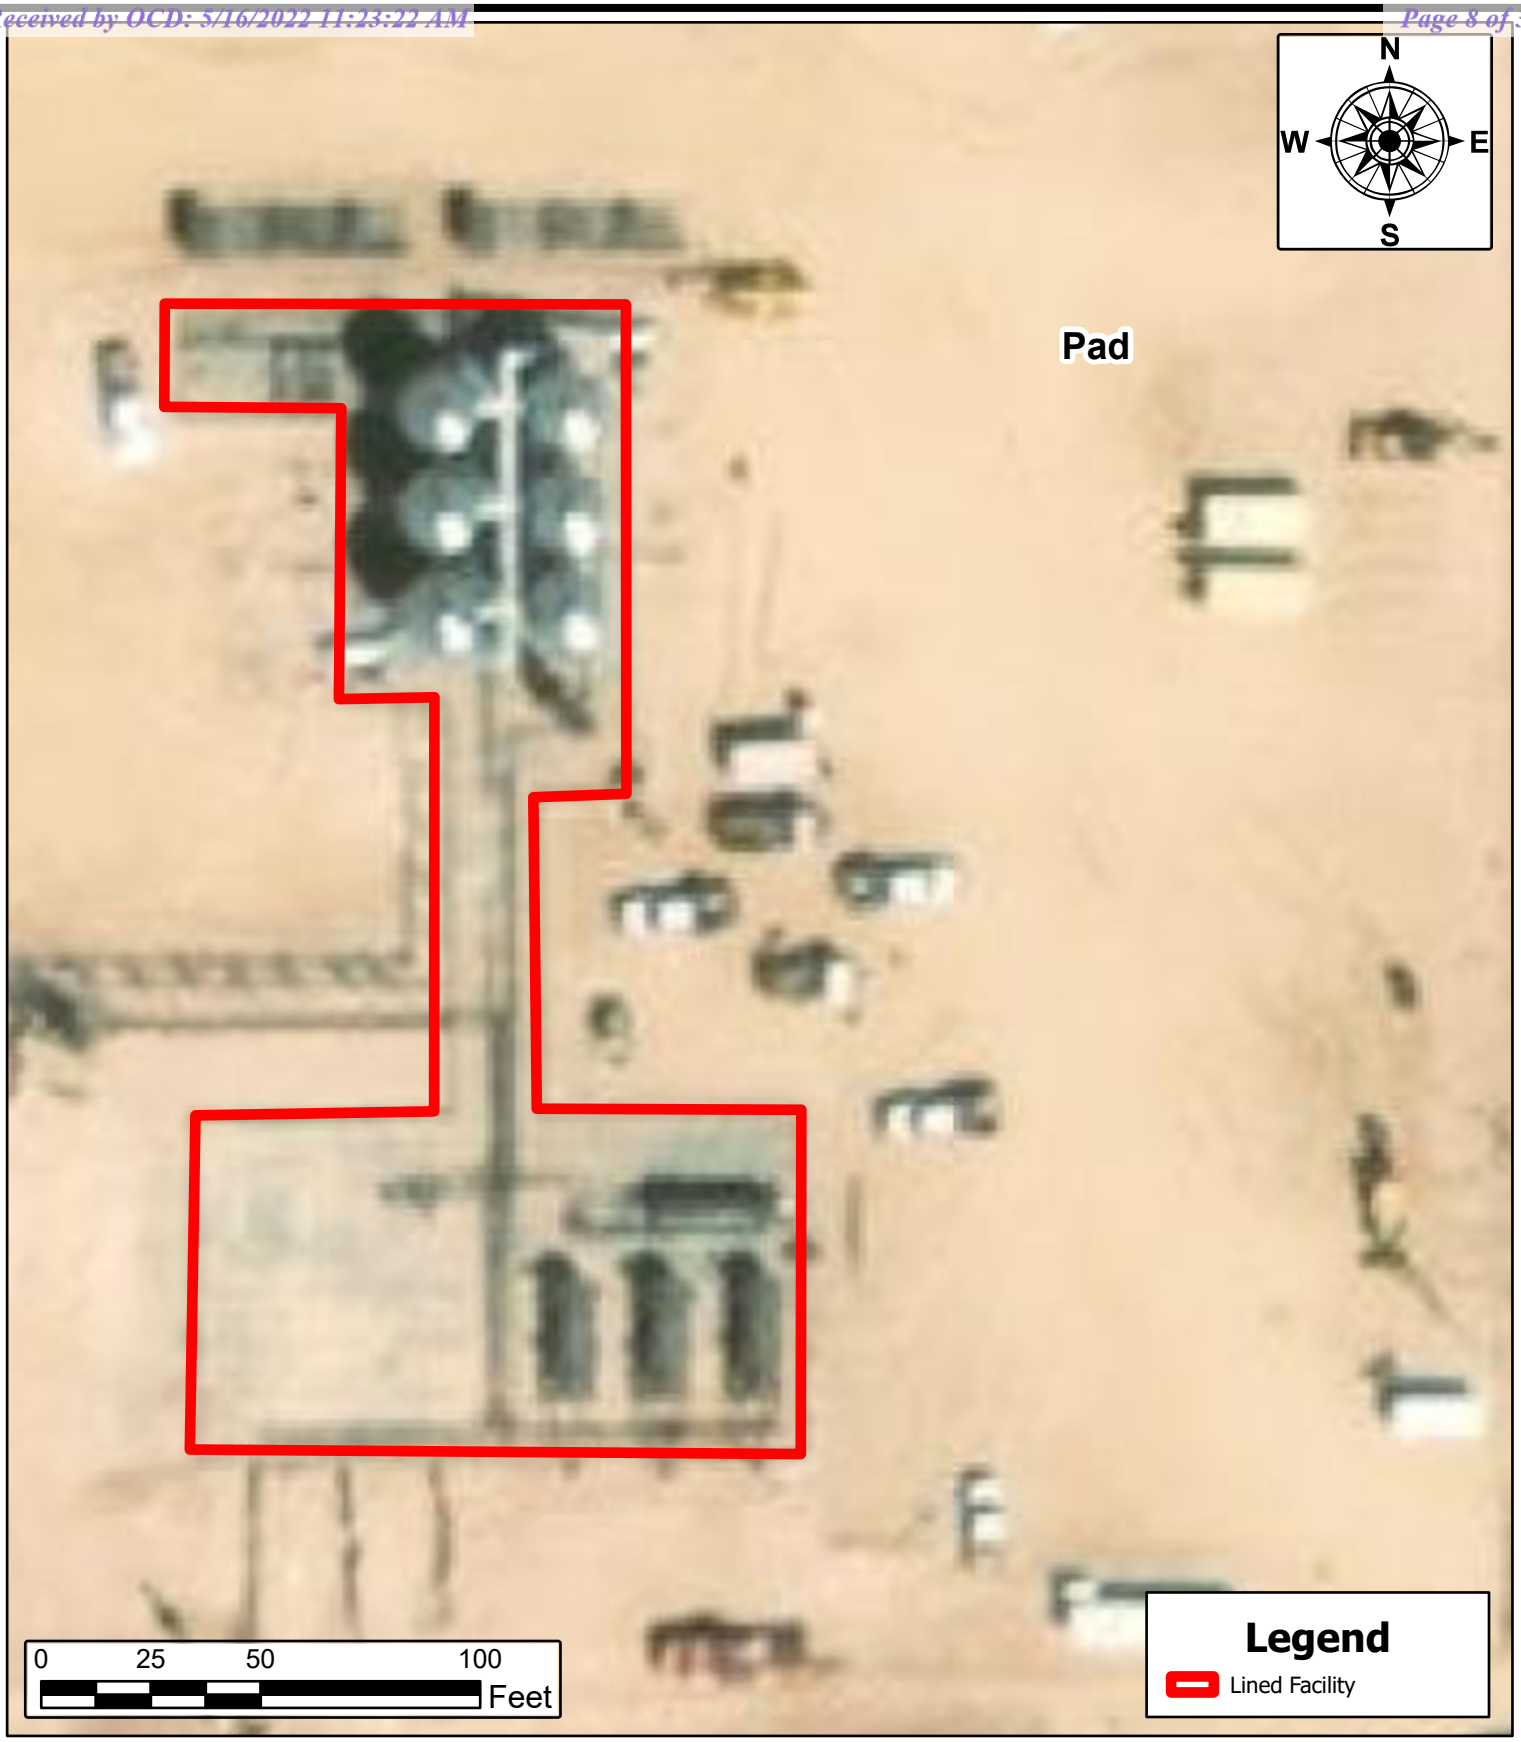
DRAWING NUMBER:
FIGURE 3
SHEET NUMBER:
1 of 1

Based on the initial C-141 obtained from the New Mexico Oil Conservation Division (NMOCD), the release was discovered on February 10, 2022, due to a failed connection point in the steel line. It resulted in approximately ninety-four (94) barrels of crude oil. Ninety-four (94) barrels were recovered. See figure 3. The initial C-141 form is attached in Appendix B.

SECONDARY CONTAINMENT MAP
COG OPERATING
MERCURY CTB (02.10.22)
EDDY COUNTY, NEW MEXICO
32.036947, -104.128051

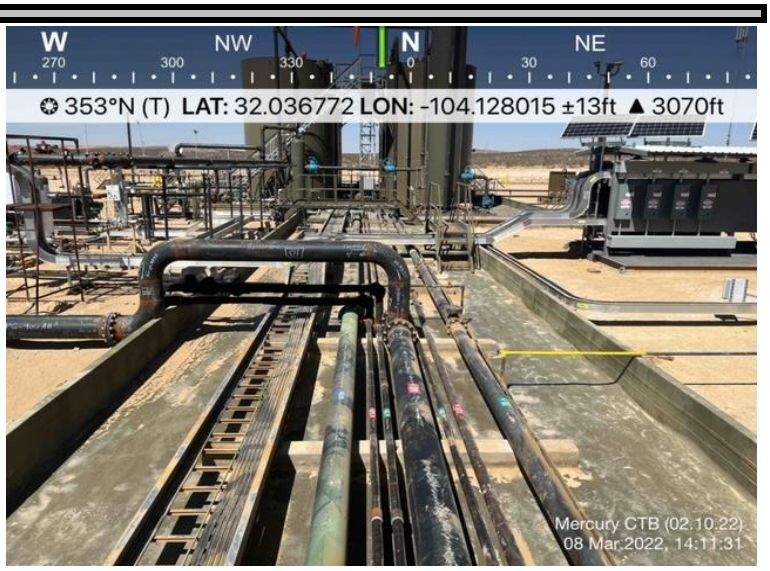
Photograph No. 4

Description:
View Southeast of lined facility.

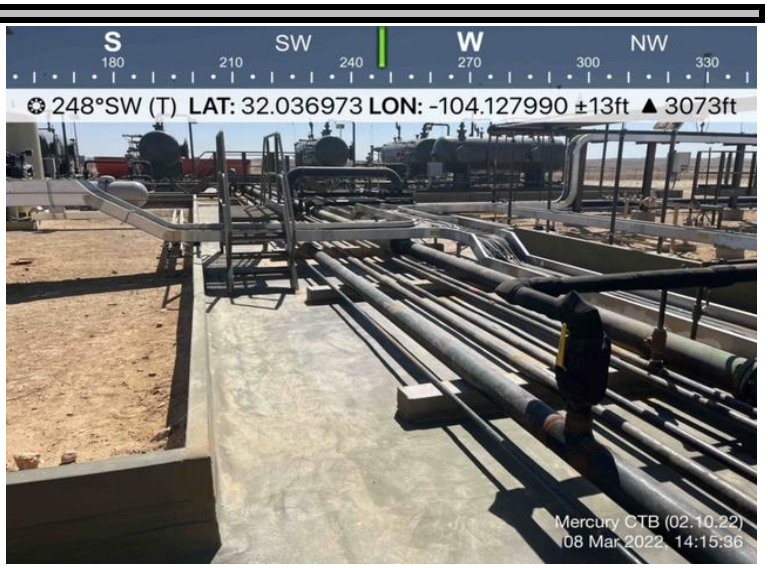
Photograph No. 7

Description:
View Southwest of lined facility.
