State of New Mexico
Oil Conservation Division

Incident ID	nKJ1602628821
District RP	1RP-4116
Facility ID	
Application ID

Site Assessment/Characterization

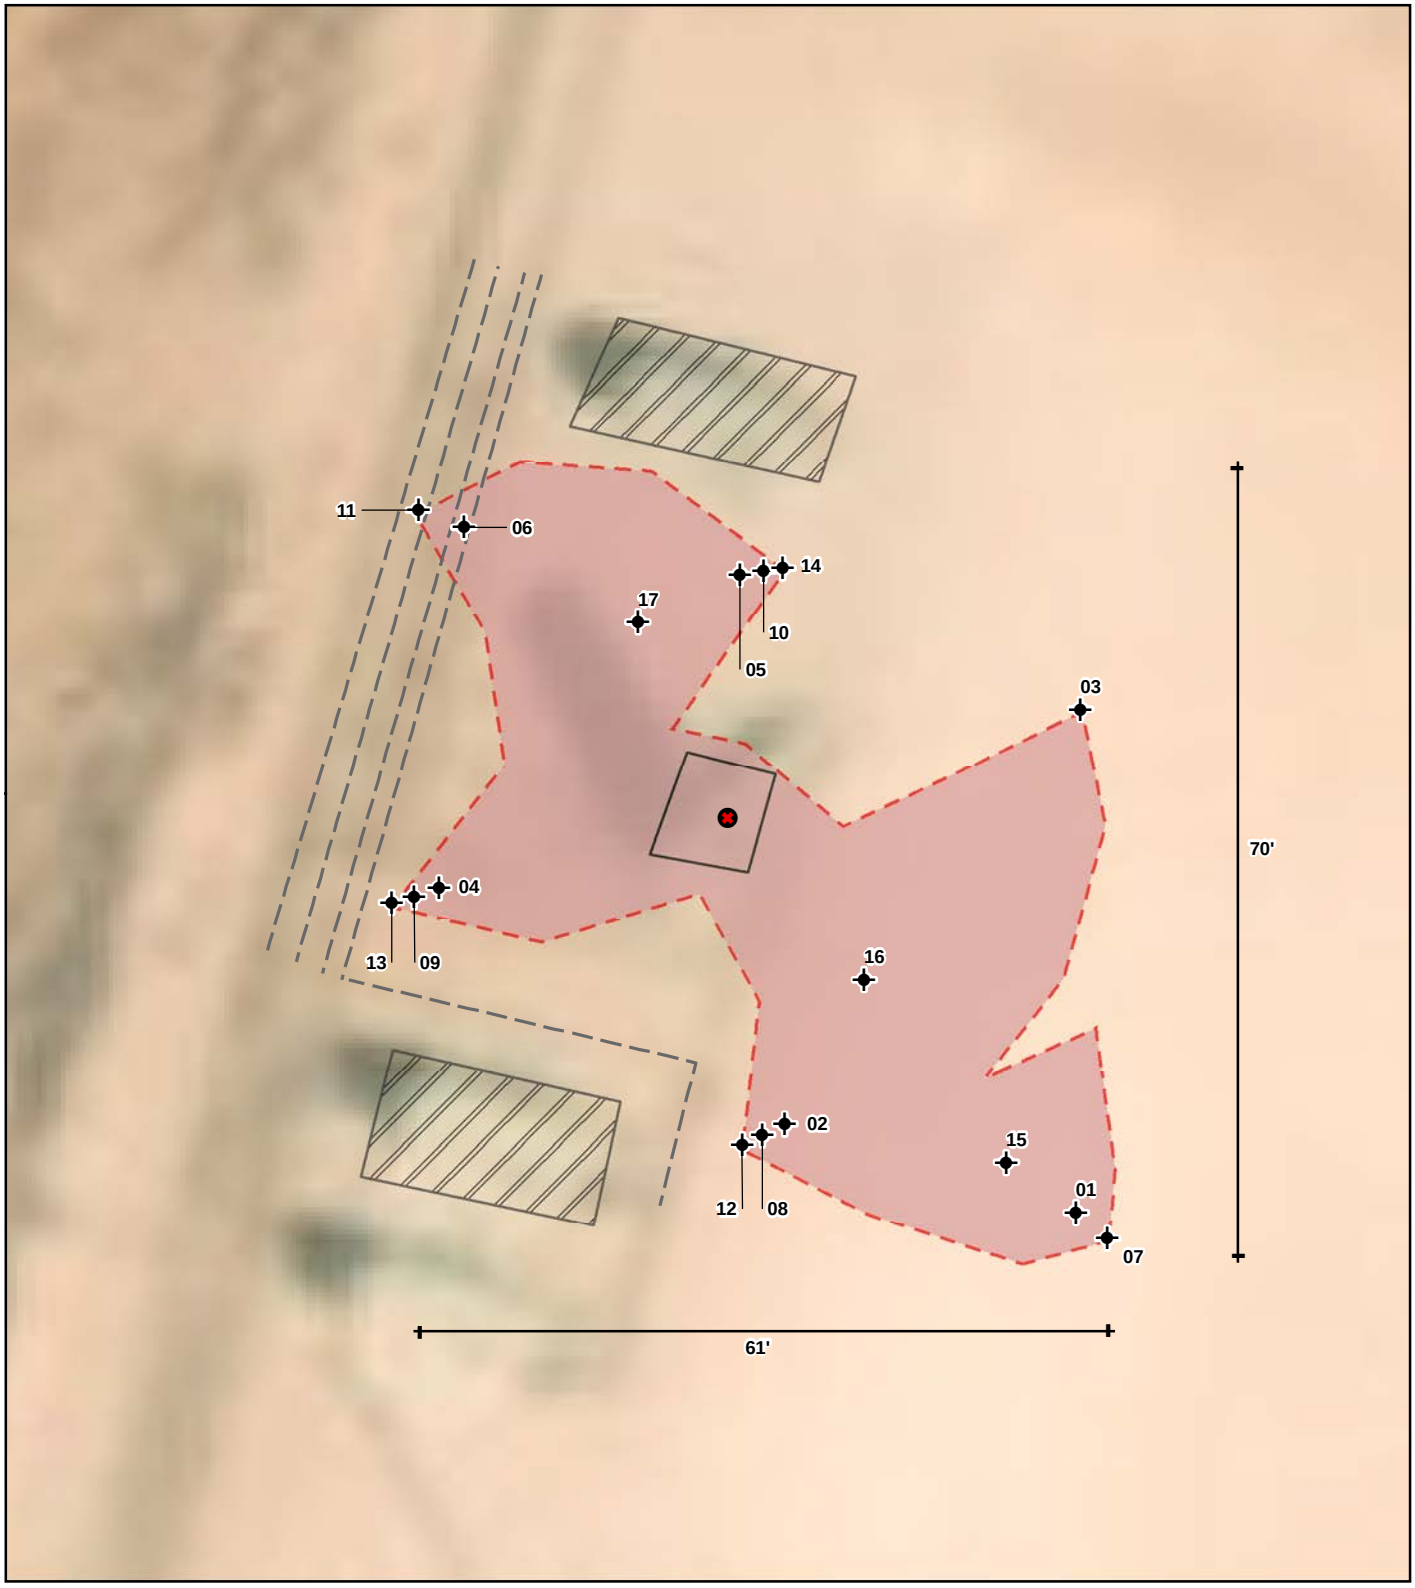
Borehole (Prefixed by "BH22-")
Point of Release
Pipeline (Aboveground)
Approximate Release Area (2,079 sq. ft.)
Heater Treater
Separator

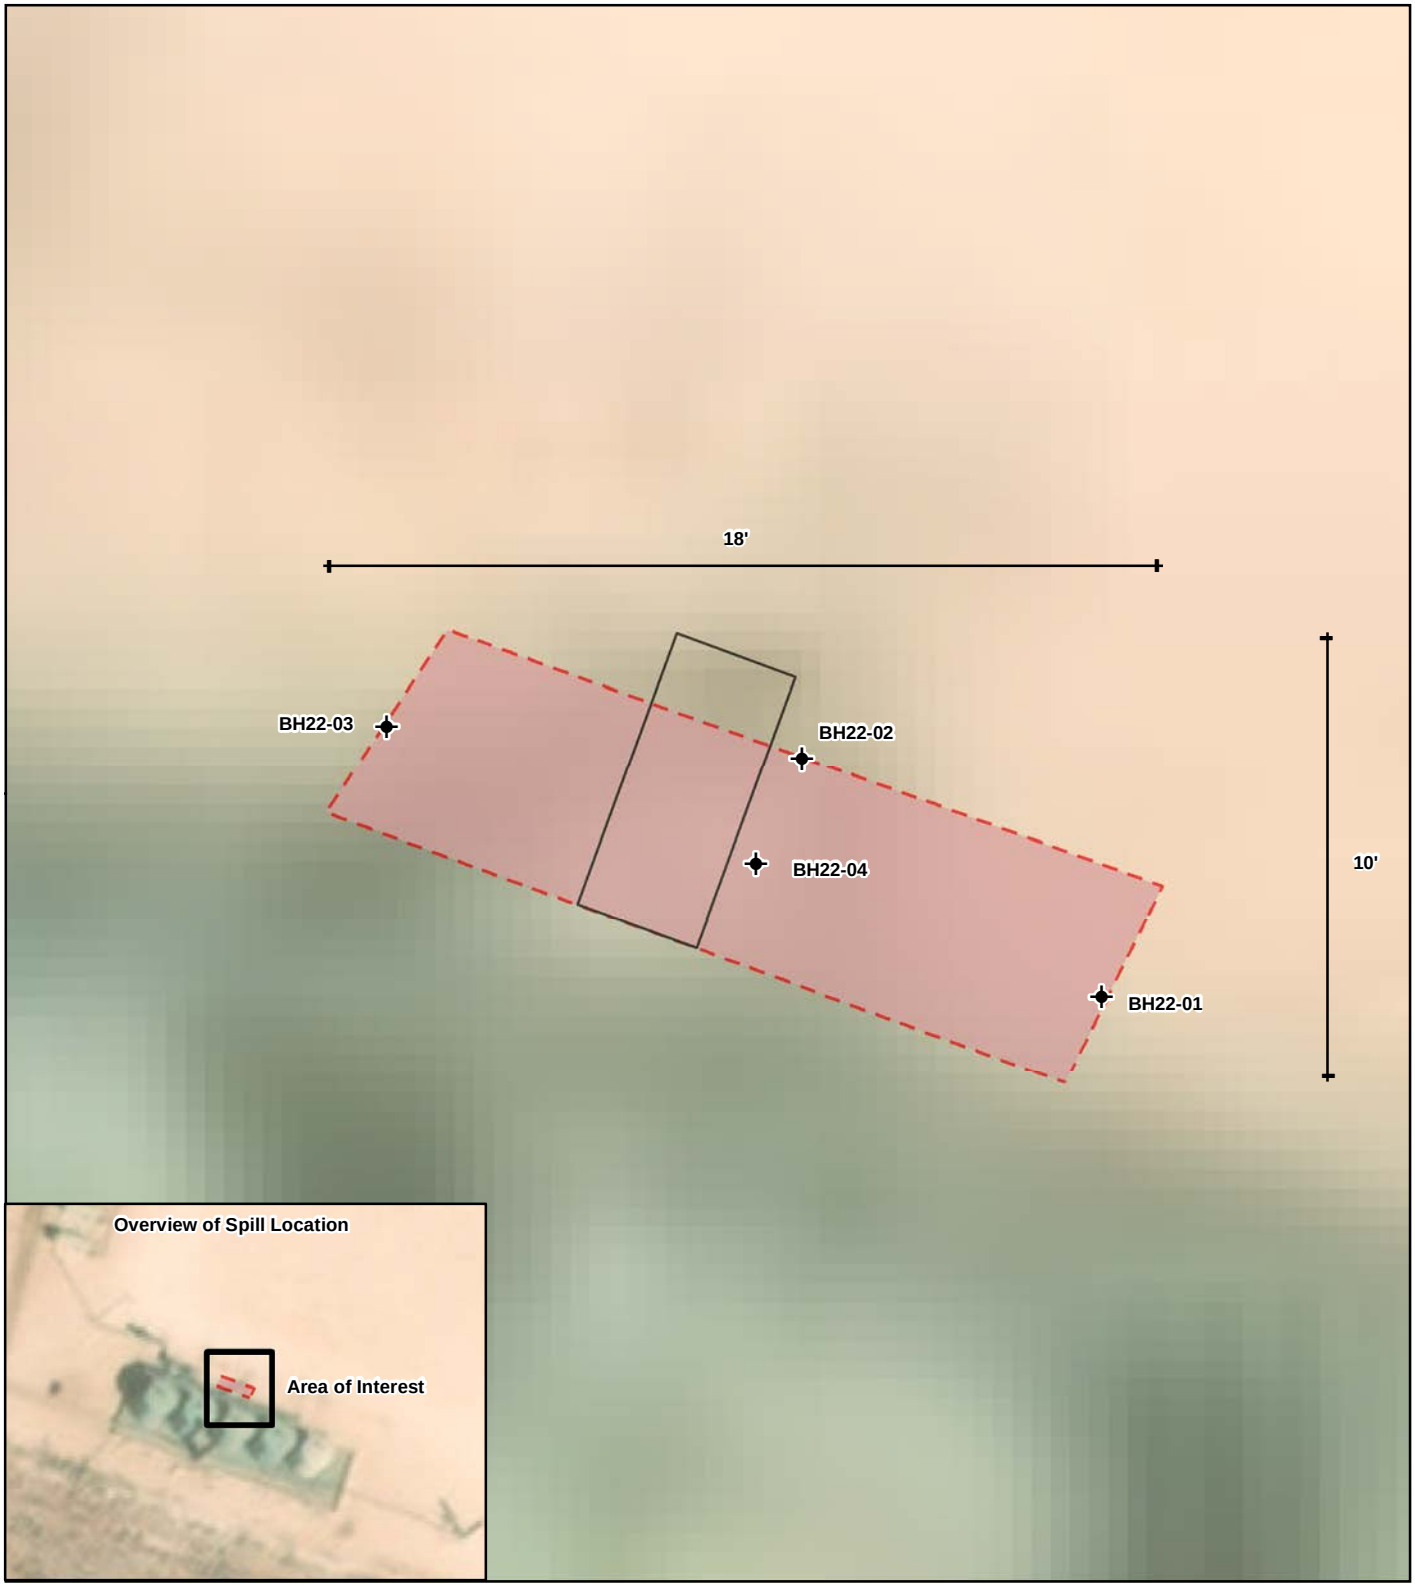
FIGURE: 1

Borehole
Pipeline (Aboveground)
Approximate Release Area (78 sq. ft.)
Stairs

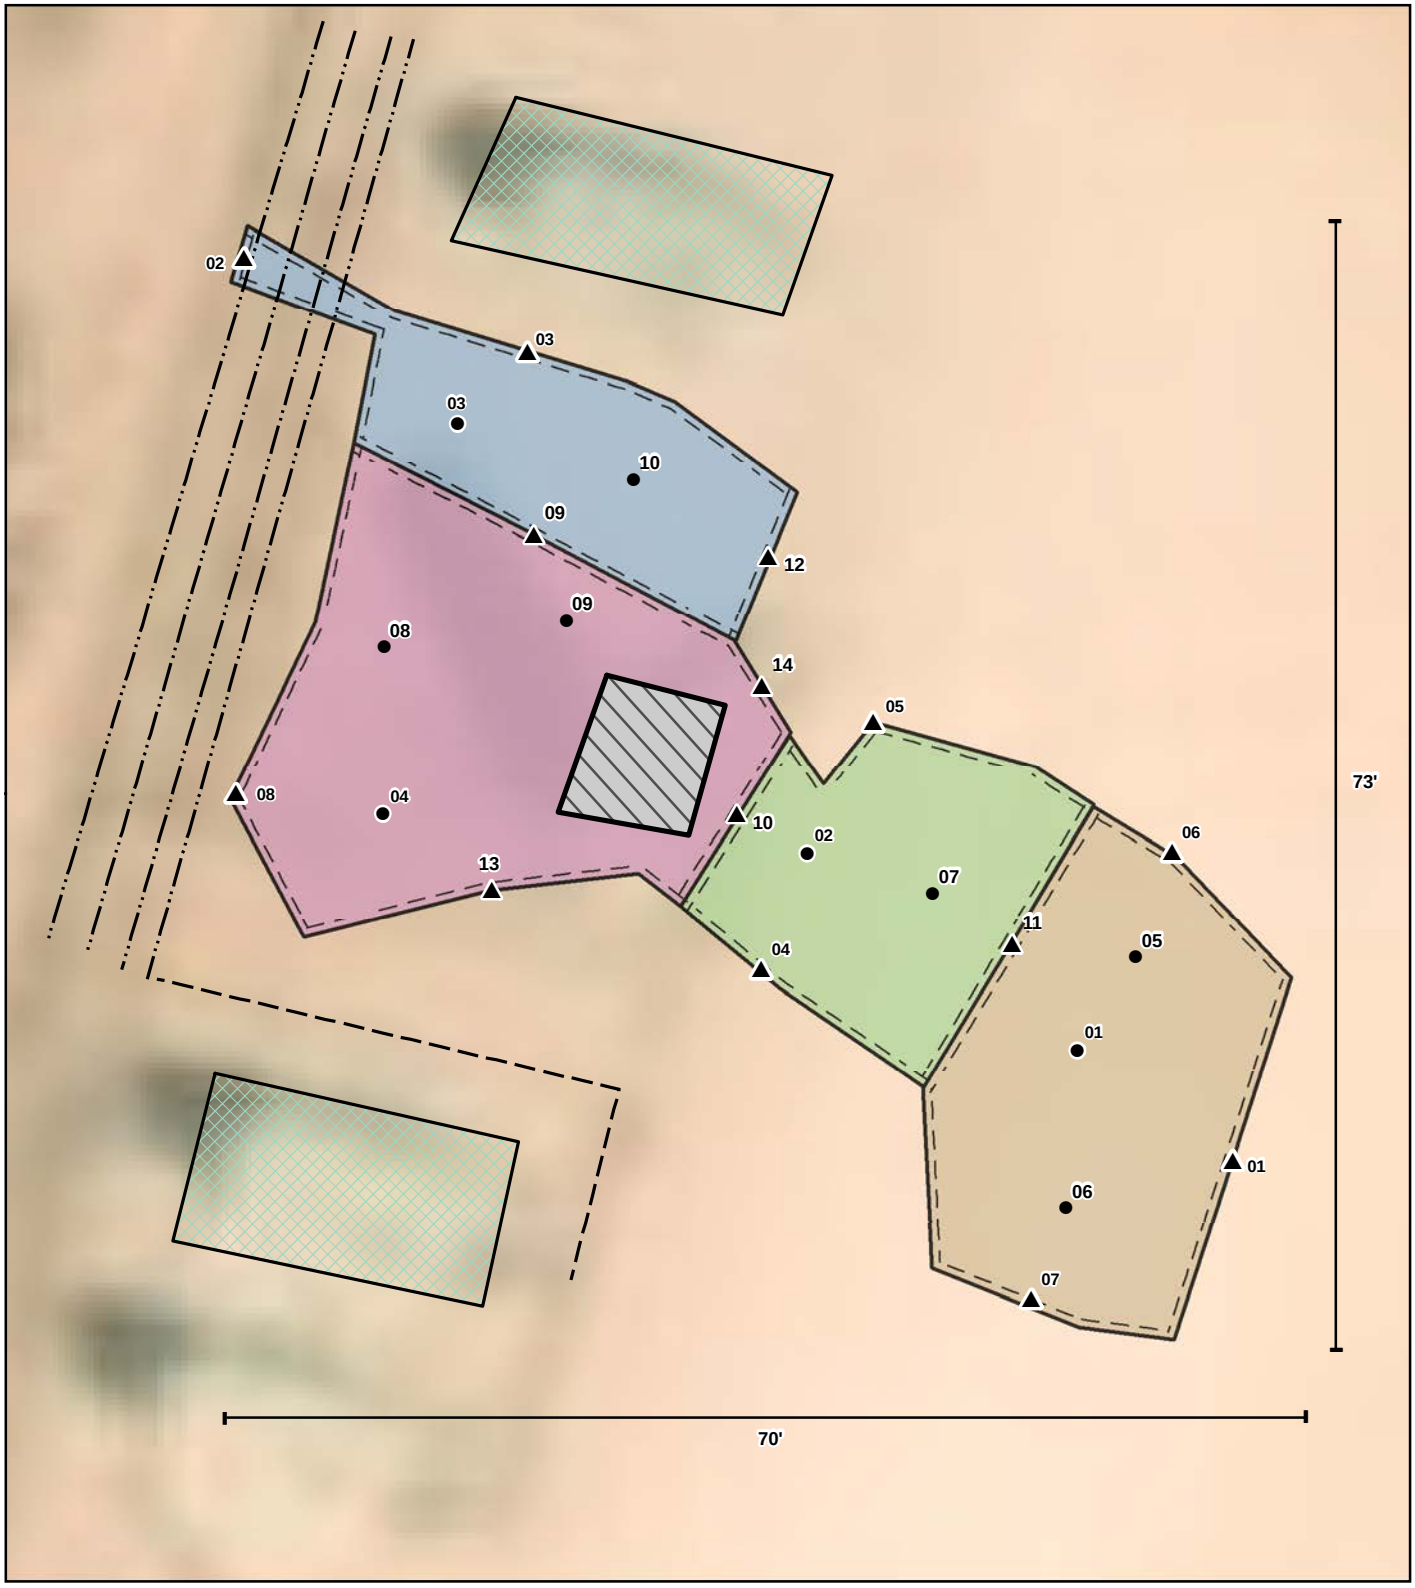
- Base Sample (Prefixed by "BES22-")
- Wall Sample (Prefixed by "WES22-")
- Pipeline
- Pipeline (Above Ground)
- 0.5' Excavation Area (~709 sq. ft.)
- 4' Excavation Area (~ 341 sq. ft.)
- 5' Excavation Area (~ 542 sq. ft.)
- 6' Excavation Area (~ 361 sq. ft.)

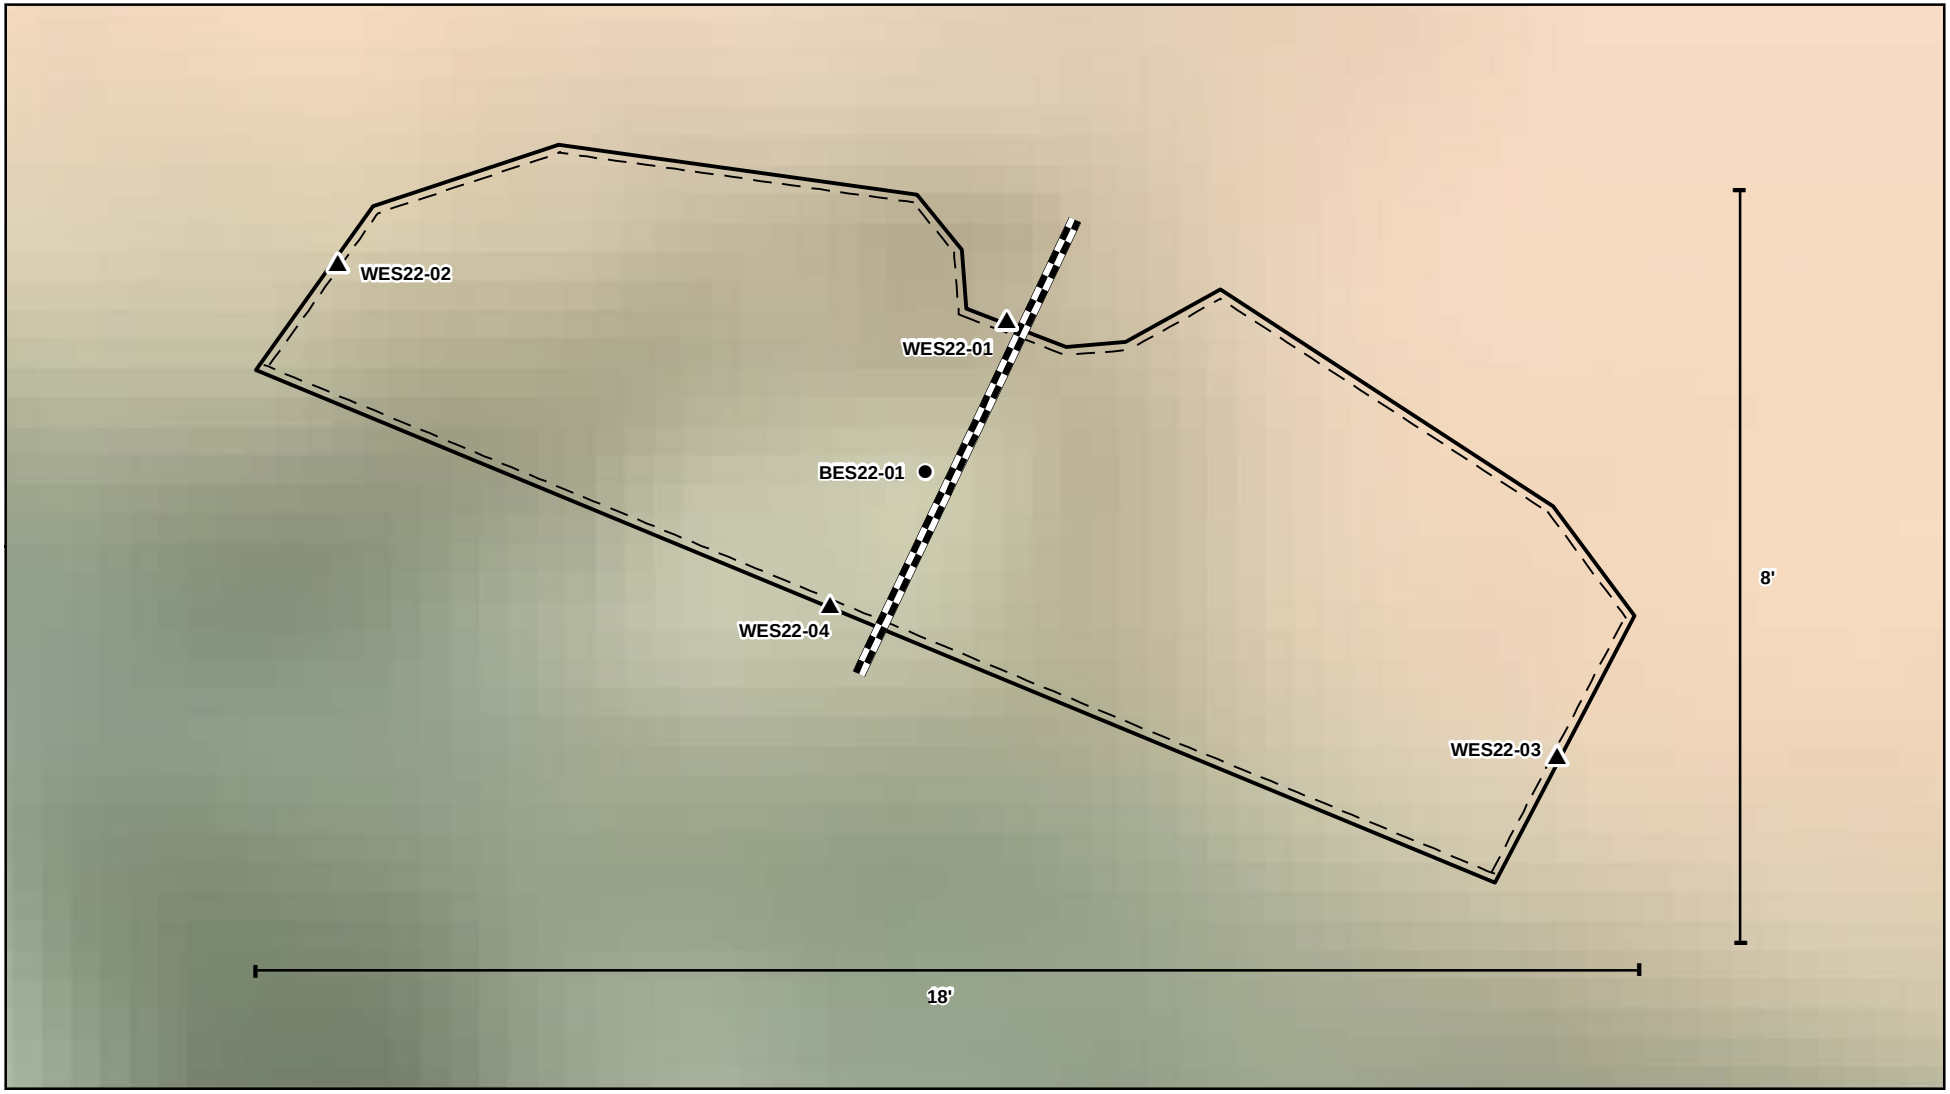
FIGURE: 3

Notification that additional confirmation sampling was scheduled to be completed was provided to the NMOCD on July 5, 2022 (Attachment 6). Additional confirmatory samples were collected from the base and walls of the excavation in 200 square foot increments. A total of 13 additional samples were collected for laboratory analysis following NMOCD soil sampling procedures. Samples were submitted to Hall Environmental Analysis Laboratory under chain-of-custody protocols and analyzed for BTEX (EPA Method 8021B), total petroleum hydrocarbons (GRO, DRO, MRO – EPA Method 8015D) and total chlorides (EPA Method 300.0). Laboratory results are presented in Tables 4 and 5 (Attachment 3) and the laboratory data report is included in Attachment 7. All confirmatory samples collected and analyzed were below closure criteria for the site. An aerial view of excavation and confirmatory sample locations are presented in Figures 3 and 4 (Attachment 2).

Base Sample
Excavation Area (~82 sq. ft.)
Wall Sample
Stairs
