January 13, 2023

Re: Fourth Quarter 2022 – SVE System Update
Lambe 2C
San Juan County, New Mexico
Hilcorp Energy Company
NMOCD Incident Number: NVF1836050592
Ensolum Project No. 07A1988008

PROJECT PHOTOGRAPHS
Lambe 2C
San Juan County, New Mexico
Hilcorp Energy Company

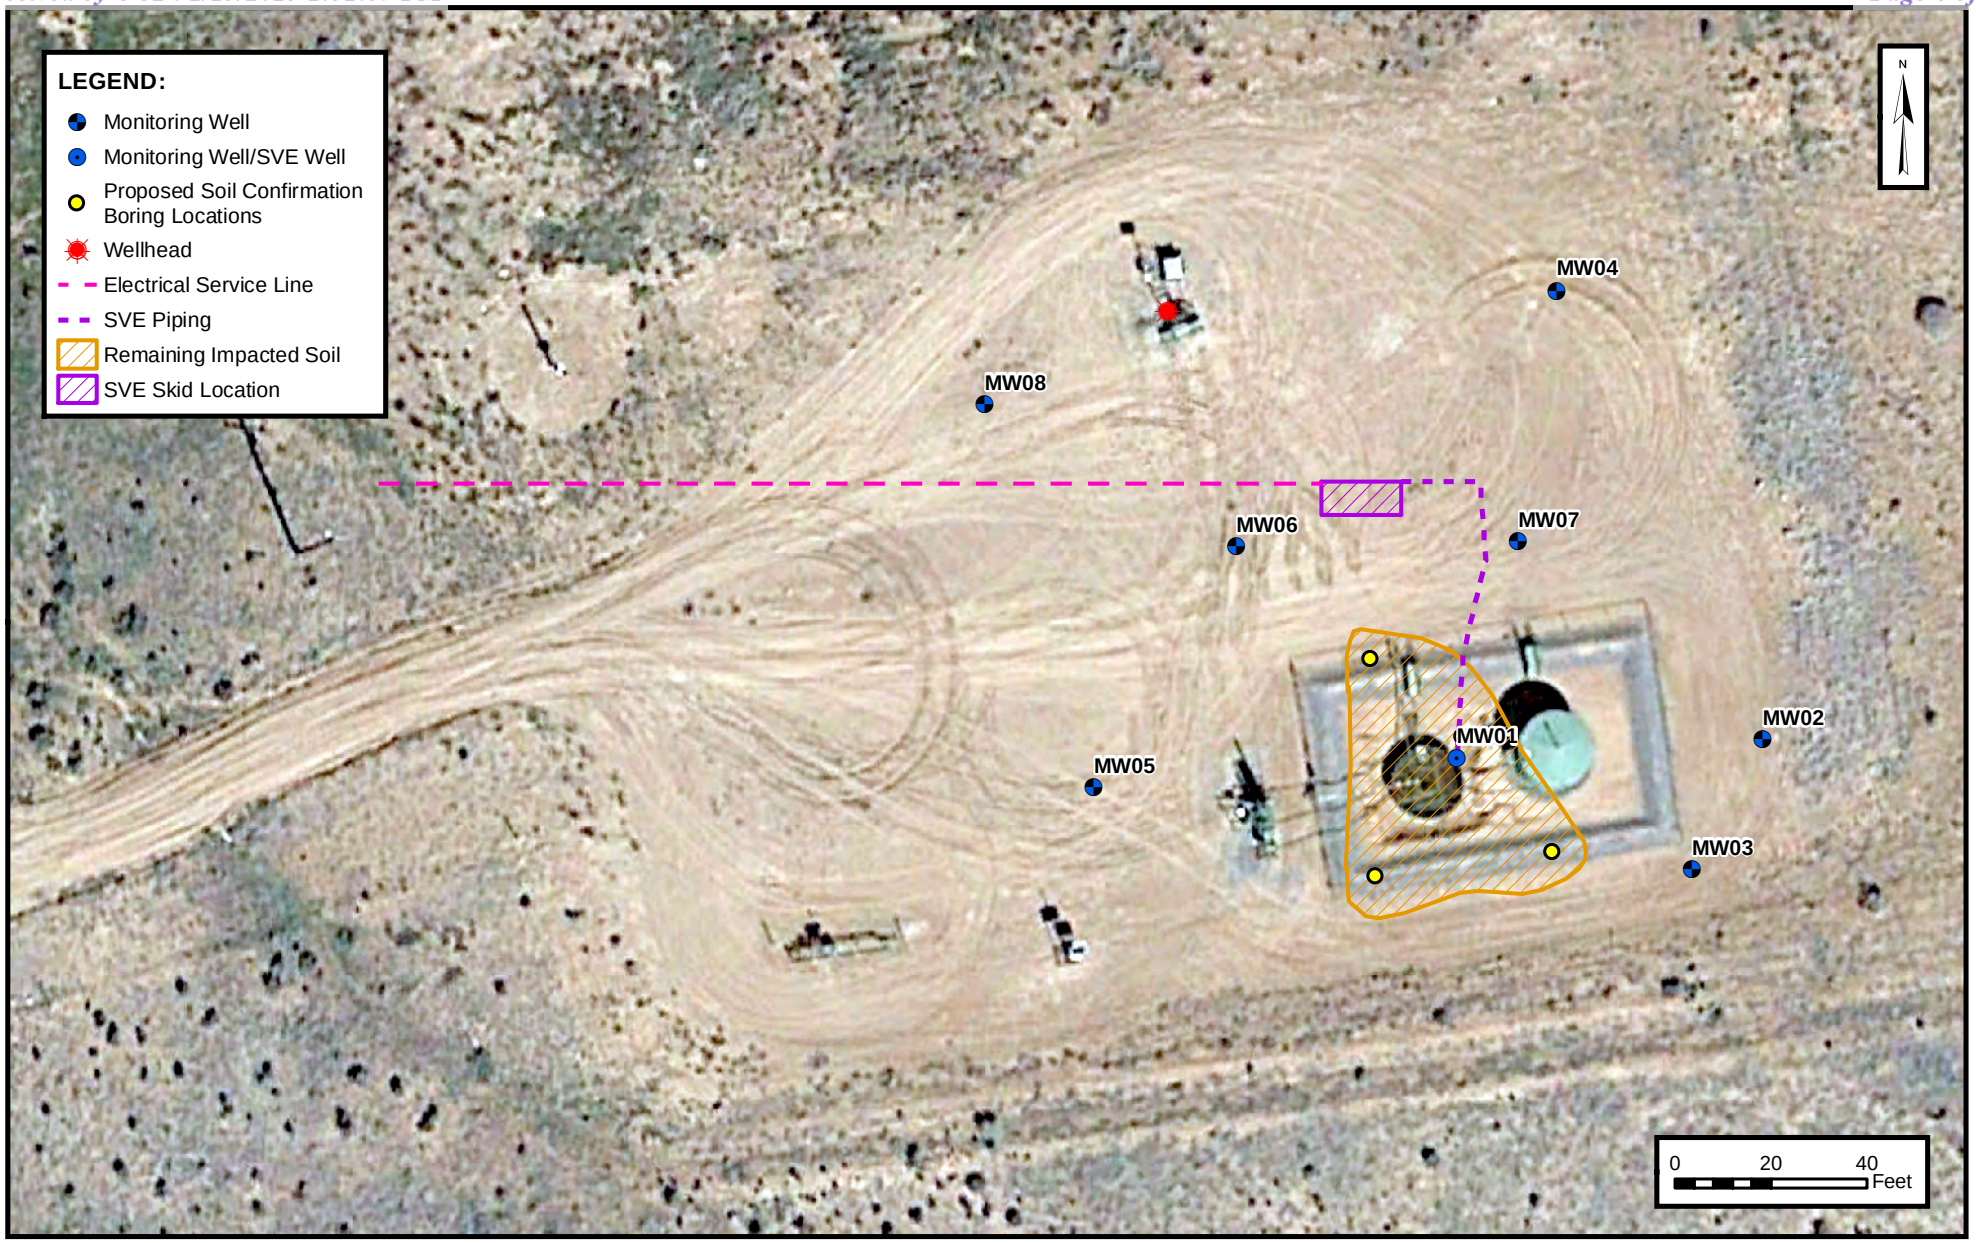
FIGURE

The current SVE system was installed at the Site in September 2021, with operation beginning on September 24, 2021. The SVE system is configured so vacuum is being applied to well MW01 (shown on Figure 2). SVE well MW01 is screened across the impacted soil interval from approximately 20 feet to 35 feet below ground surface (bgs). The SVE system consists of a 1 horsepower Atlantic Blower model AB-202/1 regenerative blower capable of producing 50 standard cubic feet per minute (scfm) flow and 30 inches of water column (IWC) vacuum. The layout of the SVE system and piping is shown on Figure 2.
