Pima Environmental Services
5614 N. Lovington Highway
Hobbs, NM 88240
575-964-7740

March 3, 2023

Re: Site Assessment, Remediation, and Closure Report
Marwari 28 CTB 1
API No. N/A
GPS: Latitude 32.105915 Longitude -103.687761
UL -- D, 28, T25S, R32E
Lea County, NM
NMOCD Ref. No. NAPP2201145173

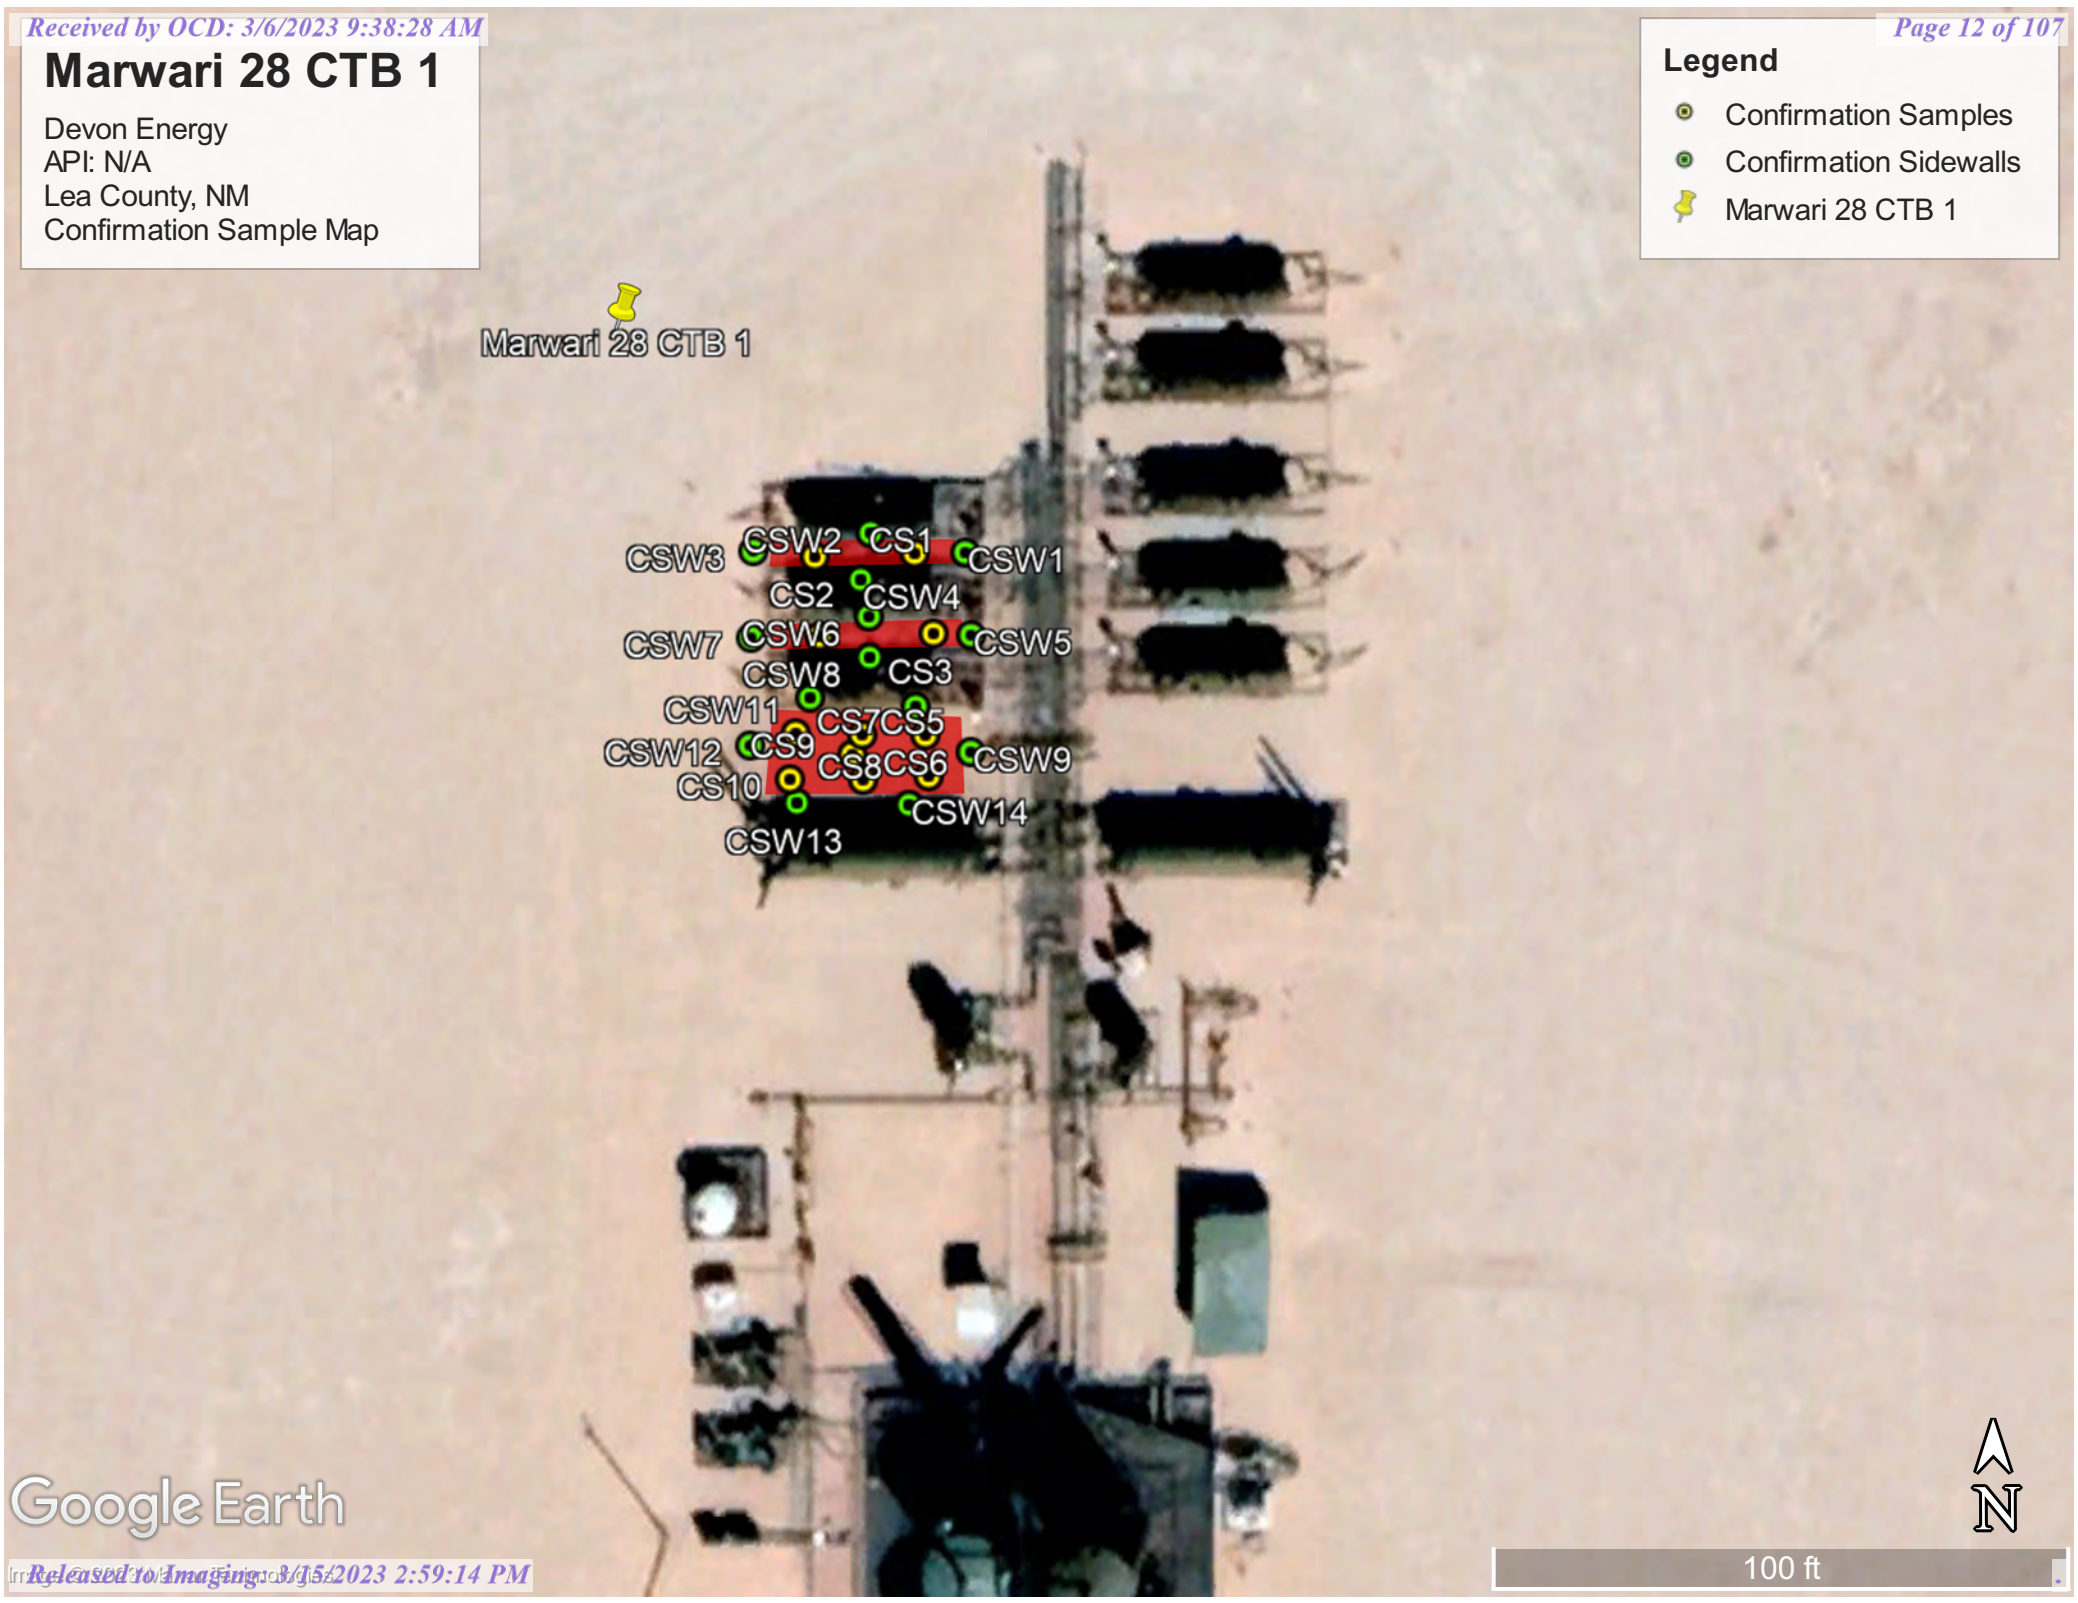
Devon Energy
API: N/A
Lea County, NM
Confirmation Sample Map

On January 26, 2023, after sending a 48-hour notification (Appendix C), Pima returned to the site to collect confirmation samples of the excavation. The results of this sampling event can be found in the following table. A Confirmation Sample Map can be found in Figure 5.

Based on the sample results, the bottoms and sidewalls were below NMOCD Closure Criteria 19.15.29 NMAC. The contaminated material was removed then transported to an NMOCD approved disposal site. The excavation was then backfilled with clean like material, machine compacted and returned to its previous state. See Appendix D for Photographic Documentation.

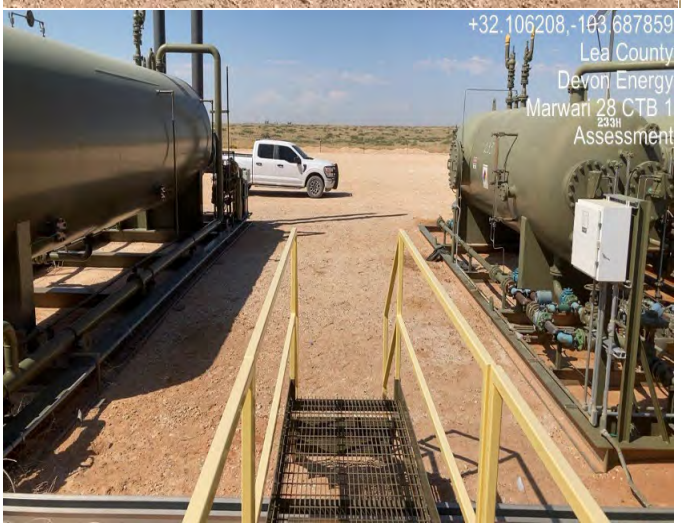
Site Assessment

NAPP2201145173: On December 27, 2021, a site glass broke on a 3-phase separator causing a produced water leak. The released fluids were calculated to be approximately 12.4 barrels (bbls) of produced water. A vacuum truck was able to recover approximately 10 bbls of standing fluid.

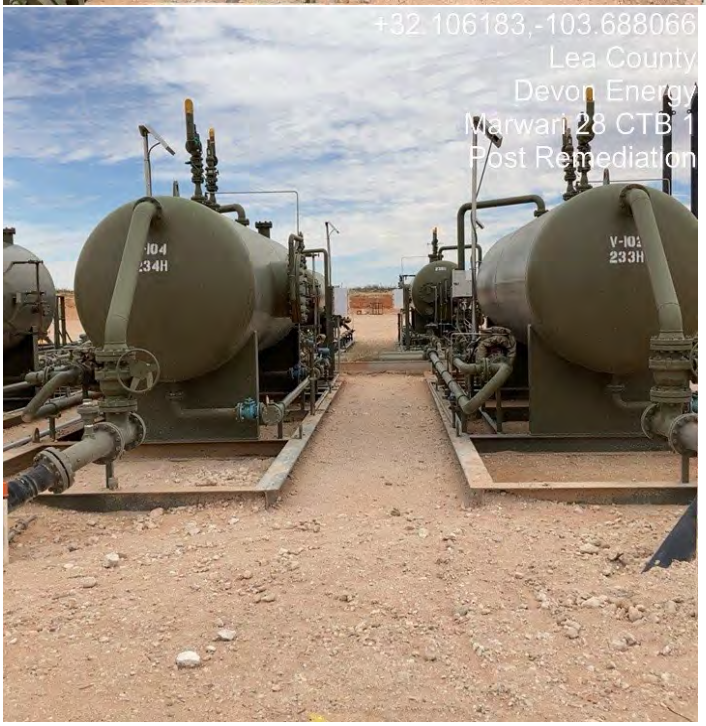
+32.106325,-103.687830
Lea County
Devon Energy
Marwari 28 CTB 1
Post Remediation

+32.106183,-103.688066
Lea County
Devon Energy
Marwari 28 CTB 1
Post Remediation
