State of New Mexico
Oil Conservation Division

Incident ID	nAPP2211730678
District RP	
Facility ID	
Application ID

SUBJECT: Amendment to Work Plan for the Hayhurst Pad 10 Release (nAPP2211730678), Eddy County, New Mexico

Table 1, Summary of Soil Analytical Results
Hayhurst Pad 10 Site Delineation
Unit O, Section 26, Township 25S, Range 27E
Eddy County, New Mexico
Incident #nAPP2211730678

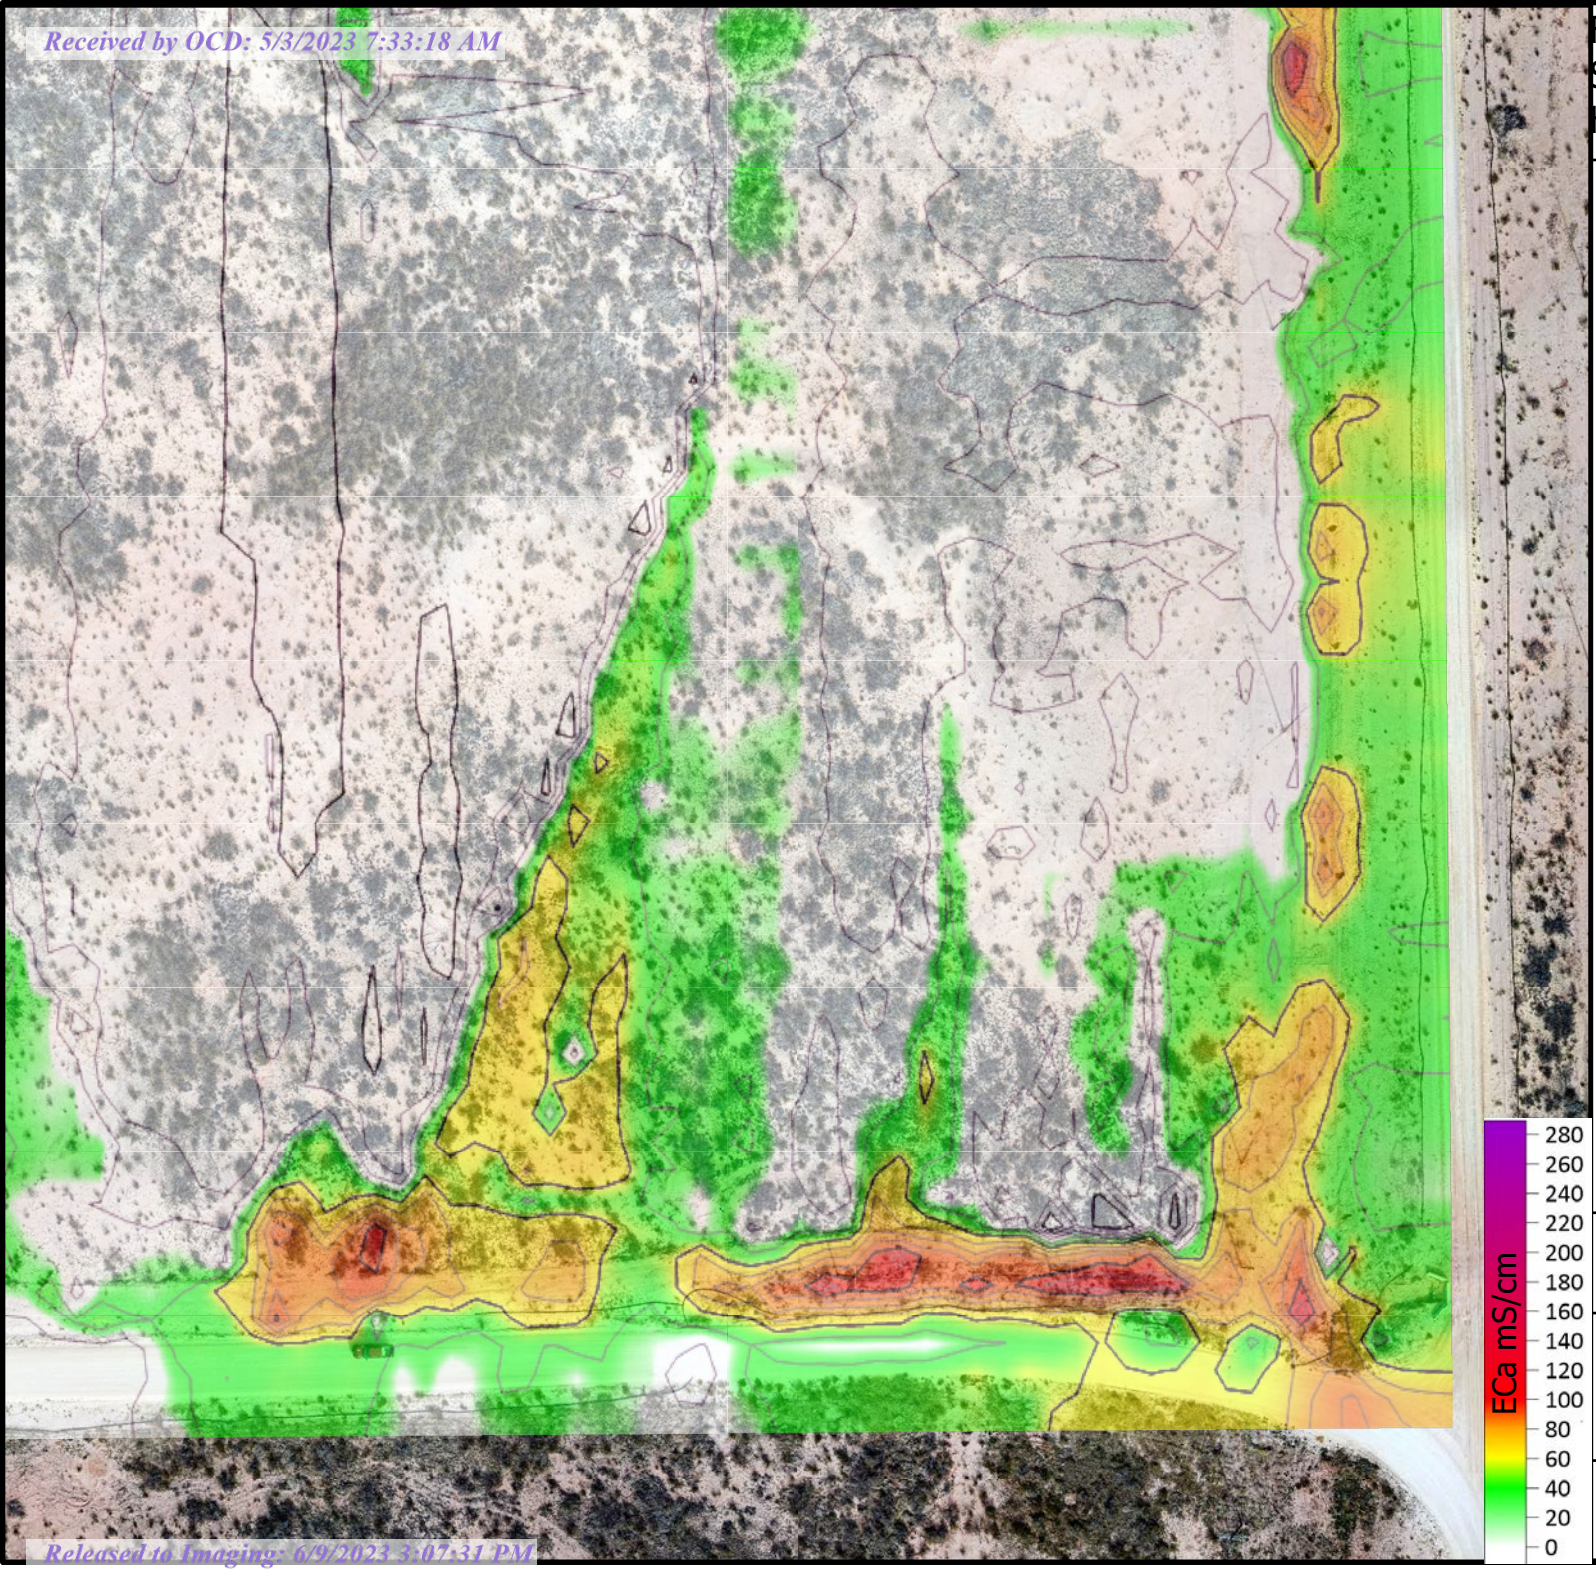
FIGURE 1 EM 38 ECa
South area
Hayhurst Release

Figure 1 attached is a product of the fixed-frequency EM method used to map variations in ground conductivity to identify anomalously conductive soils and infer changes in the soil characteristics and composition. This method used portable instrumentation consisting of a transmitter coil and a receiver coil. primary magnetic field from the transmitter coil induces subsurface eddy currents, which in turn generate a secondary magnetic field that is intercepted by the receiver coil. The ratio of the primary and secondary magnetic fields is related to ground conductivity represented as ECa in mS/m.
The conductivity values are not specific values from discrete depths; they are weighted averages of conductivity between the surface and the depth of exploration of the EM field and are termed “apparent conductivities”. The apparent conductivity values obtained are in units of millisiemens per meter (mS/m). The apparent conductivity (ECa) of the soil has been related to the paste extract conductivity {ECe) by the relationship ECa=5ECa (McNeill, 1986a). Table 2 (from McNeill, 1986a) illustrates this general relationship. Measurements are expressed in millisiemens/meter (mS/m).

The table above shows the general correlation between laboratory soil saturated paste ECe and the apparent conductivity ECa measured by an EM unit. The Electromagnetic surveying confirmed the previously submitted release area and samples.

Figure 1 shows the extent of the proposed excavation and existing sample locations. All laboratory results are summarized in Envirotec Table 1. Laboratory reports are included in Appendix . AEA was operating under the assumption that because the release is not on pad that all areas would be remediated to the strictest closure standards.

Comparing the delineation performed by Envirotech with the horizontal extent provided by the EM Survey conducted by AEA. AEA proposes an excavation of caliche and native soil to remediate the impacted soils. Most of the excavation will be less than two (2) feet except for sample areas TH-13 and TH-18.

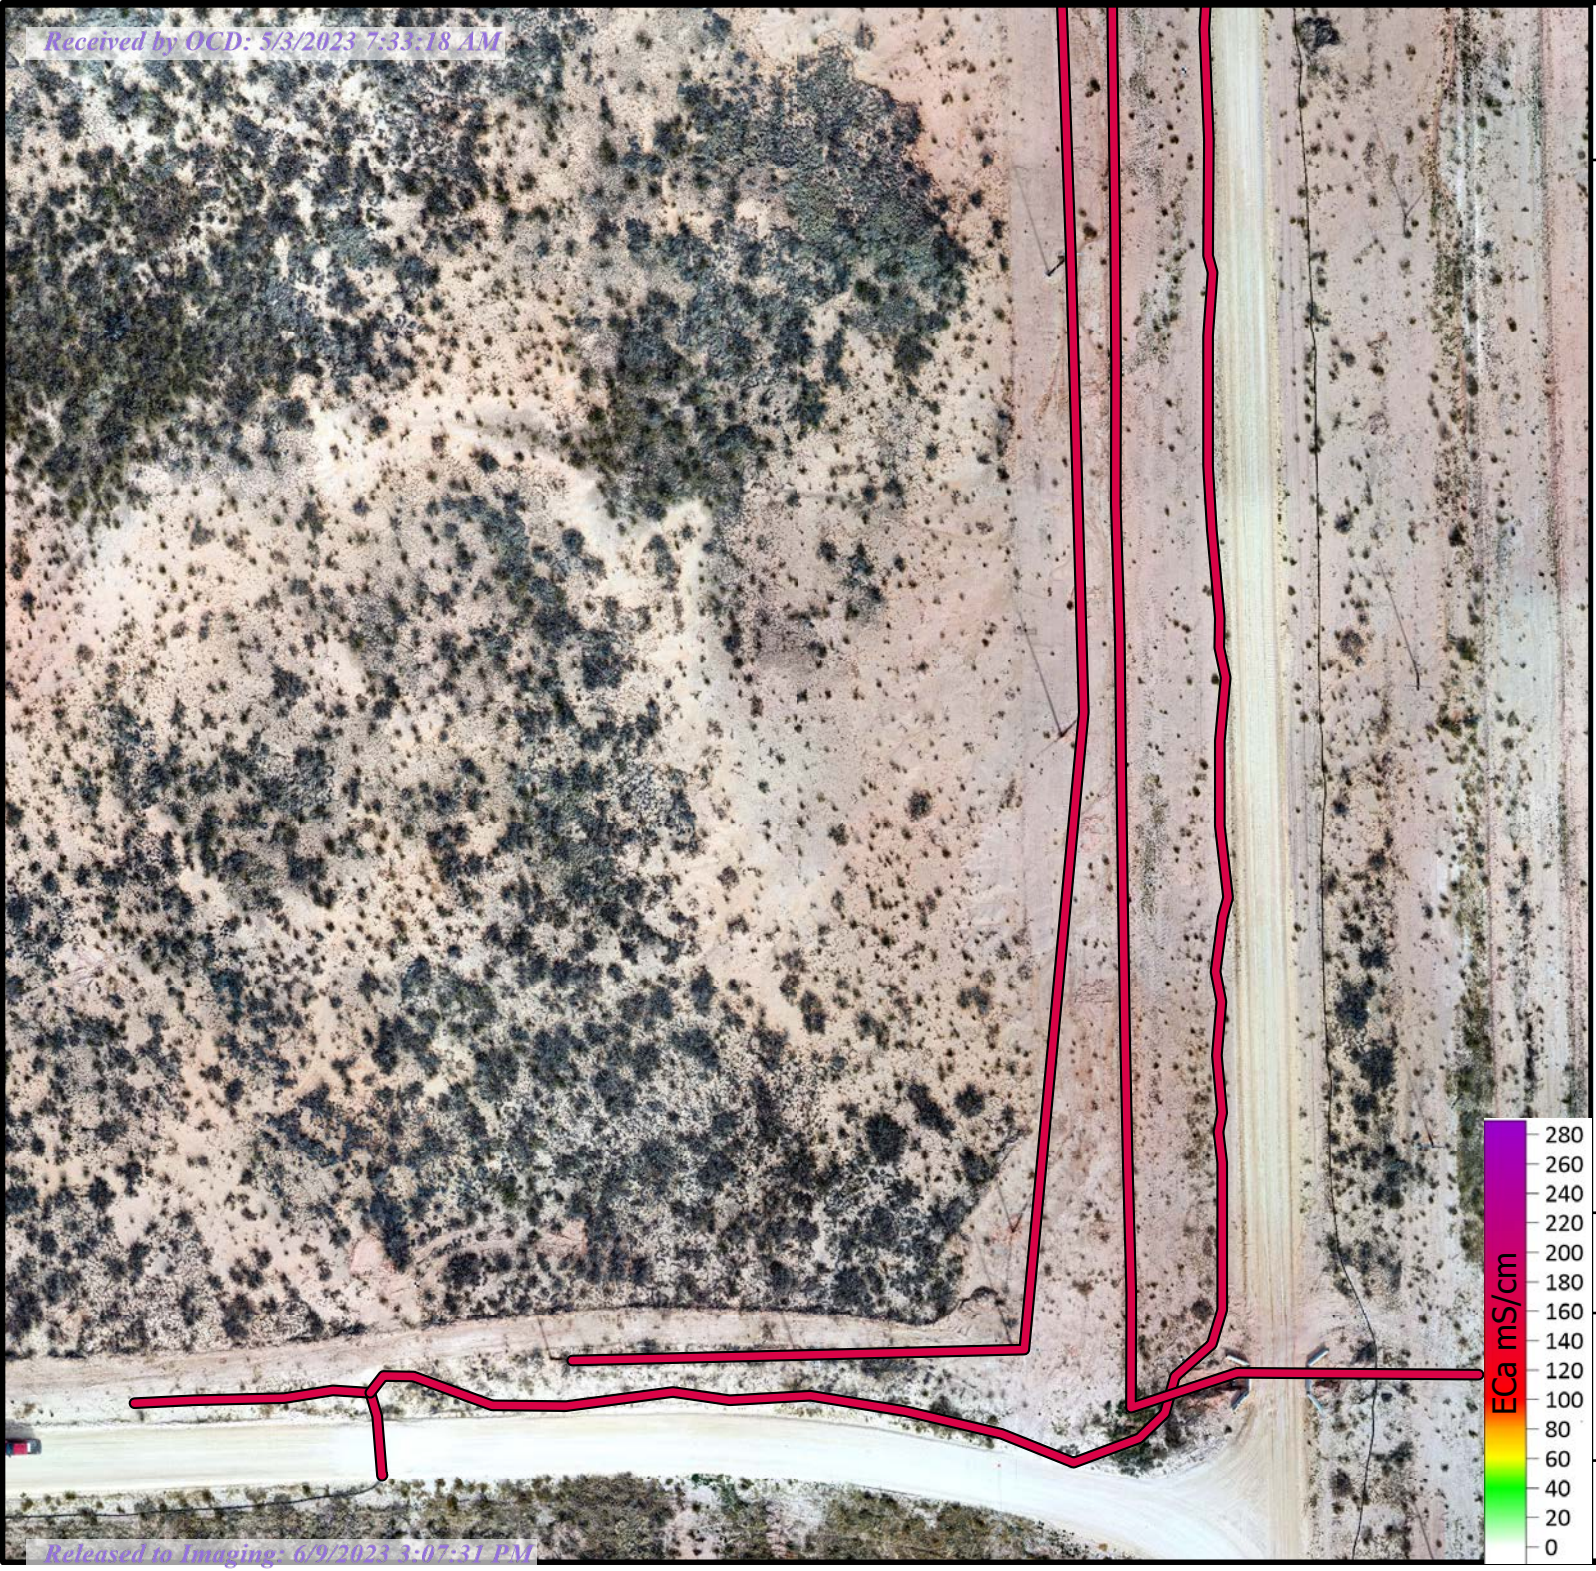
FIGURE 2 EM 38 ECa
South area
Hayhurst Utilities

Figure 2 shows the large amount of intersecting underground and above ground utilities. AEA will facilitate a project 811 an will work directly with the area utility owners to remove as much contaminate mass as safety will allow.

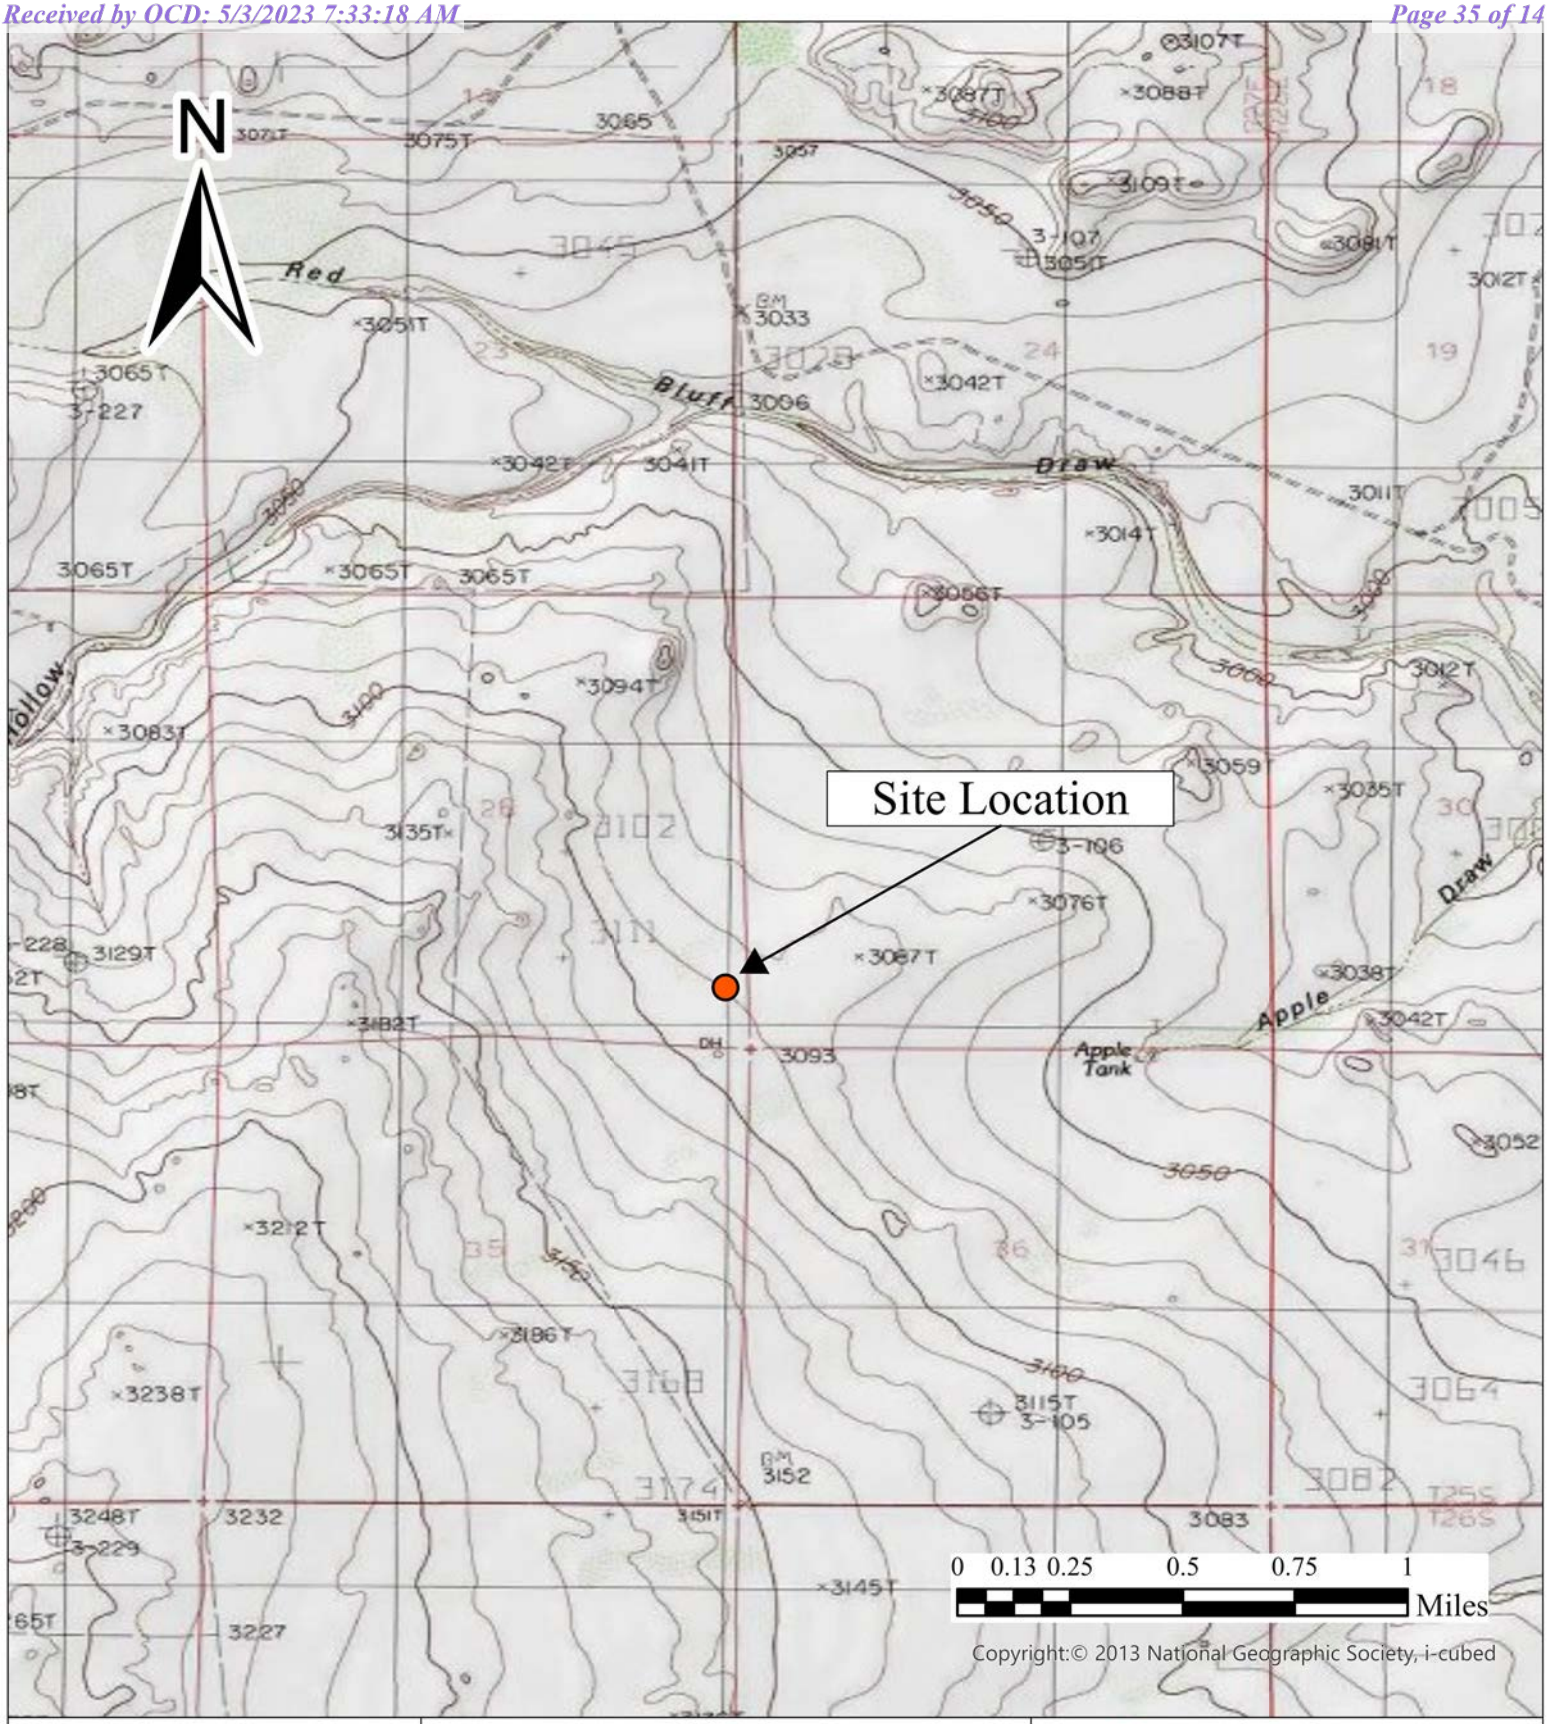
Figure 1, Vicinity Map

The subject site is identified as the Hayhurst Pad 10 Produced Water Spill and is located within Unit I and O, Section 26, Township 25 South, Range 27 East, Eddy County, New Mexico. The site location is further described as beginning at 32.09802, -104.15239 and terminating at 32.0946719, -104.154604; see **Figure 1, Vicinity Map**.

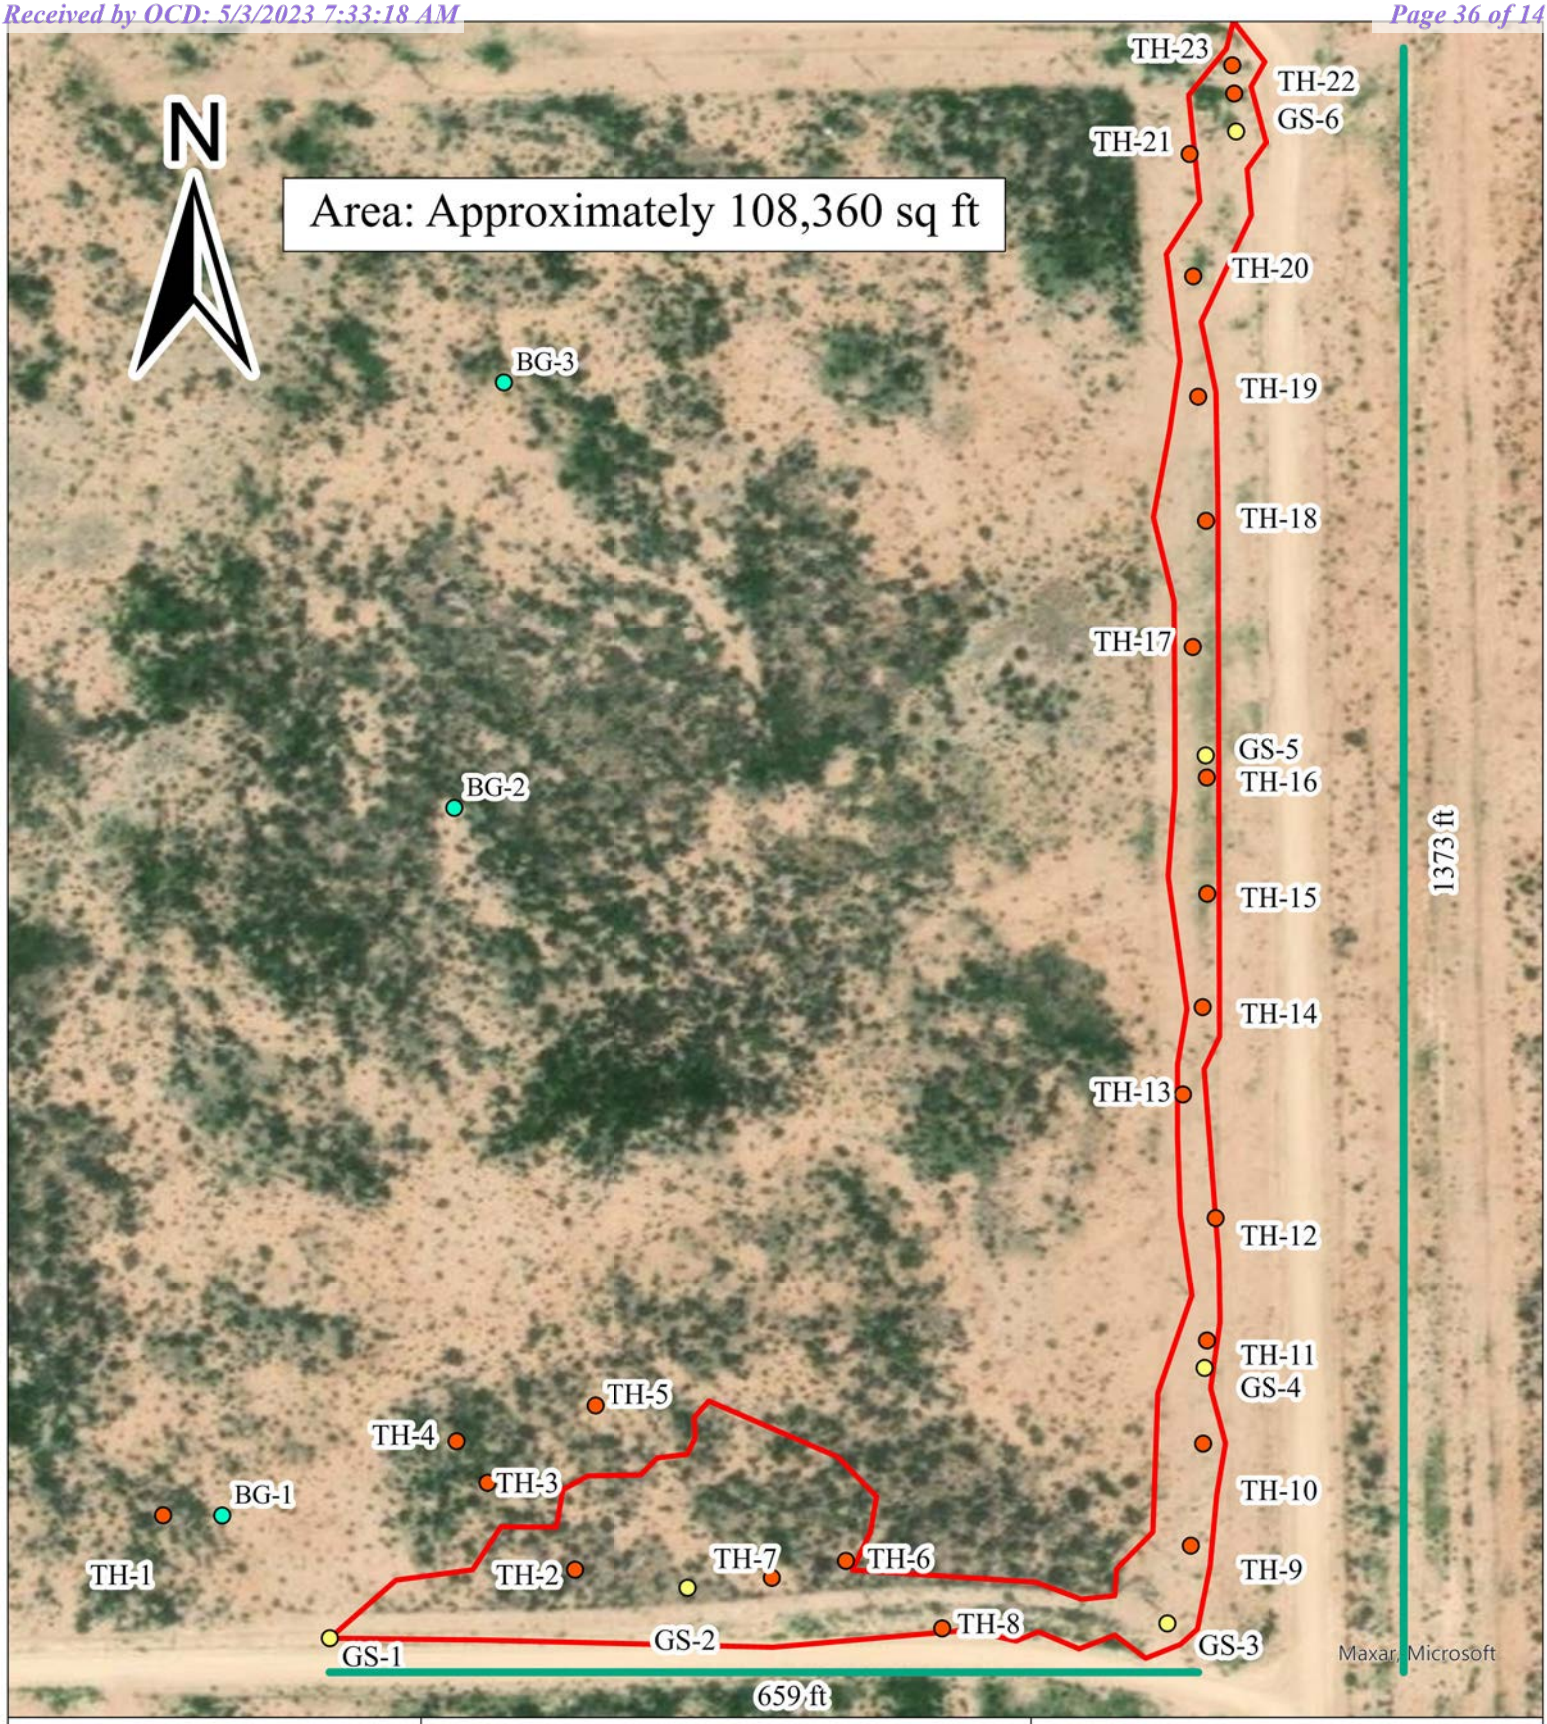
Figure 2, Site Map

A total of twenty-three (23) test holes (TH) were excavated in proximity of the spill path. Two samples were collected for laboratory analysis from each test hole, except for TH-22 and TH-23. The sample depth was limited in these test holes due to safety restrictions from buried pipelines. All soil samples collected for laboratory analysis, were placed into an individual laboratory provided 2-ounce jar, capped head space free, and transported on ice to Envirotech Analytical Laboratory under strict chain of custody. The soil sample locations are illustrated in **Figure 2, Site Map** and in **Appendix C, Site Photography.**
