SUBJECT: SOIL REMEDIATION CLOSURE REPORT FOR THE BIG EDDY UNIT DI #9 (2RP-4552), EDDY COUNTY, NEW MEXICO

Vicinity and Well Head Protection Map
Big Eddy Unit DI #9 - XTO
S 28-T21S-R30E, New Mexico

Site and Sample Location Map
Big Eddy Unit DI #9 - XTO
S 28-T21S-R30E, New Mexico

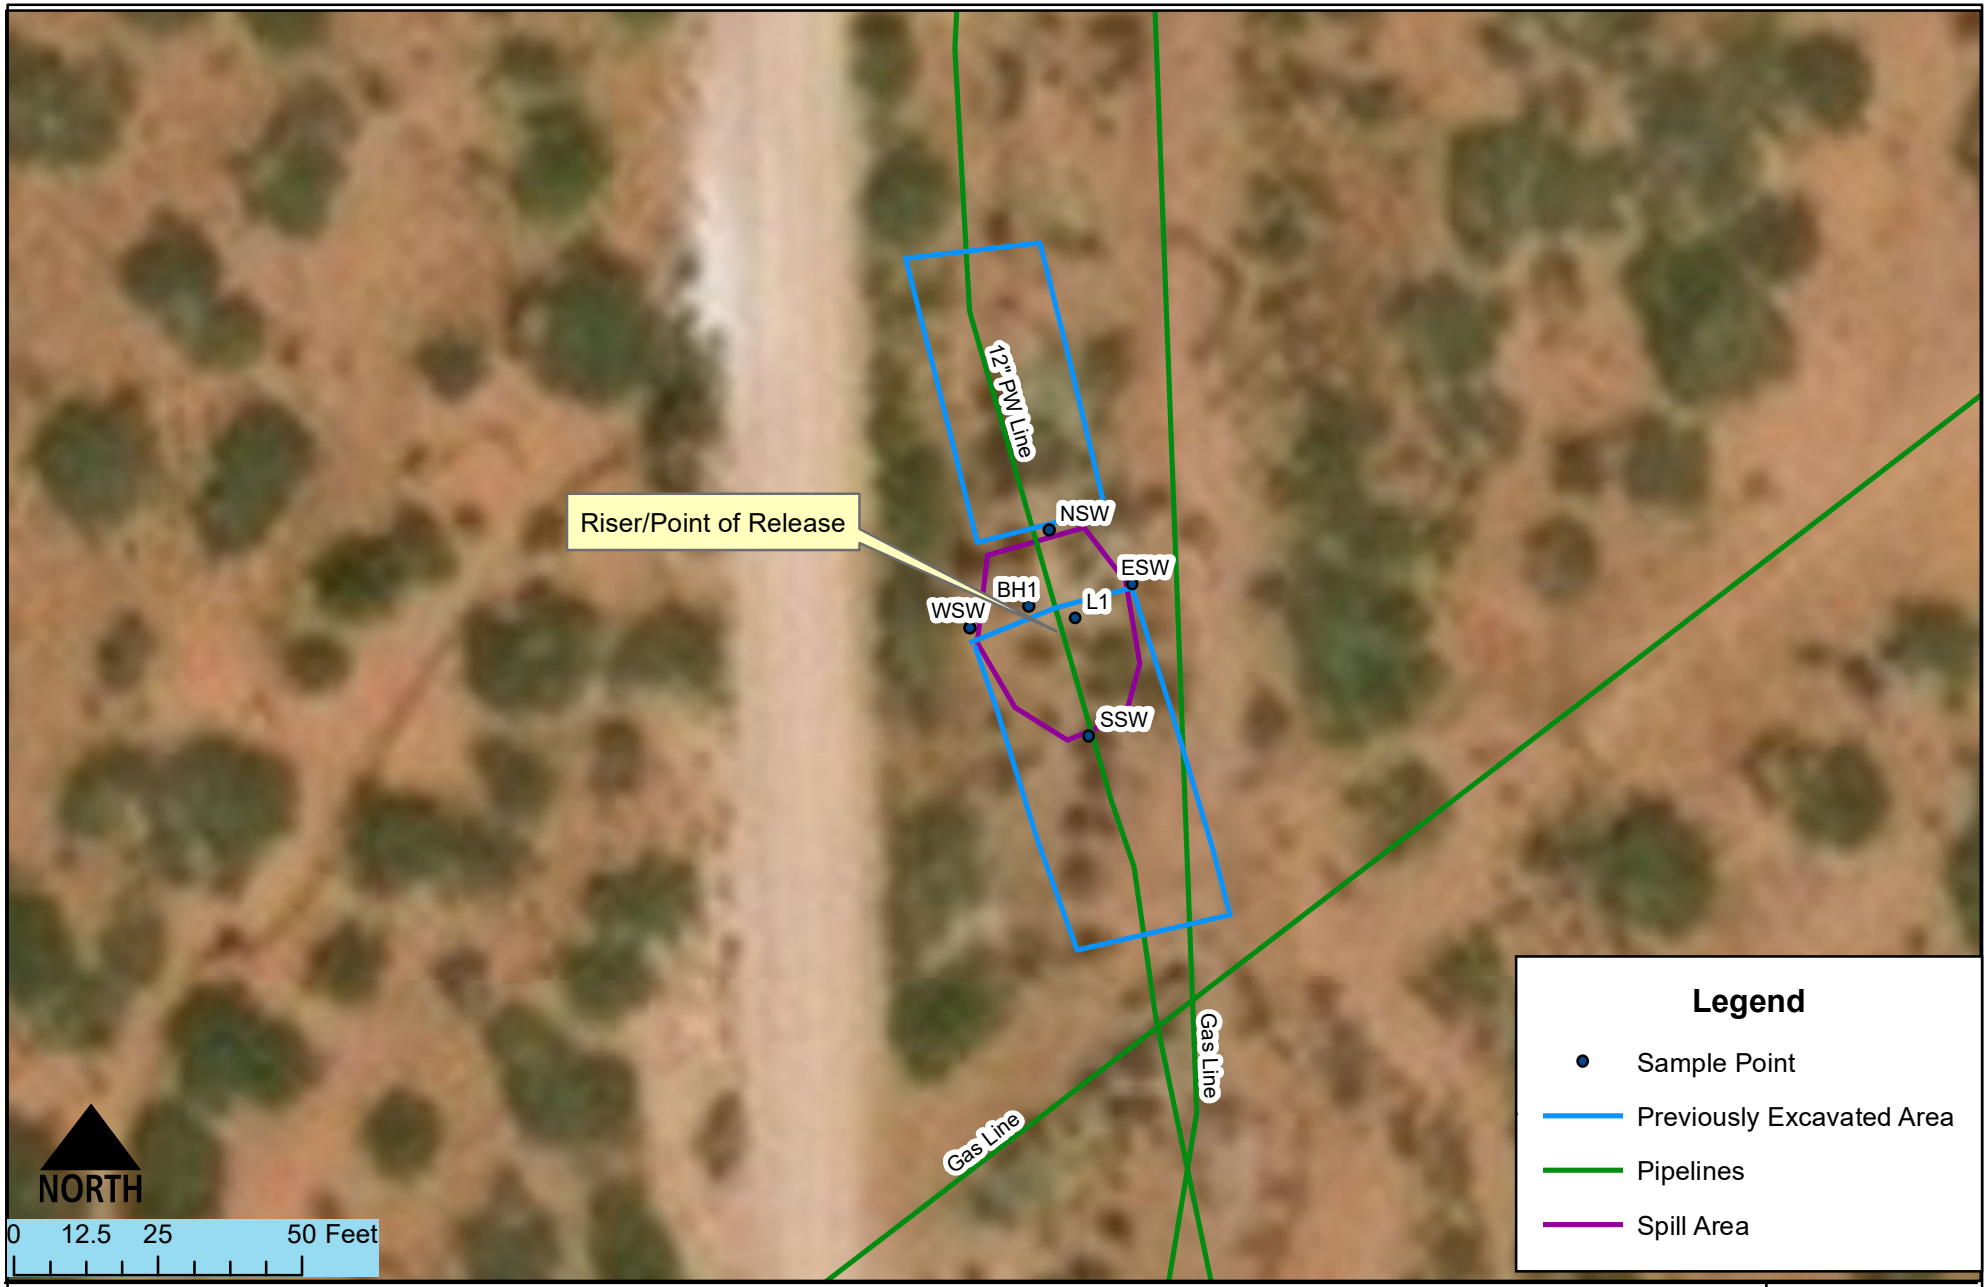
Figure 2

Location L1 was collected from the north wall of the excavation closest to the point of release. Vertical delineation samples were collected from approximately 0.5 feet to a depth of seven feet bgs. These previously excavated areas were backfilled for safety reasons.

Due to safety reasons and the presence of underground gas and SWD lines, excavation was completed with a hydrovac to the maximum extent safely possible, which was 4 feet bgs. Discrete samples were collected from the bottom of the hydro excavation near the riser and 2, 3 and 4 feet bgs (BH). The release area was excavated to an area approximately 10 feet by 12 feet. Four sidewall samples (North SW, South SW, East SW, West SW) were collected to demonstrate horizontal delineation. Due to the presence of the buried lines, SMA recommends deferral of the remaining contaminated soil beyond four feet bgs. Laboratory results demonstrate that the release has been defined horizontally, and that vertical contamination decreases with depth. The area surrounding L1 could not be further mechanically excavated due to the proximity of the riser, pipelines and nearby gas lines.

The samples were sent under chain-of-custody protocols to Hall Environmental Analysis Laboratory for analysis for Chlorides by Method 300. Contaminated soils were removed and replaced with clean backfill material to return the surface to previous contours. The contaminated soil was transported for proper disposal at an NMOCD permitted disposal facility. Sample locations are depicted on Figure 2. All laboratory results are summarized in Table 3. Laboratory reports are included in Appendix C.
