Incident Number: nJMW1317031601 and nJMW1327753065

Release Assessment and Closure

Sawbuck Water Transfer Station

July 2023

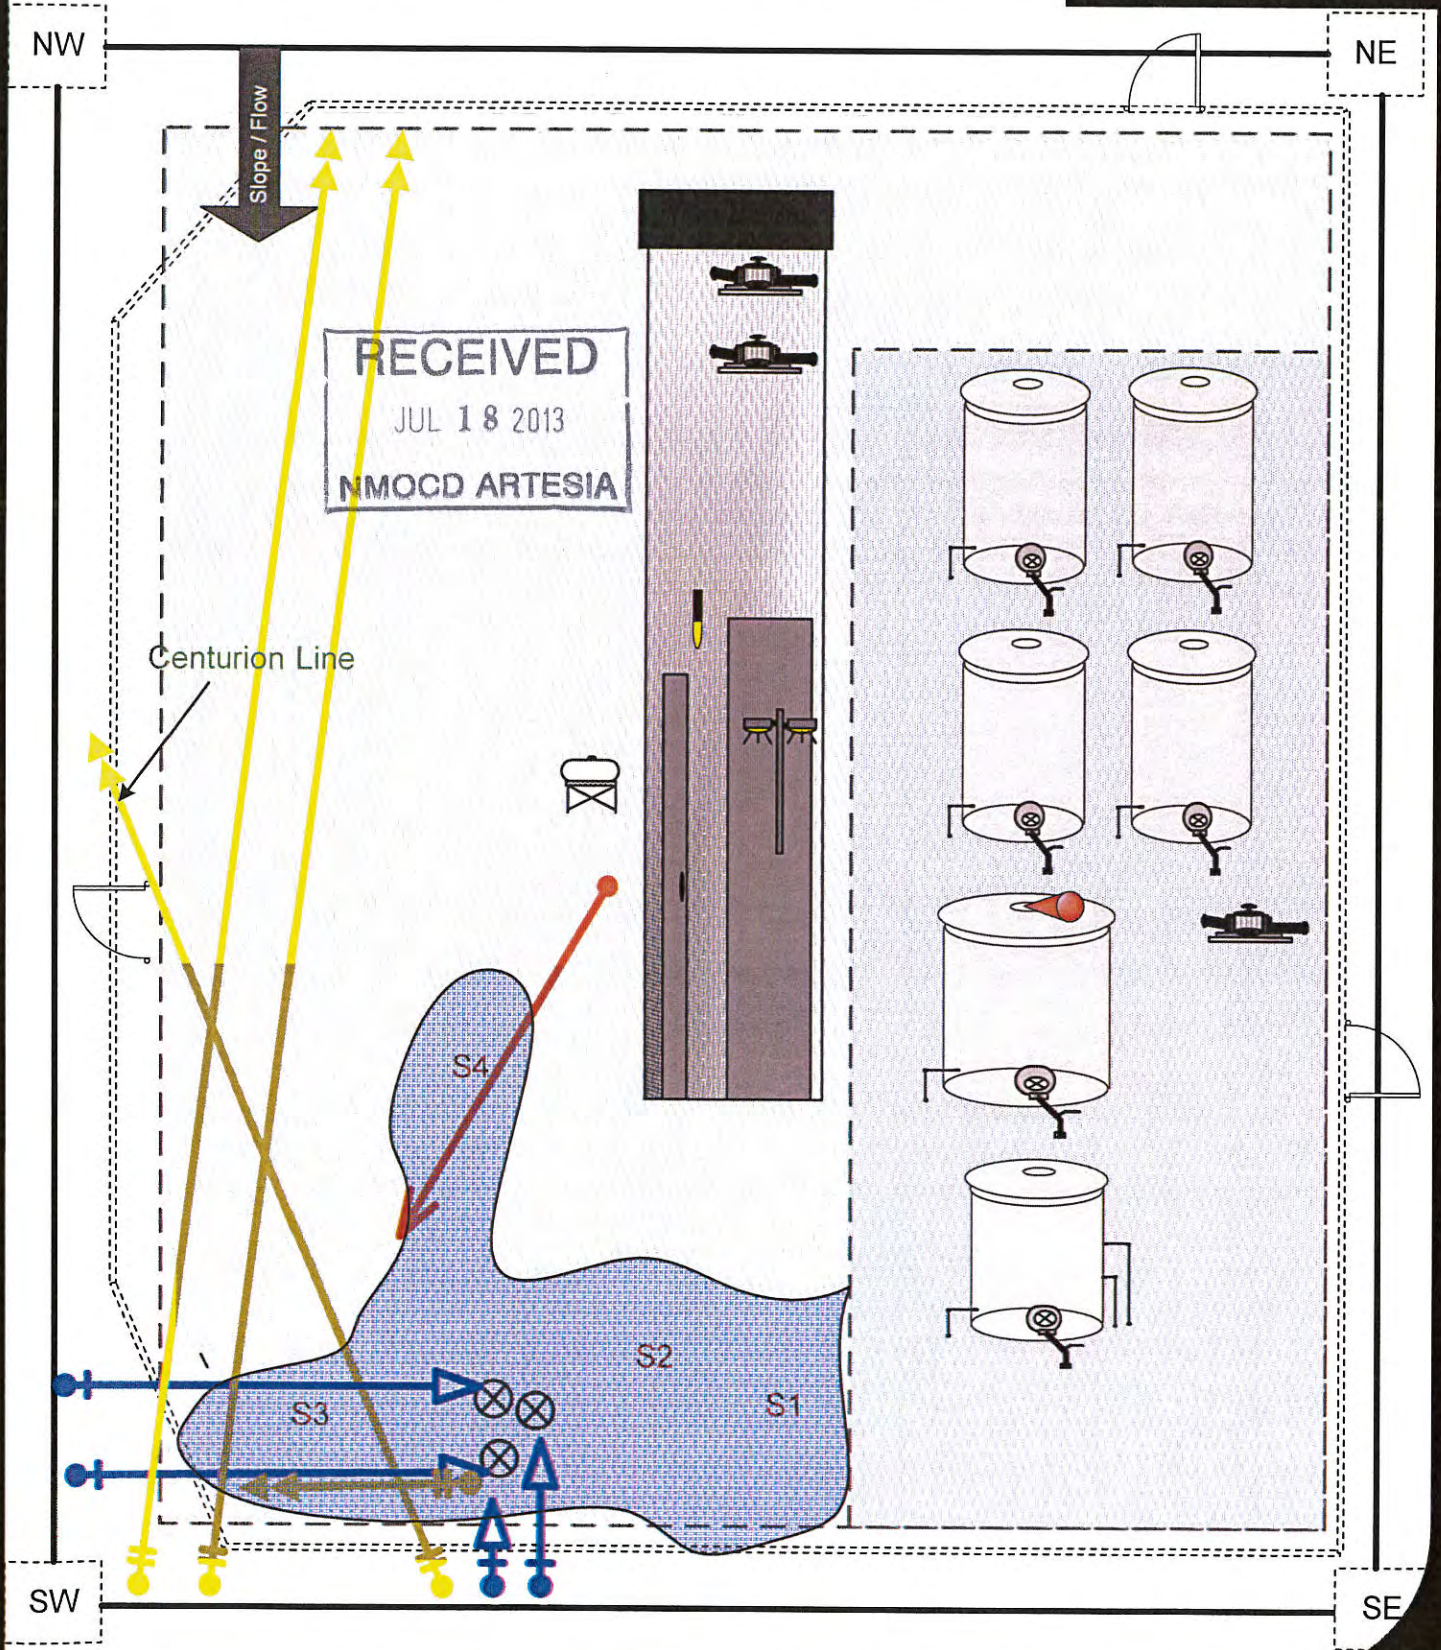
Sawbuck Water Transfer

The impacted area was divided up into four areas for sampling (S1, S2, S3, S4). The areas chosen were based on the safety aspect in regards to the amount of buried lines through the impacted area. S1 and S2 were found to be in the old pit area associated with the Hill View AHE #2 which has been plugged and abandoned. Sampling ceased at a depth of 1' due to the finding of the existing pit liner. Sampling of the S4 area ceased at a depth of 3' due to a buried electrical line in the area that was not marked with markers or during the NM One Call.

Analytical Report-H301490	Sample Date	Depth	BTEX	GRO	DRO	TOTAL TPH	CHLORIDES
S1-1'	6/25/2013	1'	737	6890	593	7483	2440
S2-1'	6/25/2013	1'	15.75	83.8	23.3	107.1	960
S3-1'	6/25/2013	1'	0.1	ND	ND	ND	2480
S3-3'	6/25/2013	3'	ND	ND	ND	ND	1310
S3-4'	6/25/2013	4'	ND	ND	ND	ND	1170
S4-1'	6/25/2013	1'	1.73	10.6	ND	ND	2960
S4-3'	6/25/2013	3'	0.217	20.4	31.5	51.9	2560

Due to the associated hazards in the area and the discover of an existing pit, Yates Petroleum Corp. is requesting that no further actions be taken beyond what has been describe in this letter. If there are no objections or further stipulations, a C-141 Final will be submitted for approval. Please feel free to contact me with any questions at (575) 748-4350.

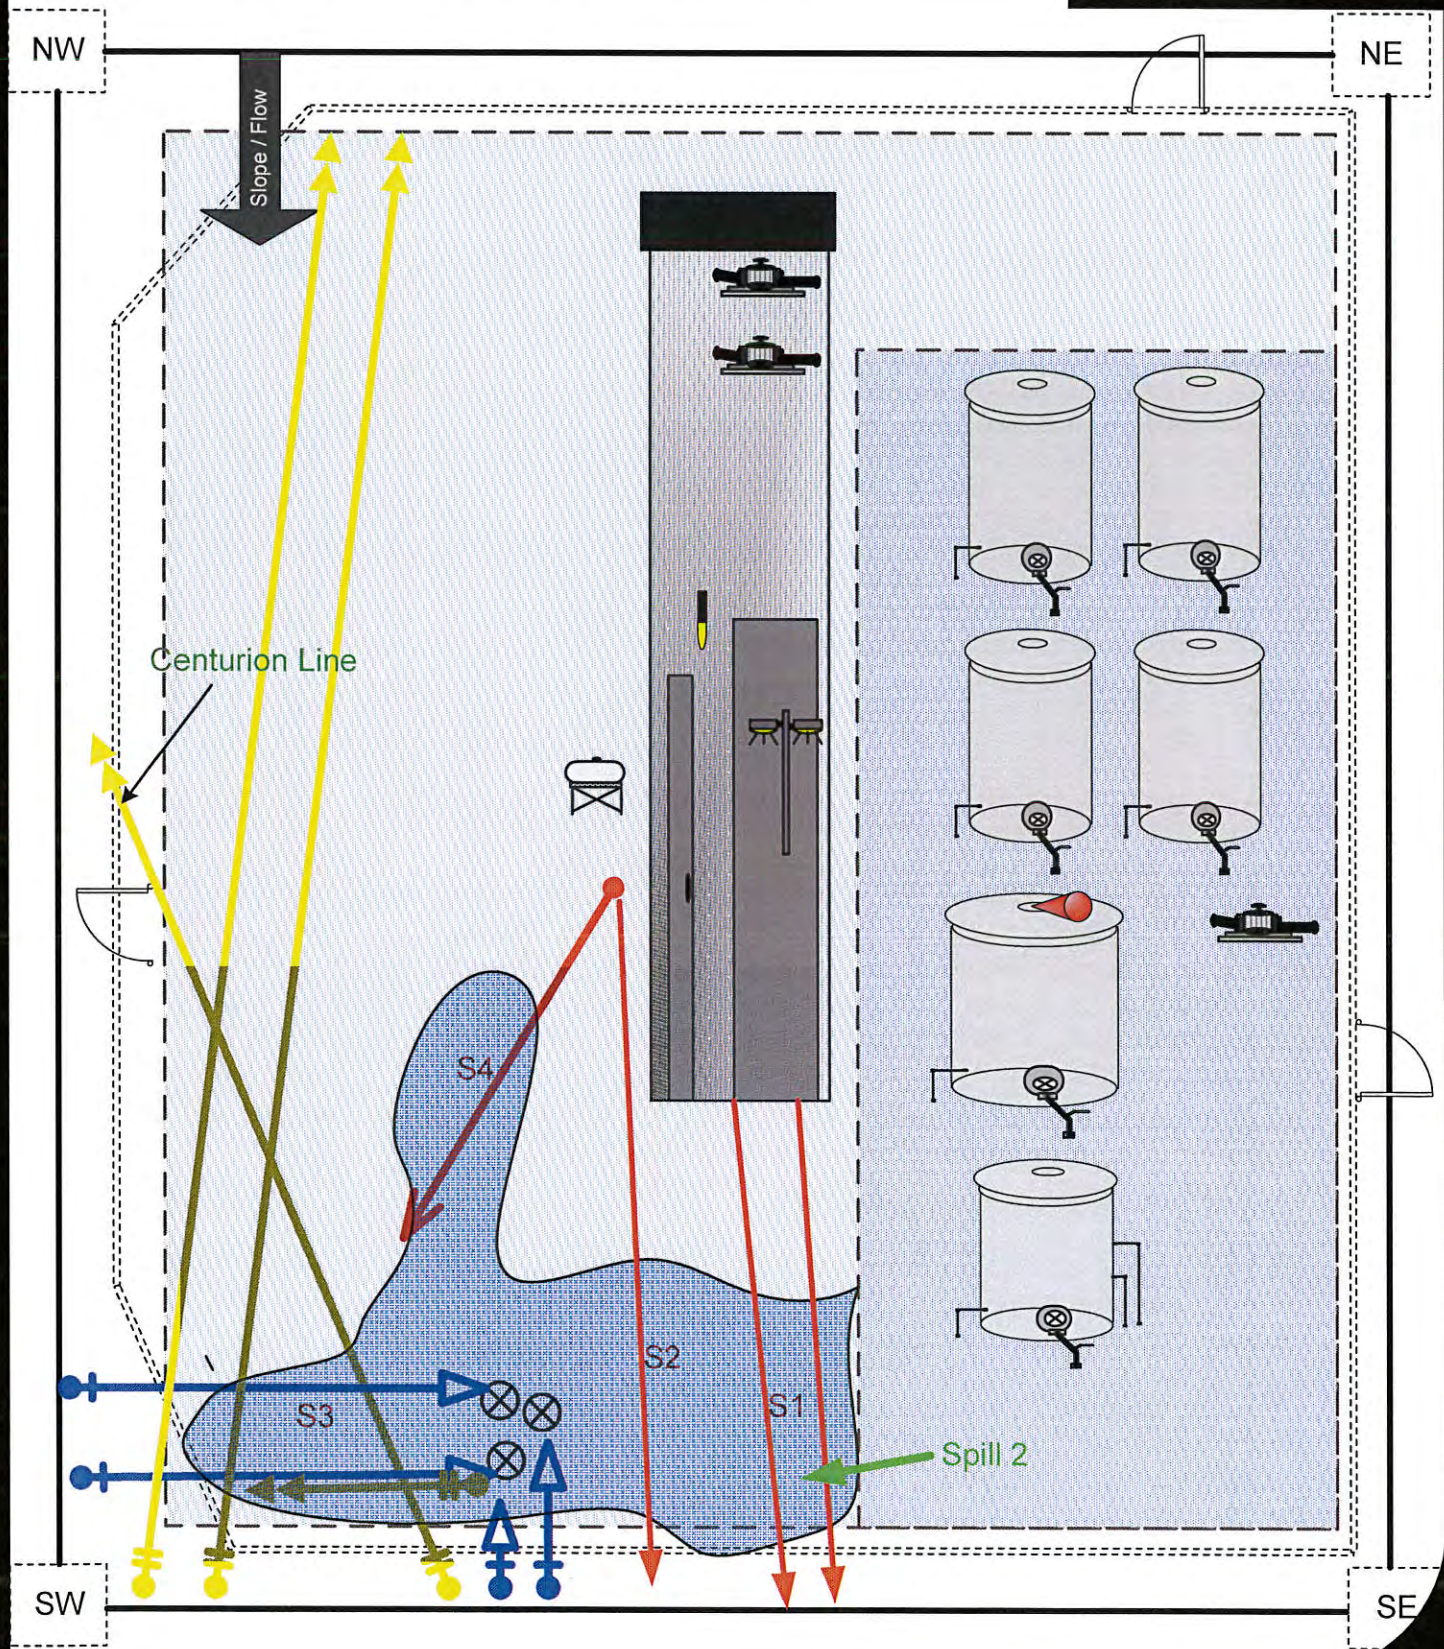
Sawbuck Water Transfer

The initial work plan submitted on July 18, 2013, had an extra stipulation from both OCD and BLM. It was agreed that Yates would excavate the S1 area down past 2' to address the BTEX levels in this area. Prior to excavation, the second release occurred during the repair of the berms around the location. The backhoe operator noticed a release of approximately 8 barrels of produced water. The release flowed into the S1 area where a vacuum truck recovered about 5 barrels. Once recovered, the back hoe operator excavated approximately 2.5 – 3' from the impacted area including the berm on the south side of the location. All impacted soil was disposed at an NMOCD approved facility. The area was sampled for delineation purposes.

The S1/Spill 2 excavation area has not been backfilled with the exception of the berms on the south side and west side which had to be replaced due to severe flooding of the area in 2013.

Analytical Report-H301490	Sample Date	Depth	BTEX	GRO	DRO	TOTAL TPH	CHLORIDES
S1-1'	6/25/2013	1'	737	6890	593	7483	2440
S1-2'	8/28/2013	2'	166	835	201	1036	2240
S1-3'	8/28/2013	3'	40.6	383	39.9	422.9	4640
S1-4'	8/28/2013	4'	4.6	31.3	12.6	43.9	2560
S1-5'	8/28/2013	5'	0.315	ND	ND	ND	304
S2-1'	6/25/2013	1'	15.75	83.8	23.3	107.1	960
S3-1'	6/25/2013	1'	0.1	ND	ND	ND	2480
S3-3'	6/25/2013	3'	ND	ND	ND	ND	1310
S3-4'	6/25/2013	4'	ND	ND	ND	ND	1170
S4-1'	6/25/2013	1'	1.73	10.6	ND	ND	2960
S4-3'	6/25/2013	3'	0.217	20.4	31.5	51.9	2560
Spill 2	10/8/2013	3'	7.10	40	16.3	56.3	544
Spill 2	10/8/2013	4'	ND	ND	ND	ND	2520
Spill 2	10/8/2013	5'	ND	ND	ND	ND	1150
Spill 2	10/8/2013	6'	ND	ND	ND	ND	800
Spill 2	10/8/2013	7'	ND	ND	ND	ND	592
Spill 2	10/8/2013	8'	ND	ND	ND	ND	160
Spill 2	10/8/2013	9'	ND	ND	ND	ND	176
