March 22, 2023

Re: 2022 Annual Groundwater Monitoring Report
Nell Hall #1
San Juan County, New Mexico
Hilcorp Energy Company
NMOCD Incident Number: NAUTOFAB000417
NMOCD Administrative Order: 3RP-090

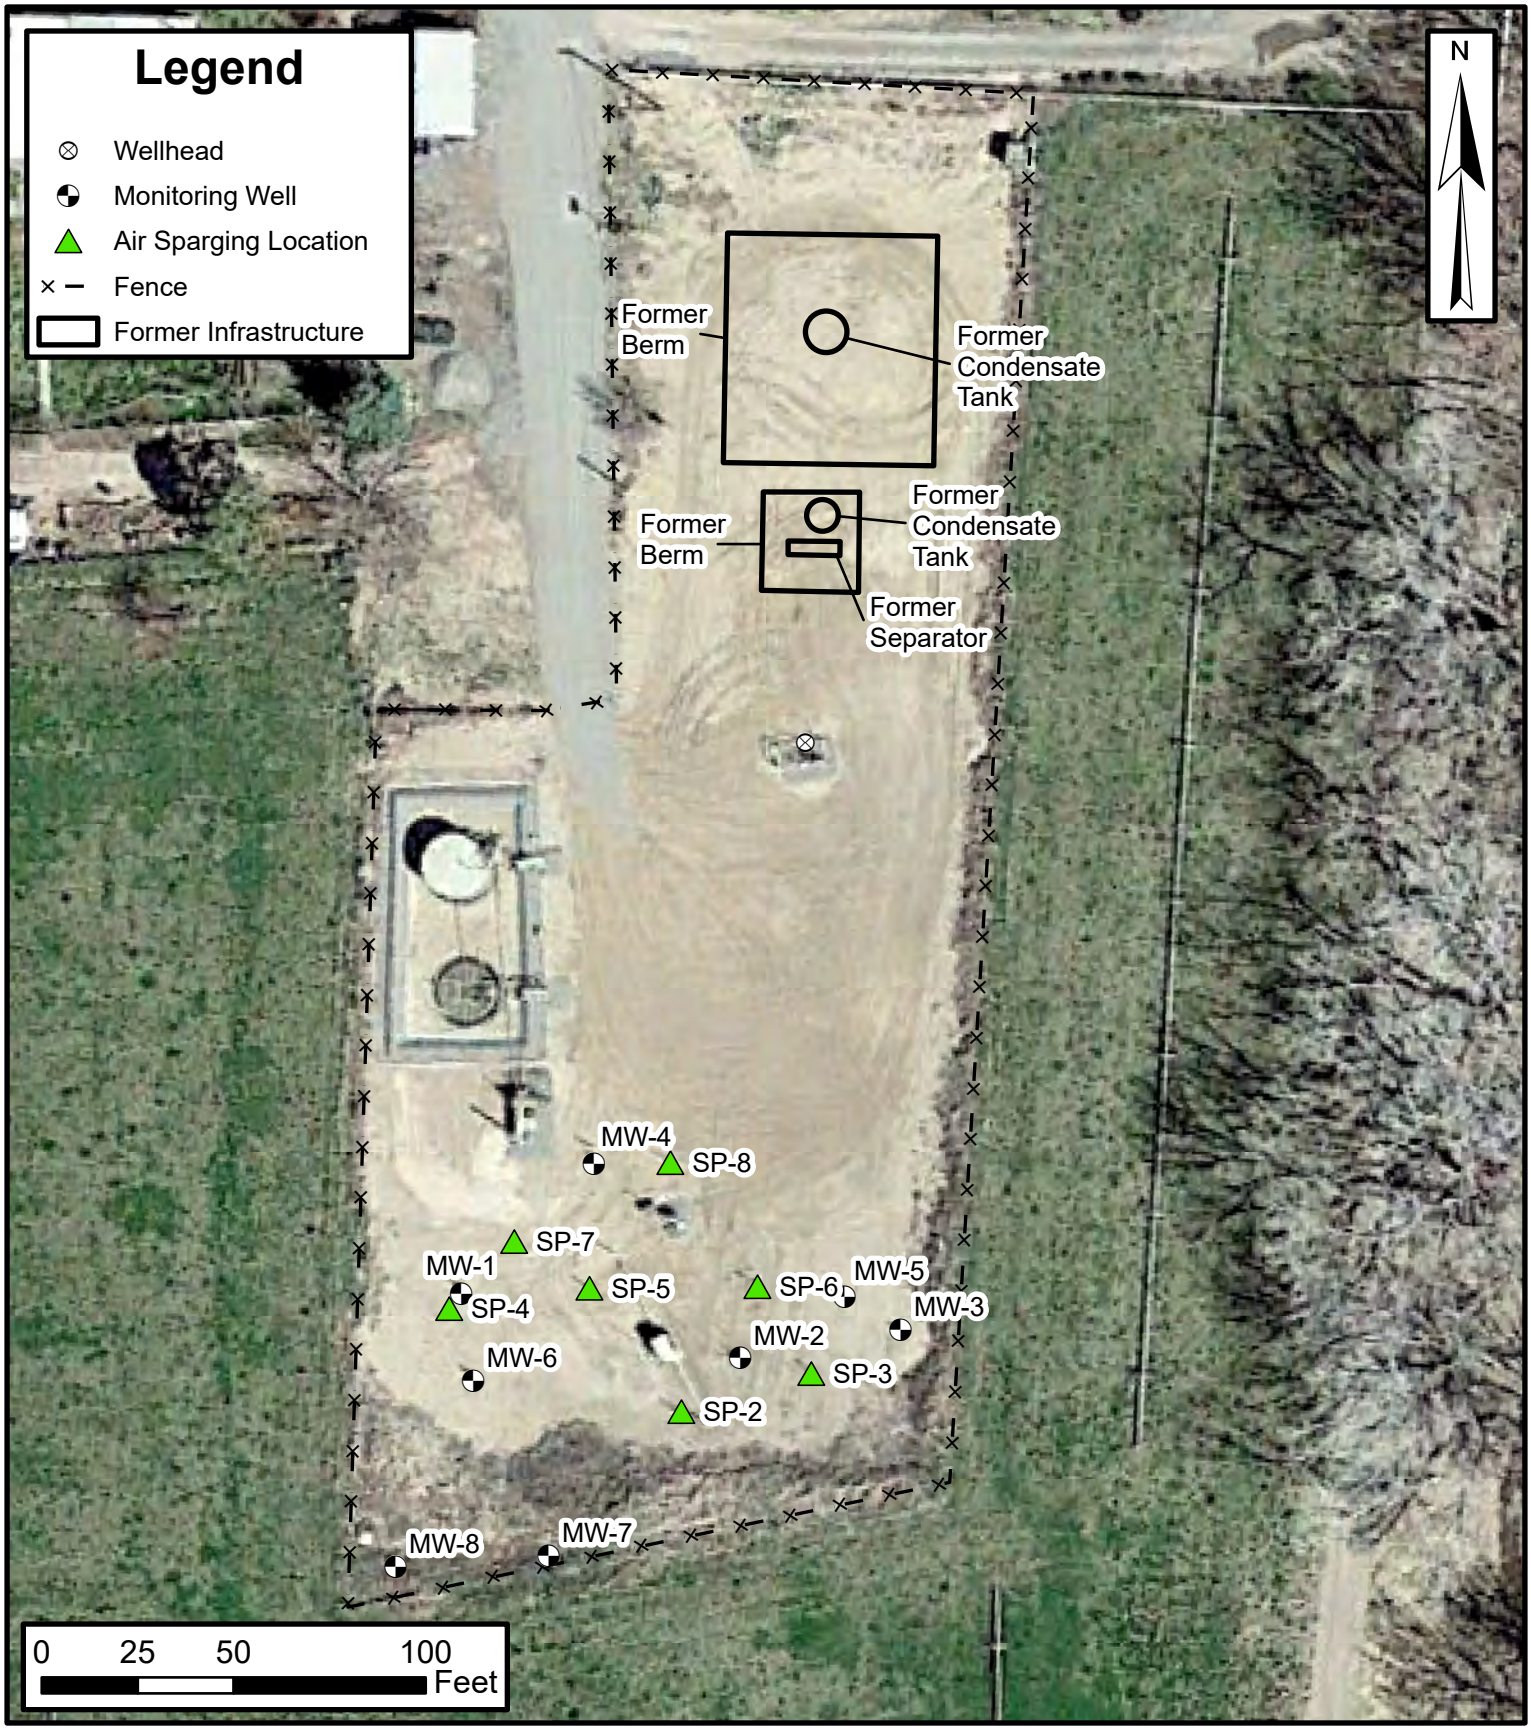
FIGURE
2

Petroleum-impacted soil was first discovered at the Site during the closure of an unlined dehydrator pit in 1994 by Conoco, Inc. (operator of the Site at the time and later ConocoPhillips Company). At the time of discovery, three monitoring wells, MW-1, MW-2, and MW-3, were installed at the Site to assess groundwater conditions and determine if groundwater had been impacted by the release. Conoco, Inc. also installed eight air-sparge wells (SP-1 through SP-8, shown on Figure 2) in order to introduce air into the water-bearing zone to enhance volatilization and biodegradation of petroleum hydrocarbons in the groundwater; however, no information or data in the historical Site reports indicated whether the air-sparge wells ever operated as intended.

- Plug and abandon air-sparge wells SP-1 through SP-8. These wells have never been used for active air-sparging and should be removed to eliminate a potential conduit to groundwater at the Site.
- Plug and abandon wells MW-1 through MW-5. With the exception of occasional exceedances of dissolved iron concentrations in MW-4, BTEX and dissolved iron concentrations have been compliant with NMWQCC standards for more than three years in these wells.

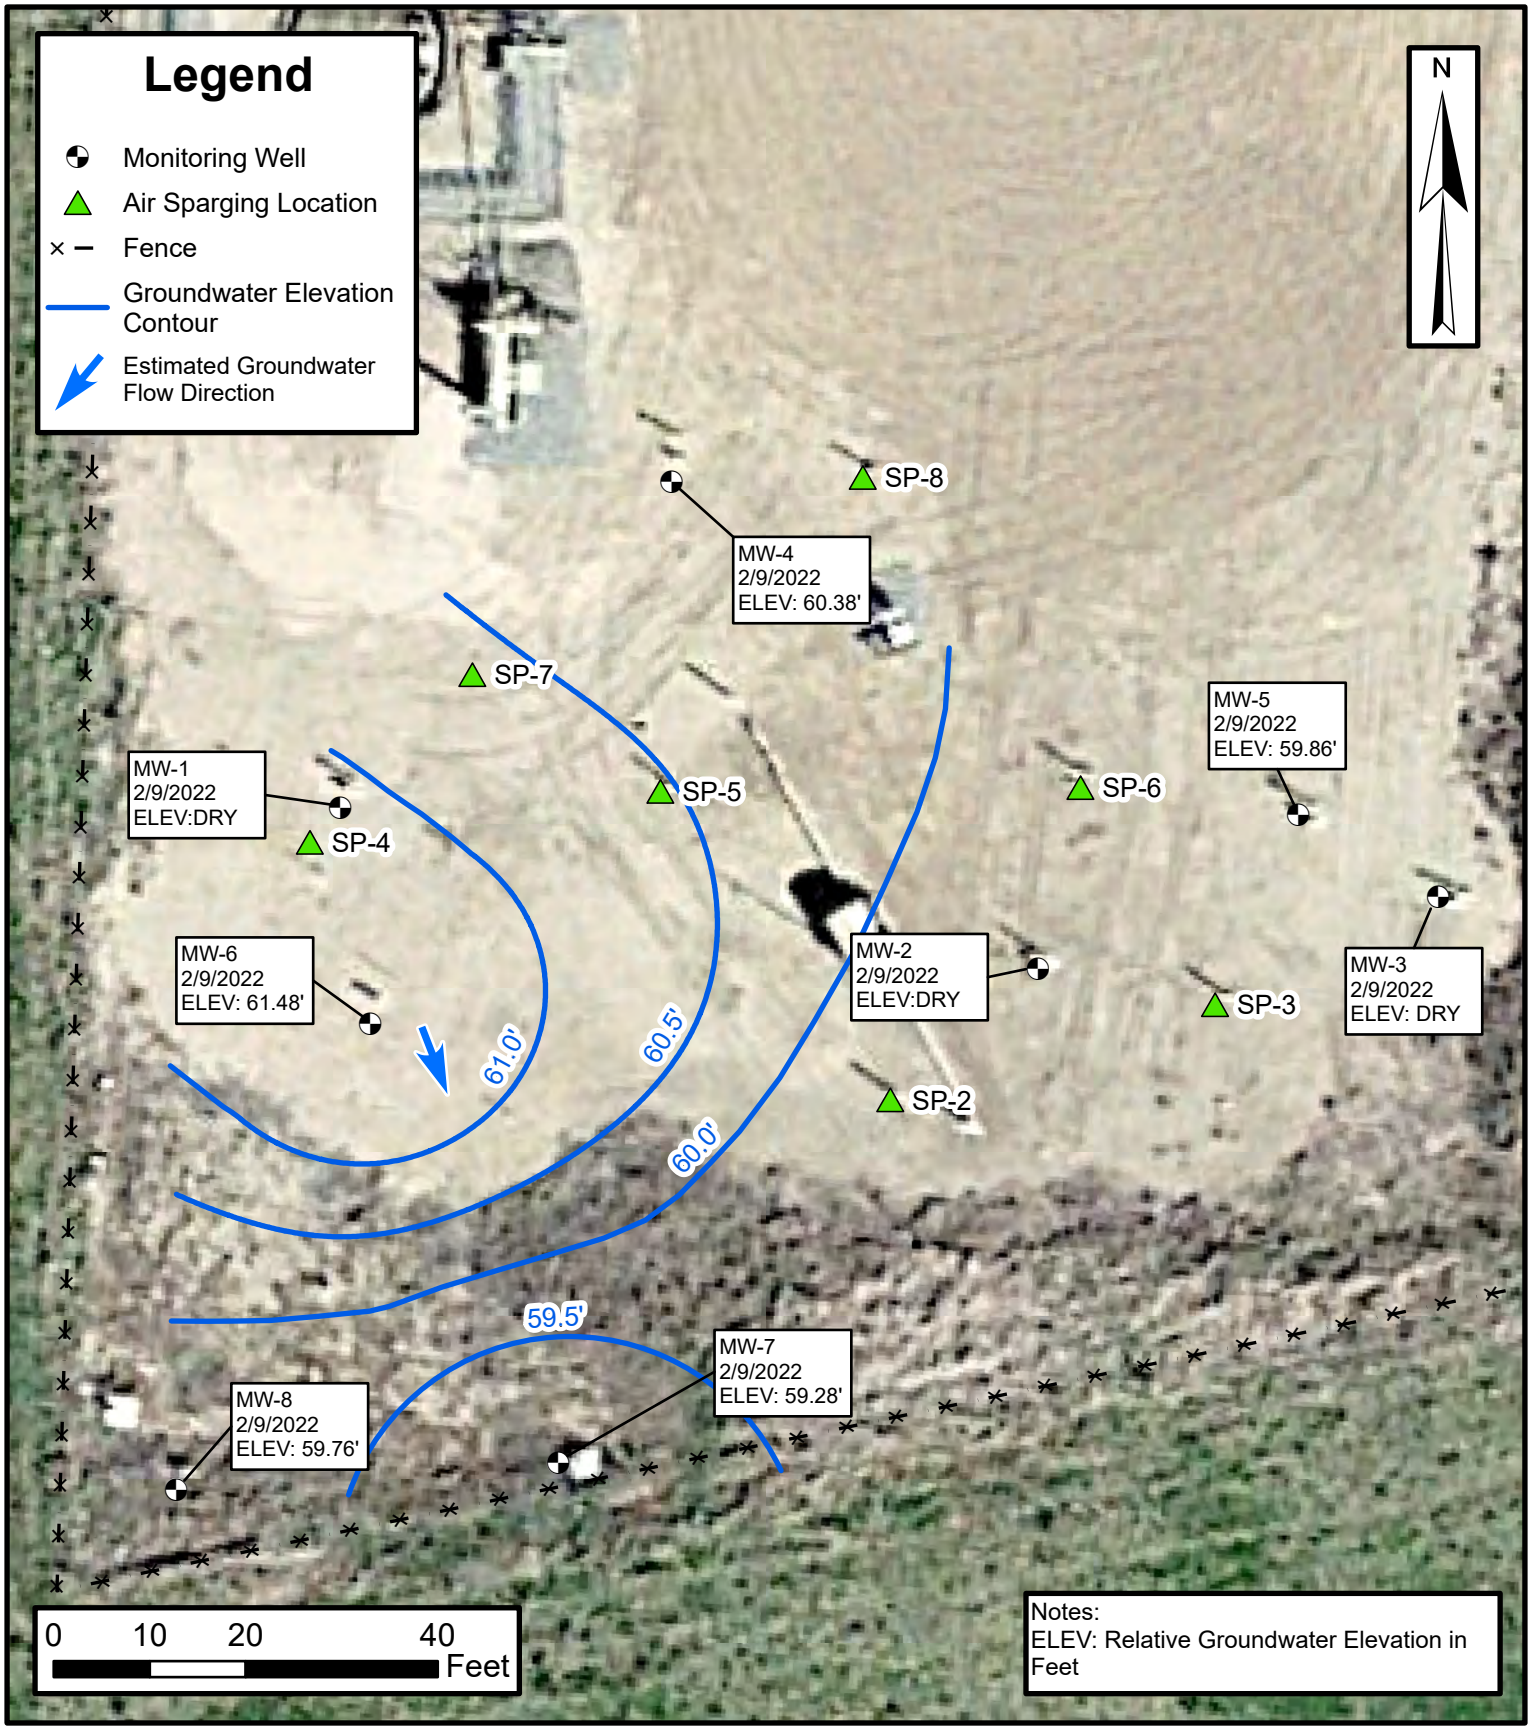
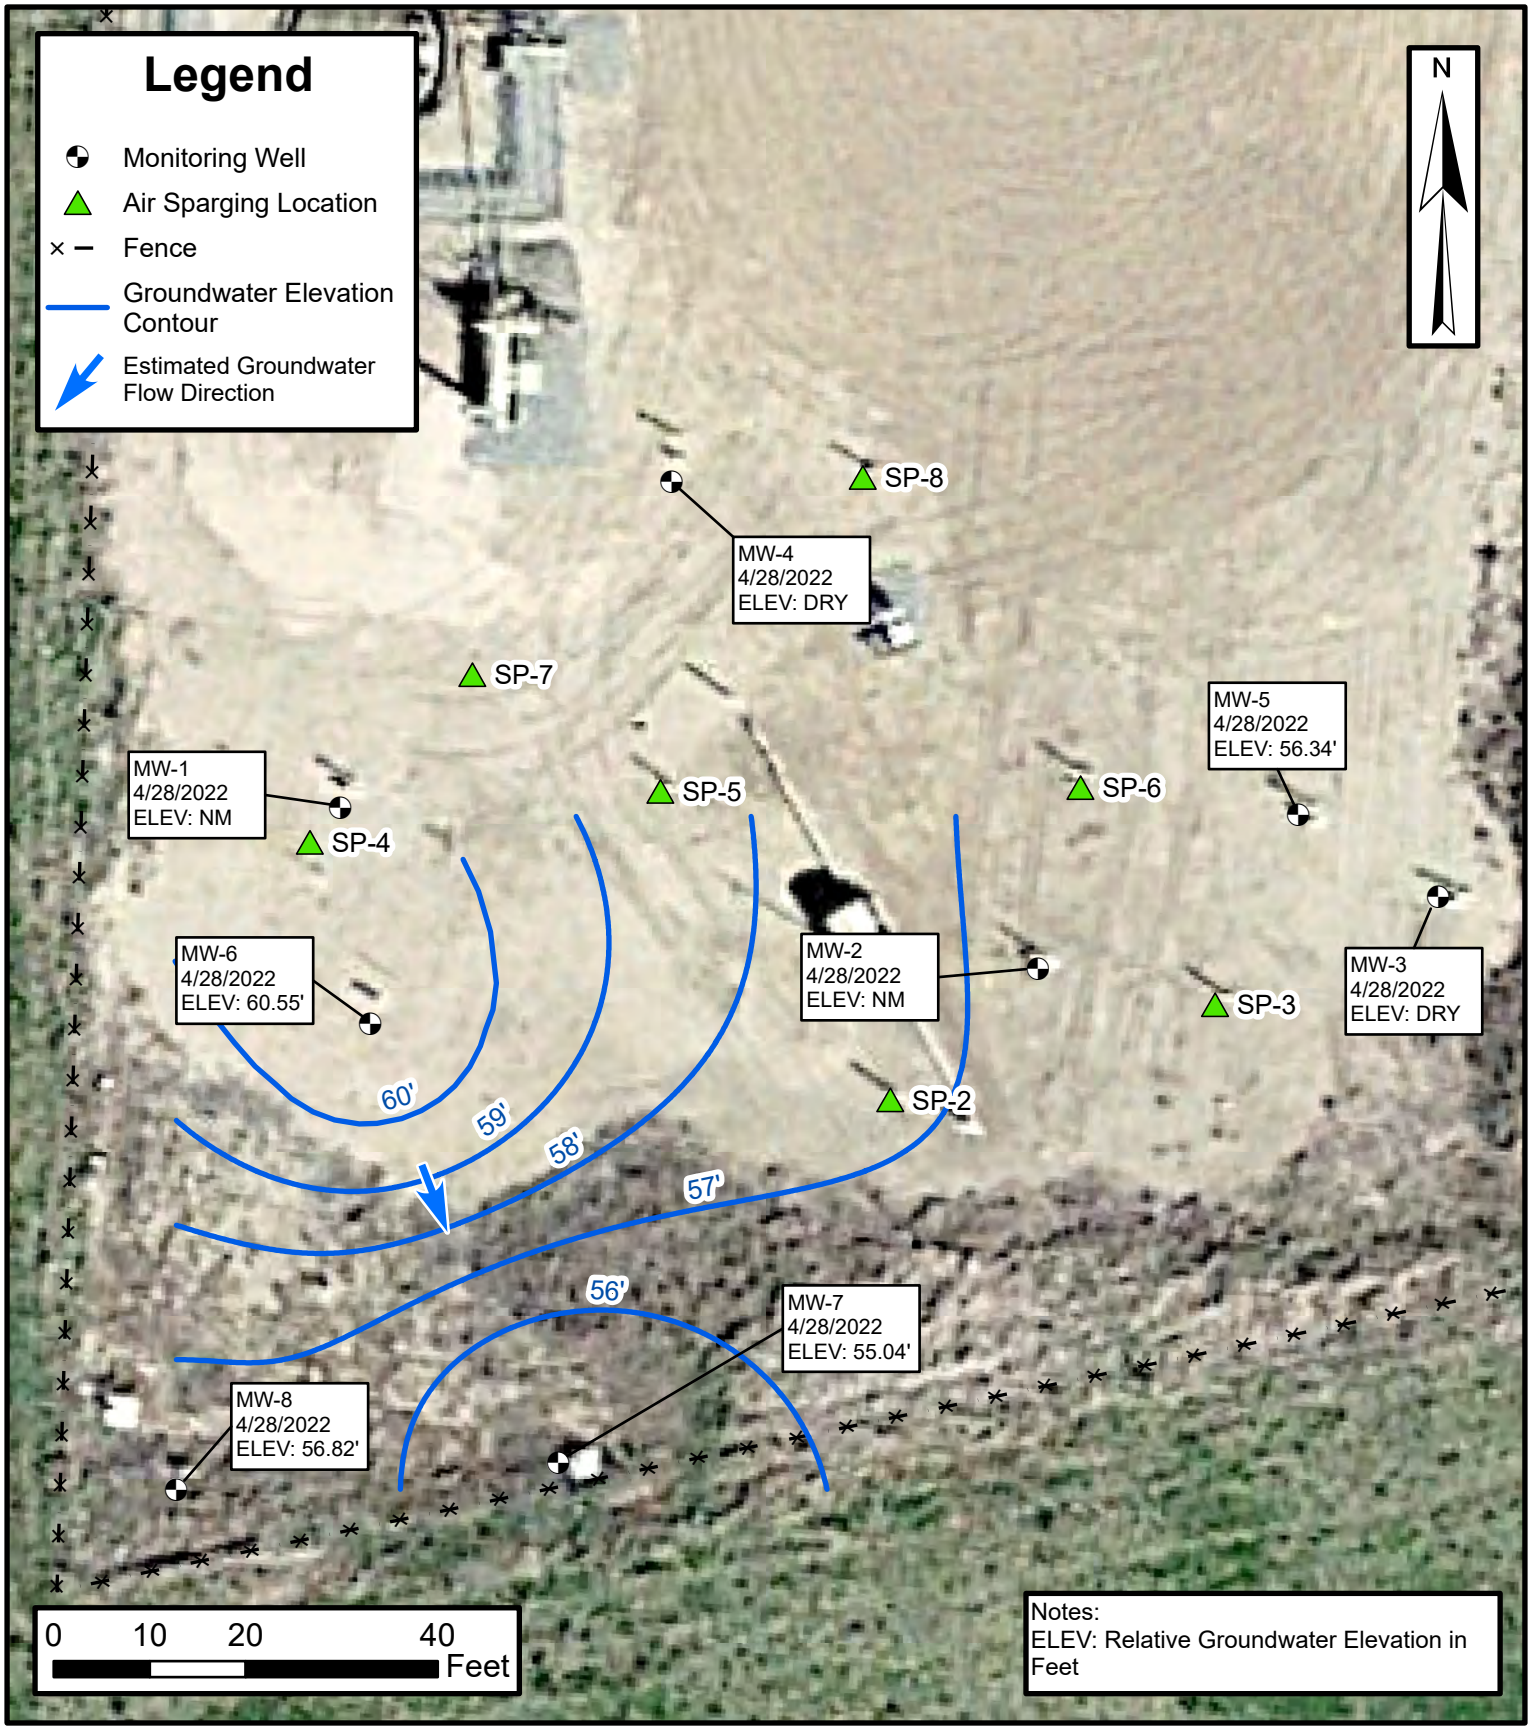
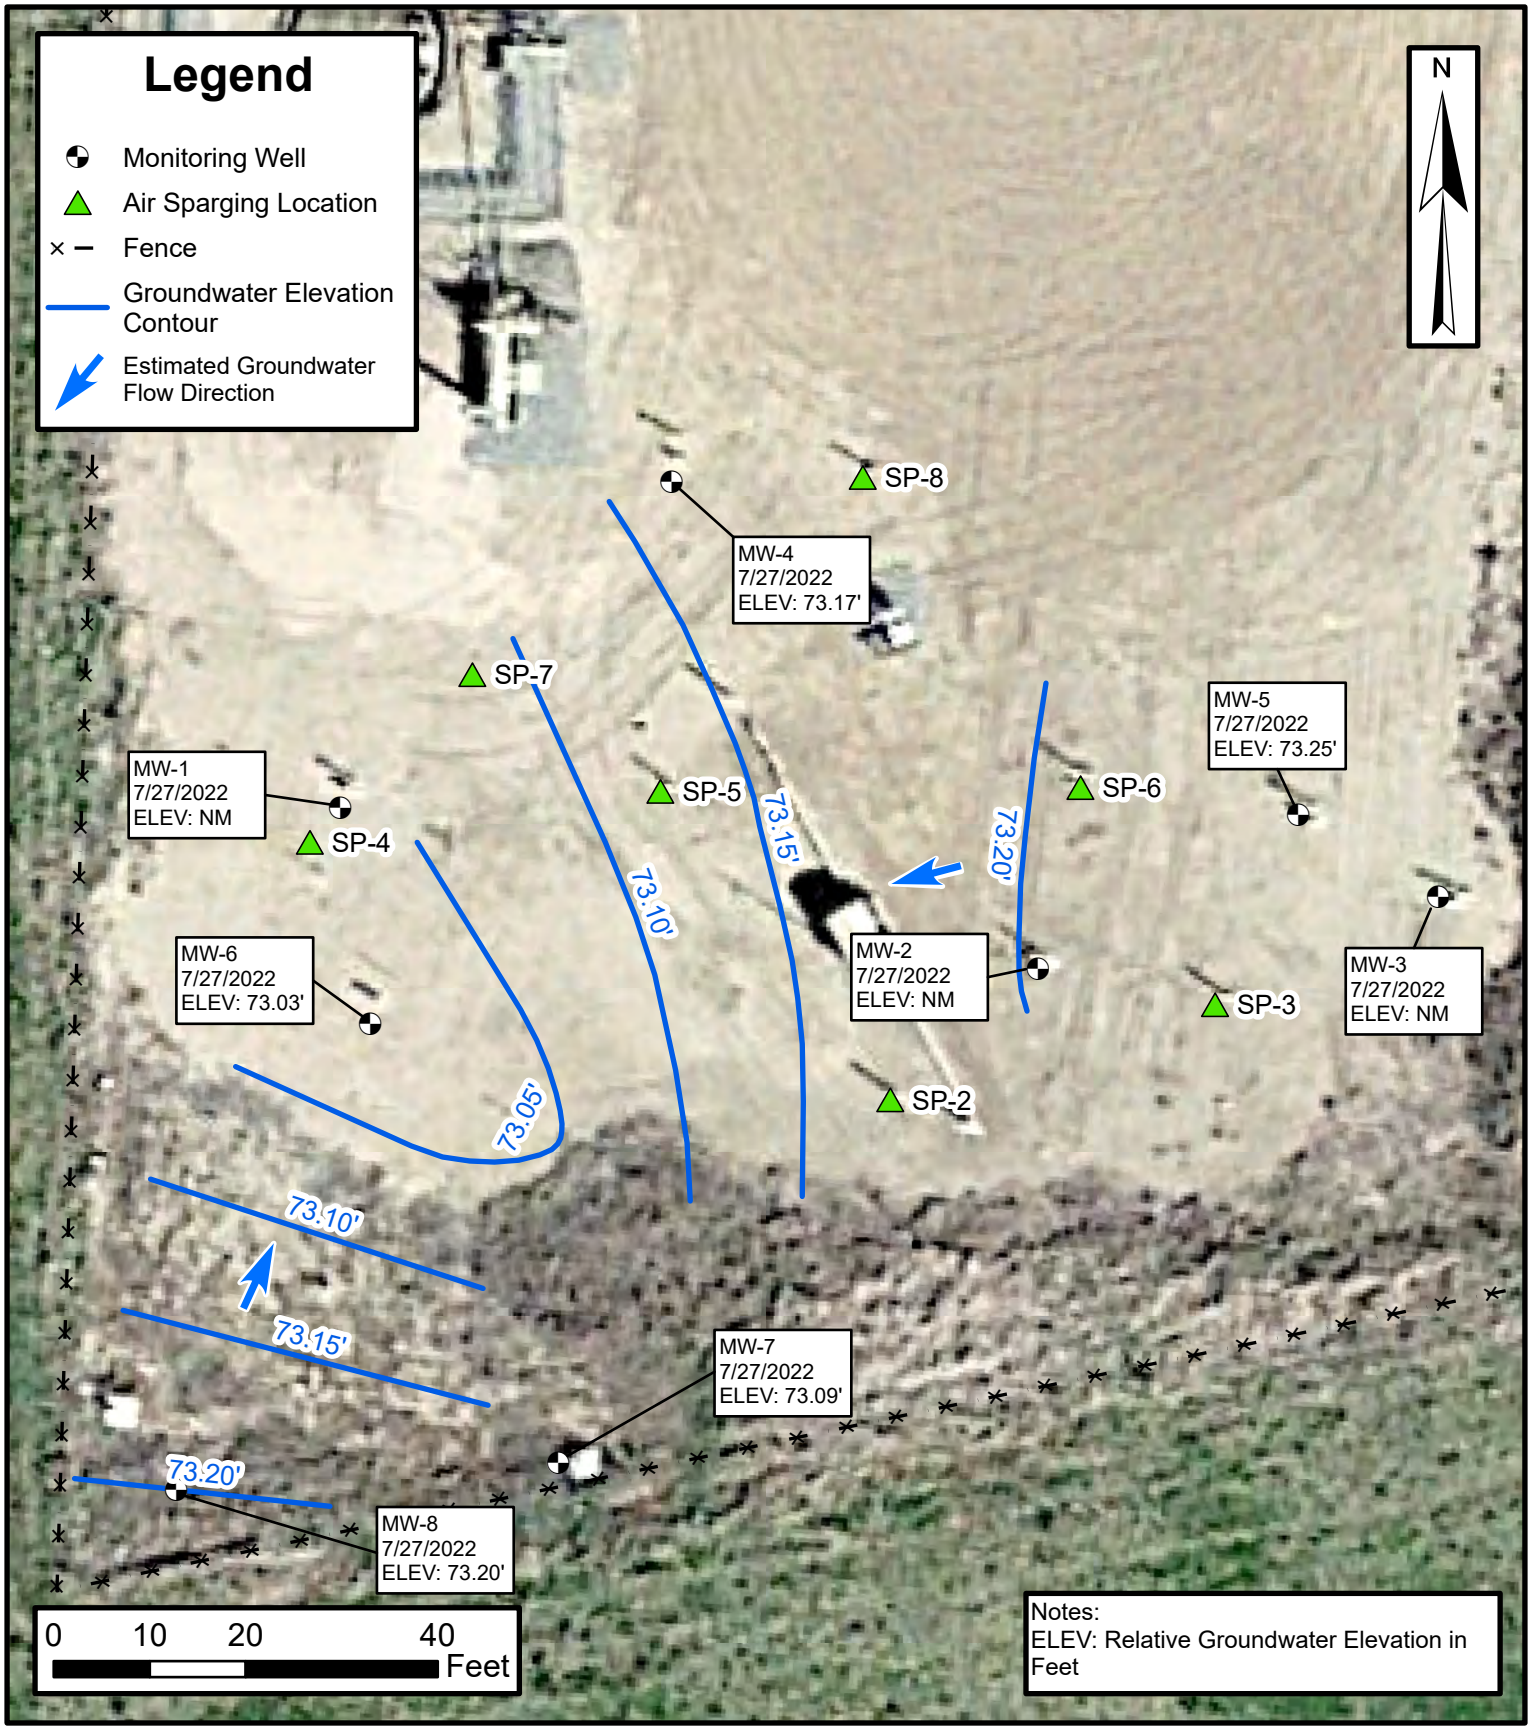
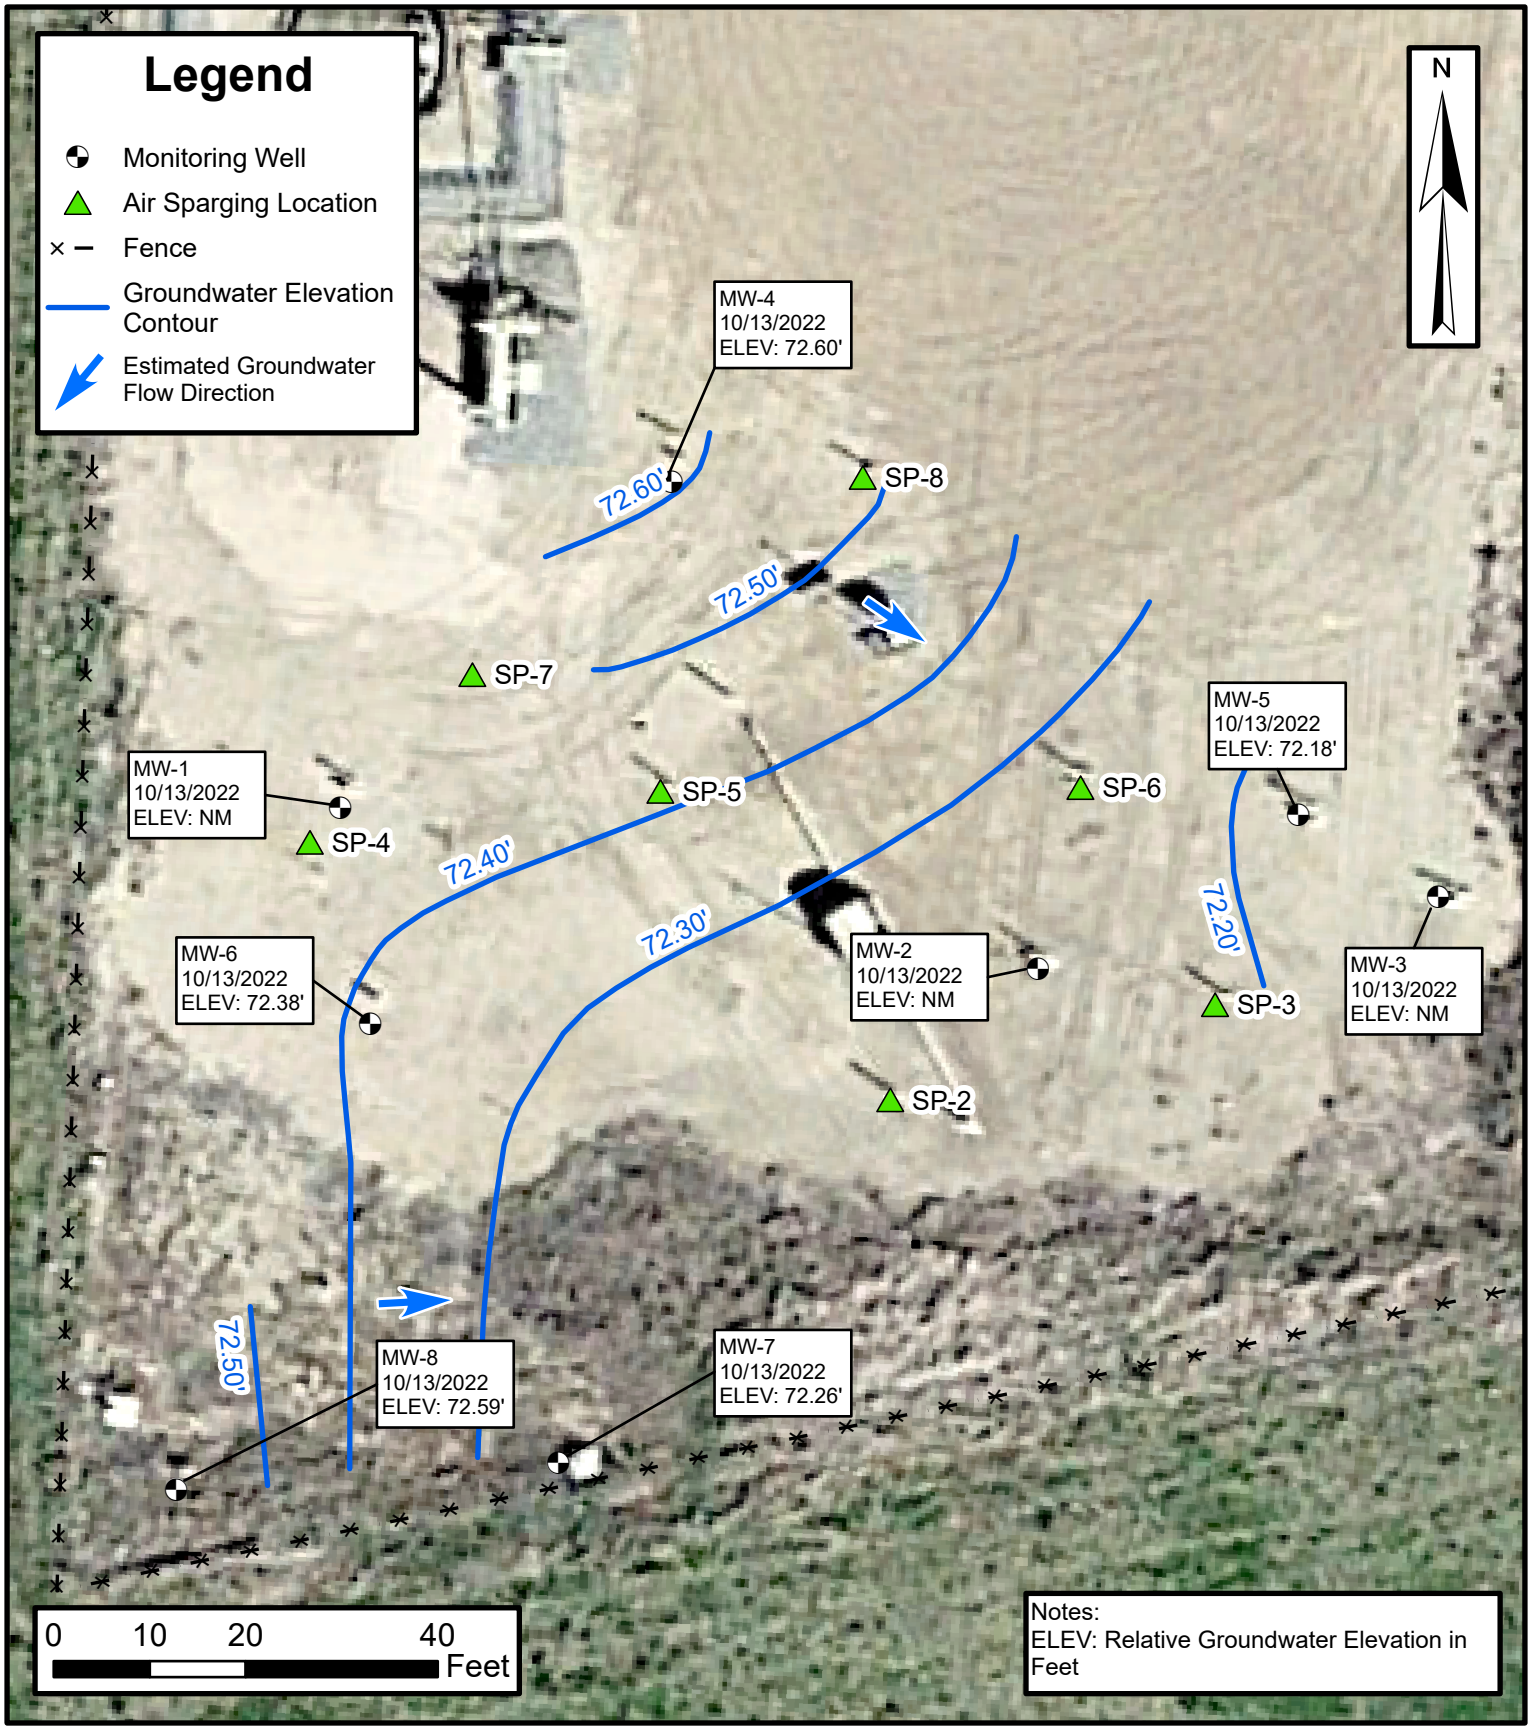
FIGURE
3

Groundwater-level measurements and samples were collected in February, April, July, and October 2022 from wells MW-4 through MW-8. Static groundwater-level monitoring included recording depth-to-groundwater using a Keck oil/water interface probe. The interface probe was decontaminated with Alconox™ soap and rinsed with distilled water prior to each measurement to prevent cross-contamination. Based on quarterly measurements, groundwater elevations fluctuate significantly throughout the year and generally increase during the summer and fall months due to nearby field irrigation. Measured depths-to-groundwater and calculated groundwater elevations are presented in Table 1. The inferred groundwater flow direction also changes throughout the year, as indicated on the quarterly groundwater potentiometric surface maps presented in Figures 3, 4, 5, and 6.

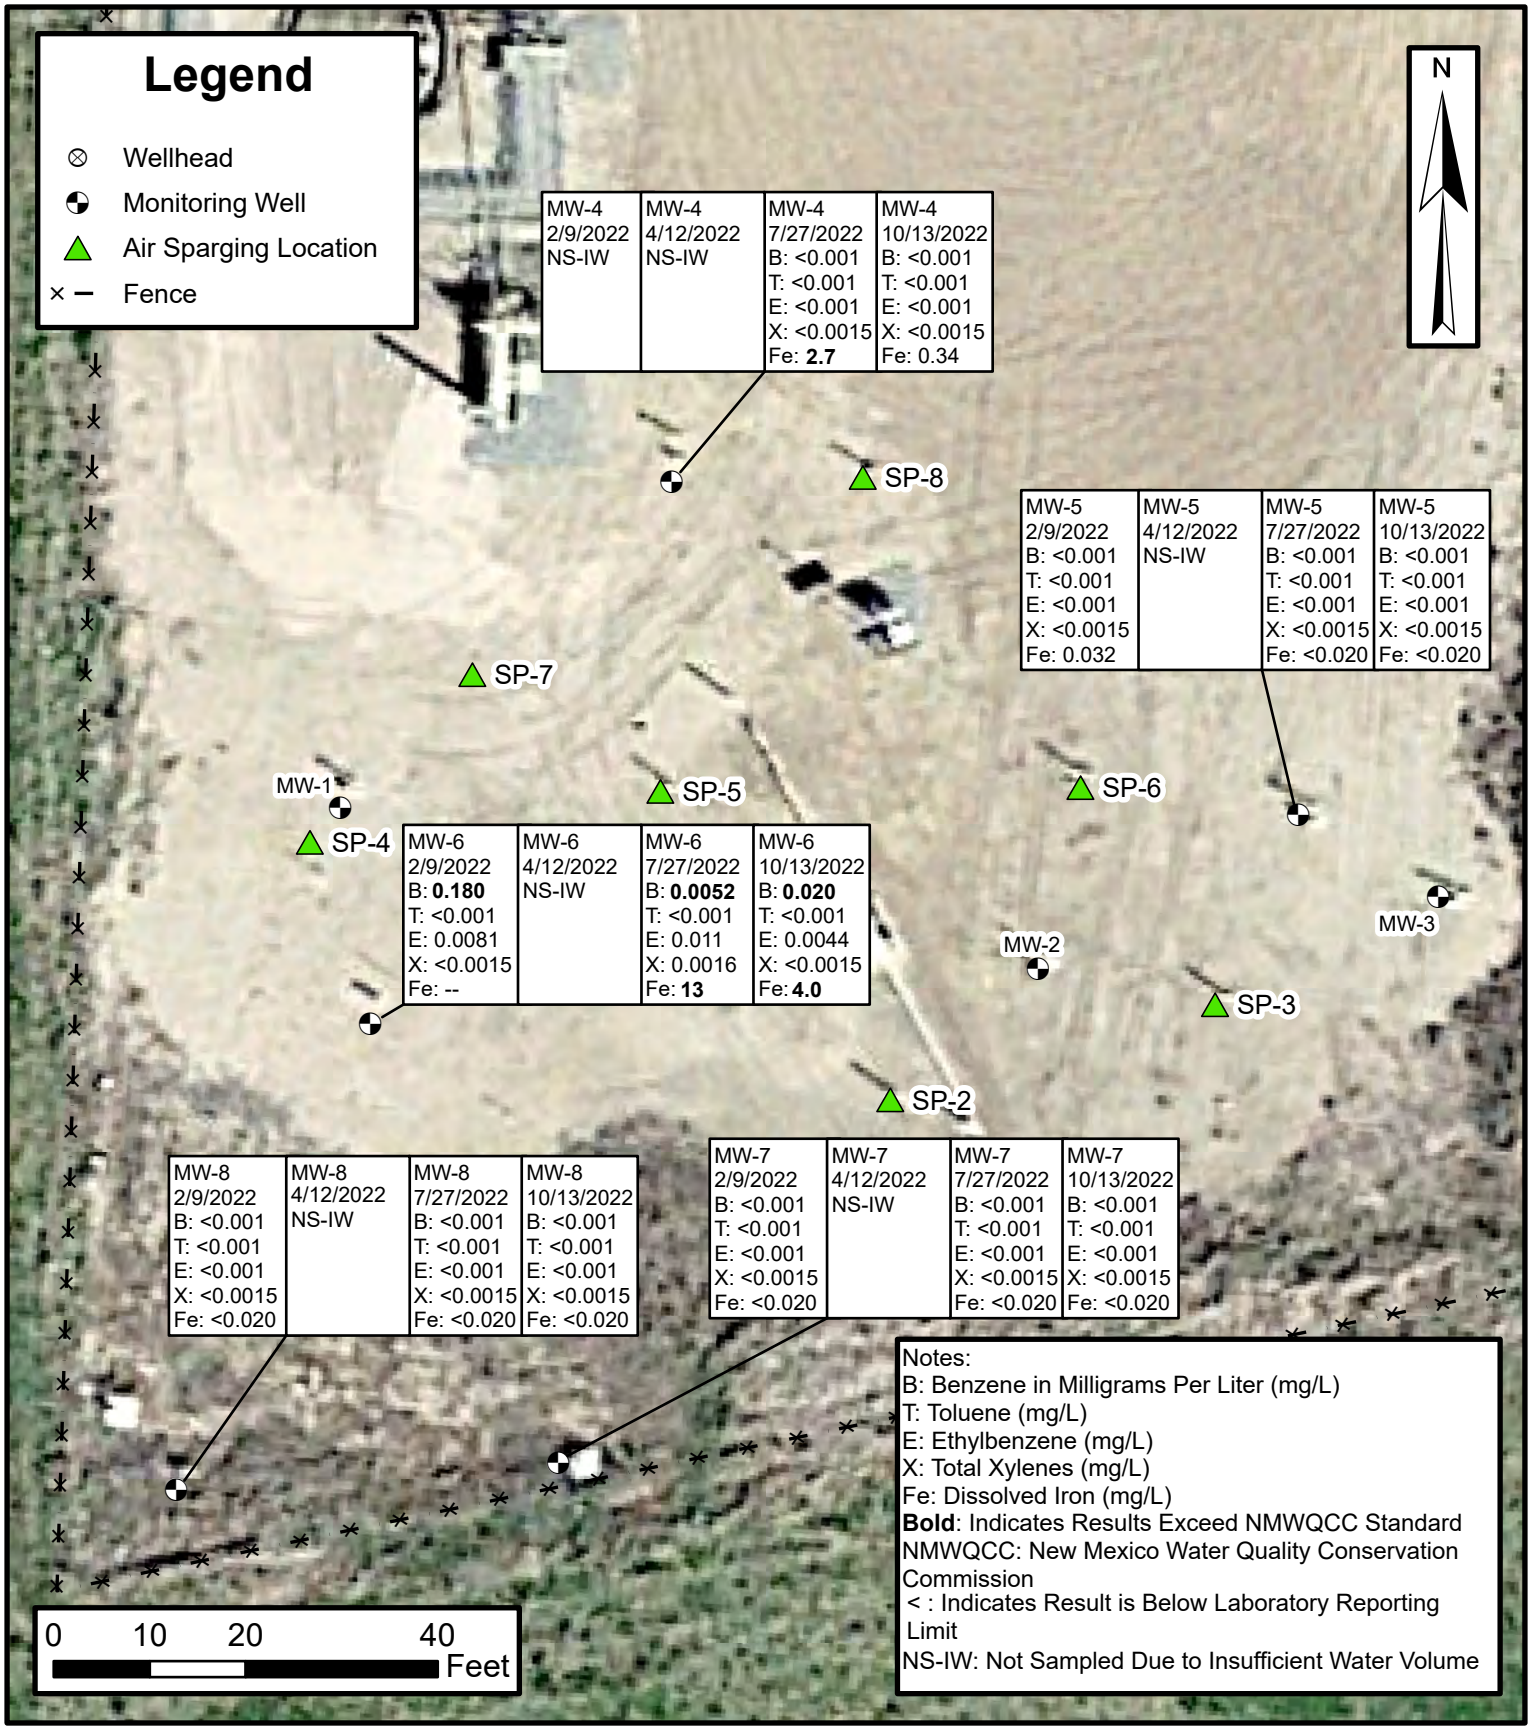
FIGURE
7

During the February 2022 sampling event, well MW-4 did not have sufficient water volumes to collect a sample for laboratory analysis. In addition, all wells were dry during the April 2022 sampling event. Benzene was detected in groundwater from well MW-6 during the February, July, and October 2022 sampling events at concentrations exceeding the NMWQCC standard. Benzene was not detected in groundwater above the NMWQCC standard in any of the other sampled wells. Toluene, ethylbenzene, and total xylenes were also not detected in groundwater above the NMWQCC standards in any of the sampled wells during any quarterly sampling event. Additionally, dissolved iron was detected in groundwater at a concentration exceeding NMWQCC

standard in MW-4 during the July 2022 sampling event, as well as MW-6 during the July and October 2022 sampling events. Of note, there was insufficient water volumes in well MW-6 during the February 2022 to collect a sample for dissolved iron analysis. Analytical results are summarized in Table 3 and depicted on Figure 7, with complete laboratory analytical reports attached as Appendix A.

Overall, BTEX concentrations in groundwater have decreased over time at the Site. BTEX concentrations have not been detected above laboratory reporting limits in wells MW-4, MW-5, MW-7, and MW-8 in more than five years. Well MW-6 has concentrations of benzene exceeding NMWQCC standards; however, concentrations have steadily declined in this well since 2013. Additionally, concentrations of dissolved iron exceeding the NMWQCC standard were only detected in wells MW-4 and MW-6 during 2022 quarterly sampling events. Although detected above standards in MW-4, concentrations of dissolved iron have generally not been detected above laboratory reporting limits and are only sporadically detected above the NMWQCC standard.

Dissolved iron concentrations have consistently exceeded the NMWQCC standard in groundwater from well MW-6 since it was first analyzed in 2009. Similar to benzene concentrations in this well, dissolved iron concentrations have also steadily declined since 2013. Elevated iron concentrations in well MW-6 appear to be a result of generally low-oxygen and reducing groundwater conditions in this area, which is a common biproduct of petroleum degradation in groundwater systems. This is further evidenced by the low concentrations of iron in wells outside of the release area and the impacted groundwater plume. As groundwater conditions at the Site equilibrate to natural background conditions and dissolved oxygen increases, groundwater in the vicinity of well MW-6 will become increasingly aerobic. As this happens, dissolved iron will likely precipitate out of solution leading to decreased concentrations in groundwater.

Lastly, groundwater downgradient of MW-6 continue to exhibit BTEX and dissolved iron concentrations below NMWQCC standards, which indicates that the groundwater plume is localized to the vicinity of MW-6 and has not migrated downgradient with groundwater flow. Furthermore, overall Site conditions indicate that the petroleum-hydrocarbon plume is stable and decreasing in magnitude indicating natural attenuation is an effective remedial method for this Site.

- Collect groundwater sample from wells MW-6, MW-7, and MW-8 on a semi-annual basis for BTEX and dissolved iron constituents. Wells MW-7 and MW-8 will serve as points of compliance at the Site to ensure that benzene and dissolved iron concentrations are not migrating off-Site. Once concentrations are compliant with NMWQCC standards, sampling frequency will be increased to quarterly until eight consecutive quarters are below applicable standards.
