Release Assessment and Closure

Aldabra 25 Federal #006H & #007H Battery

Vertex File Number: 23E-04614

Date:
March 2024

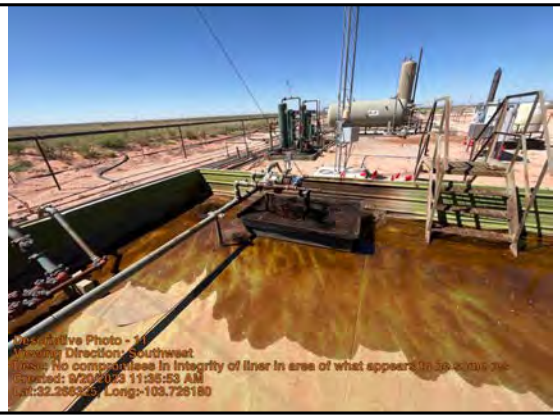
No compromises in integrity of liner in area of what appears to be some residual rainwater, with various larvae thriving, pooled in corner.	Center of containment facing east. West side, Inside containment.
Viewing Direction: East	**Viewing Direction**: East

South side of containment facing east. South side and center, inside containment.	North side of containment facing east. North side and center, inside containment.

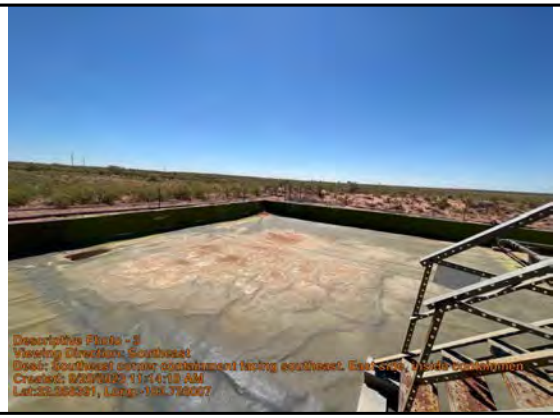
Northeast corner containment facing northeast. East side, inside containment.	Southeast corner containment facing southeast. East side, inside containment.
