Remediation Closure

PLU 29 Big Sinks West CTB

Unit F, Section 29, Township 25 South, Range 31 East

Vertex Resource Services Inc.

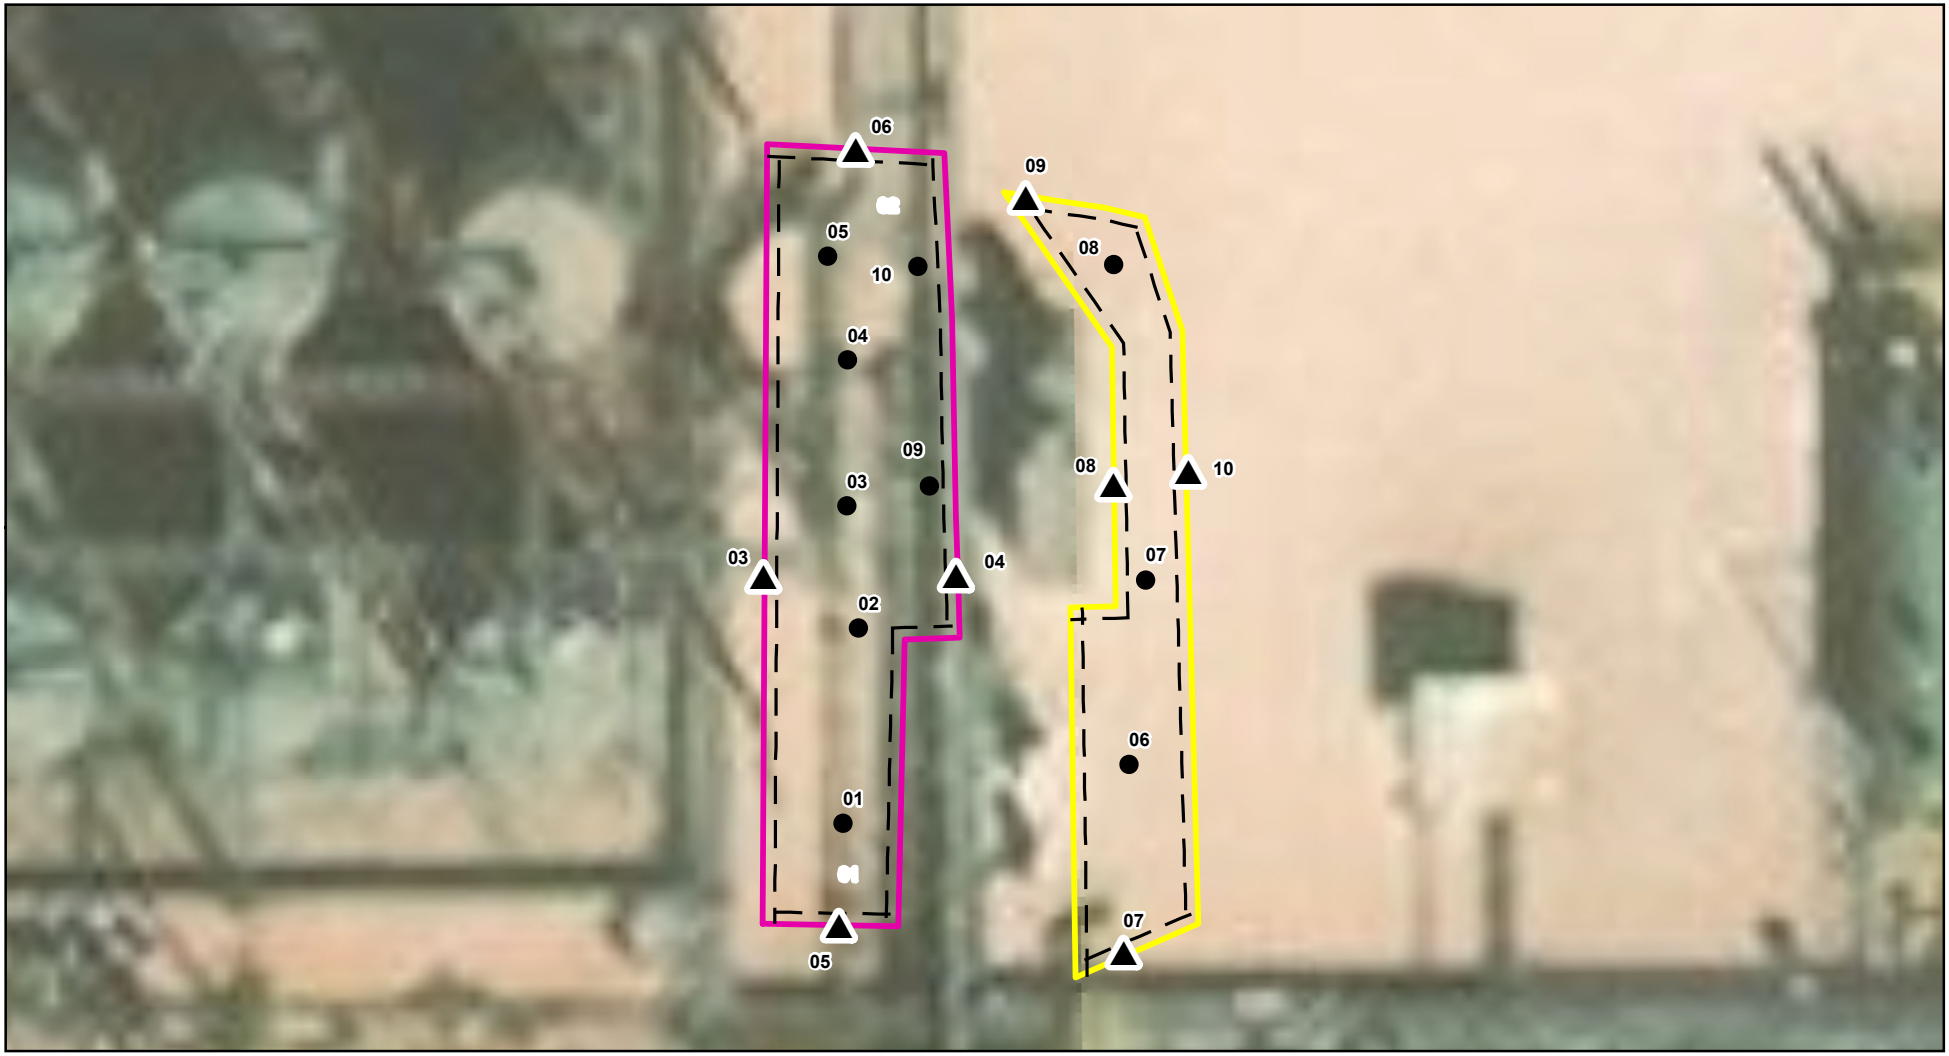
FIGURE:
1

Characterization Schematic
PLU 29 Big Sinks

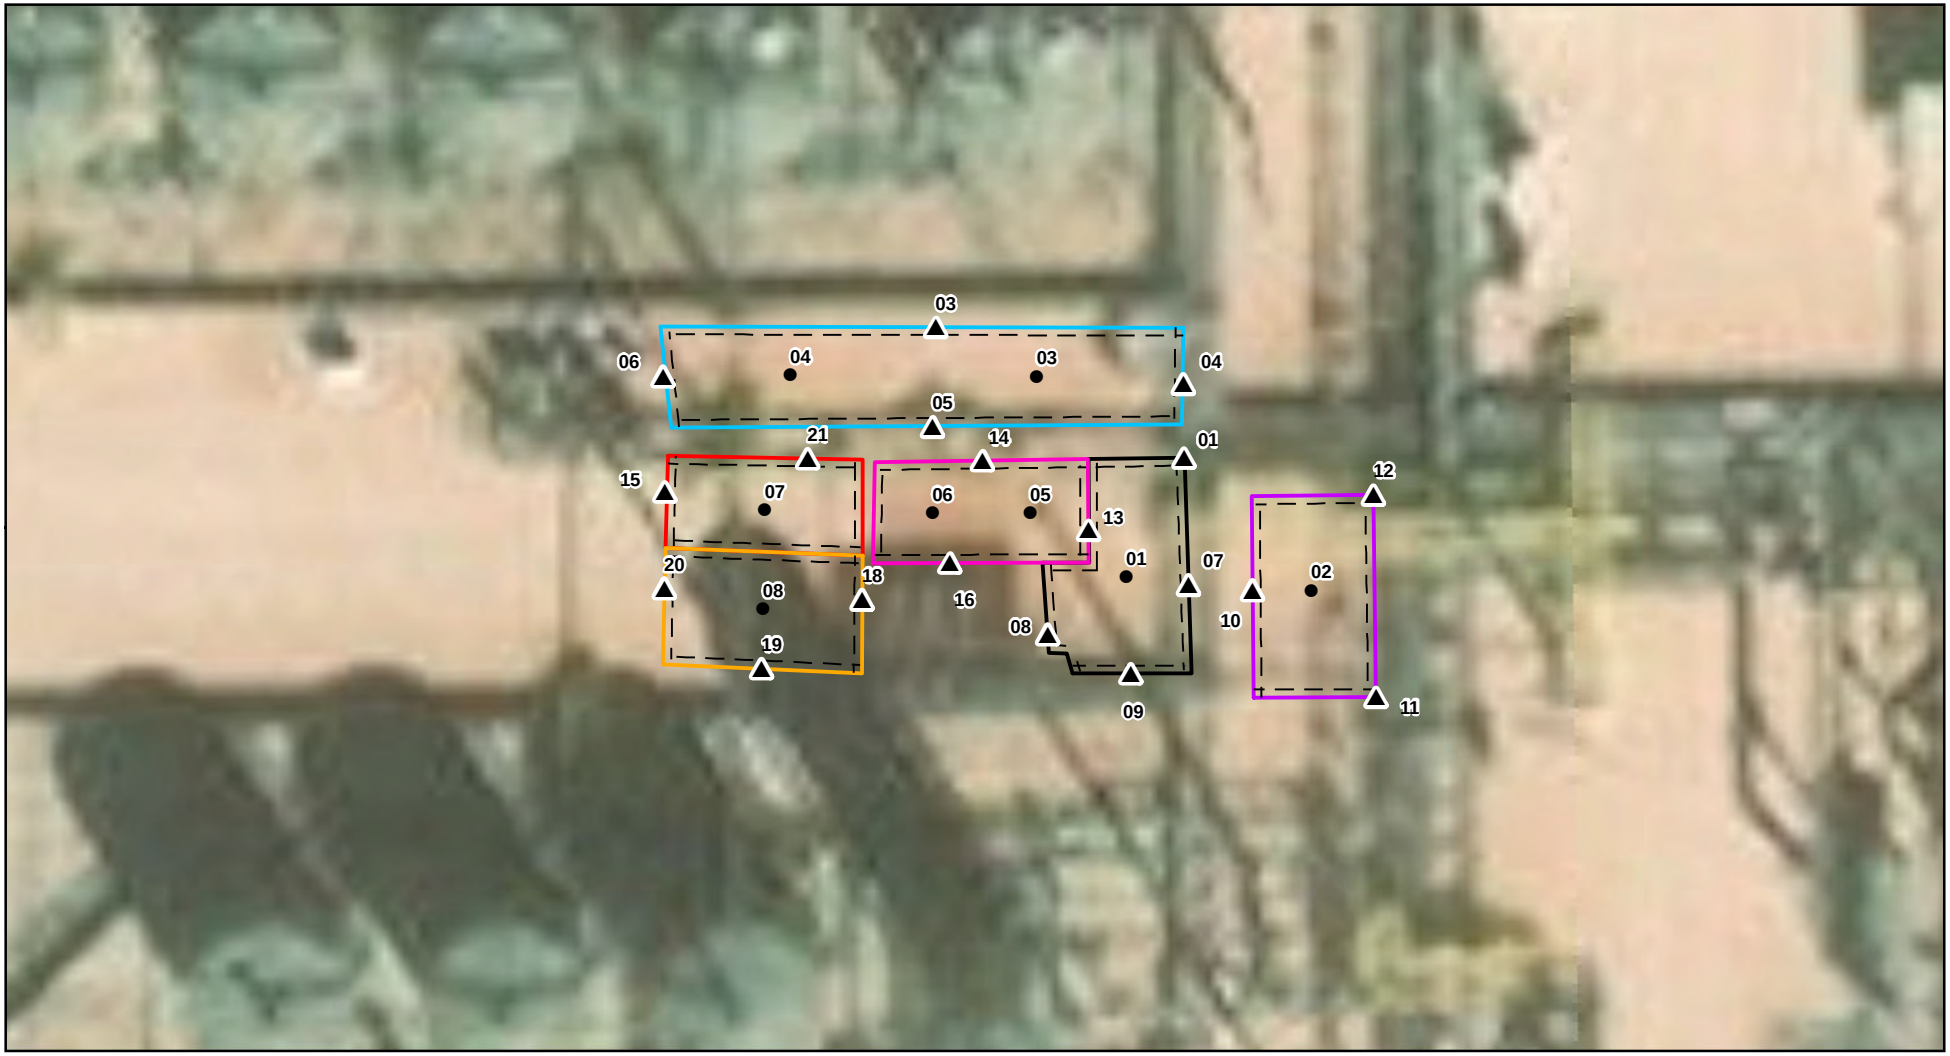
FIGURE:
1

Characterization Schematic
PLU 29 Big Sinks

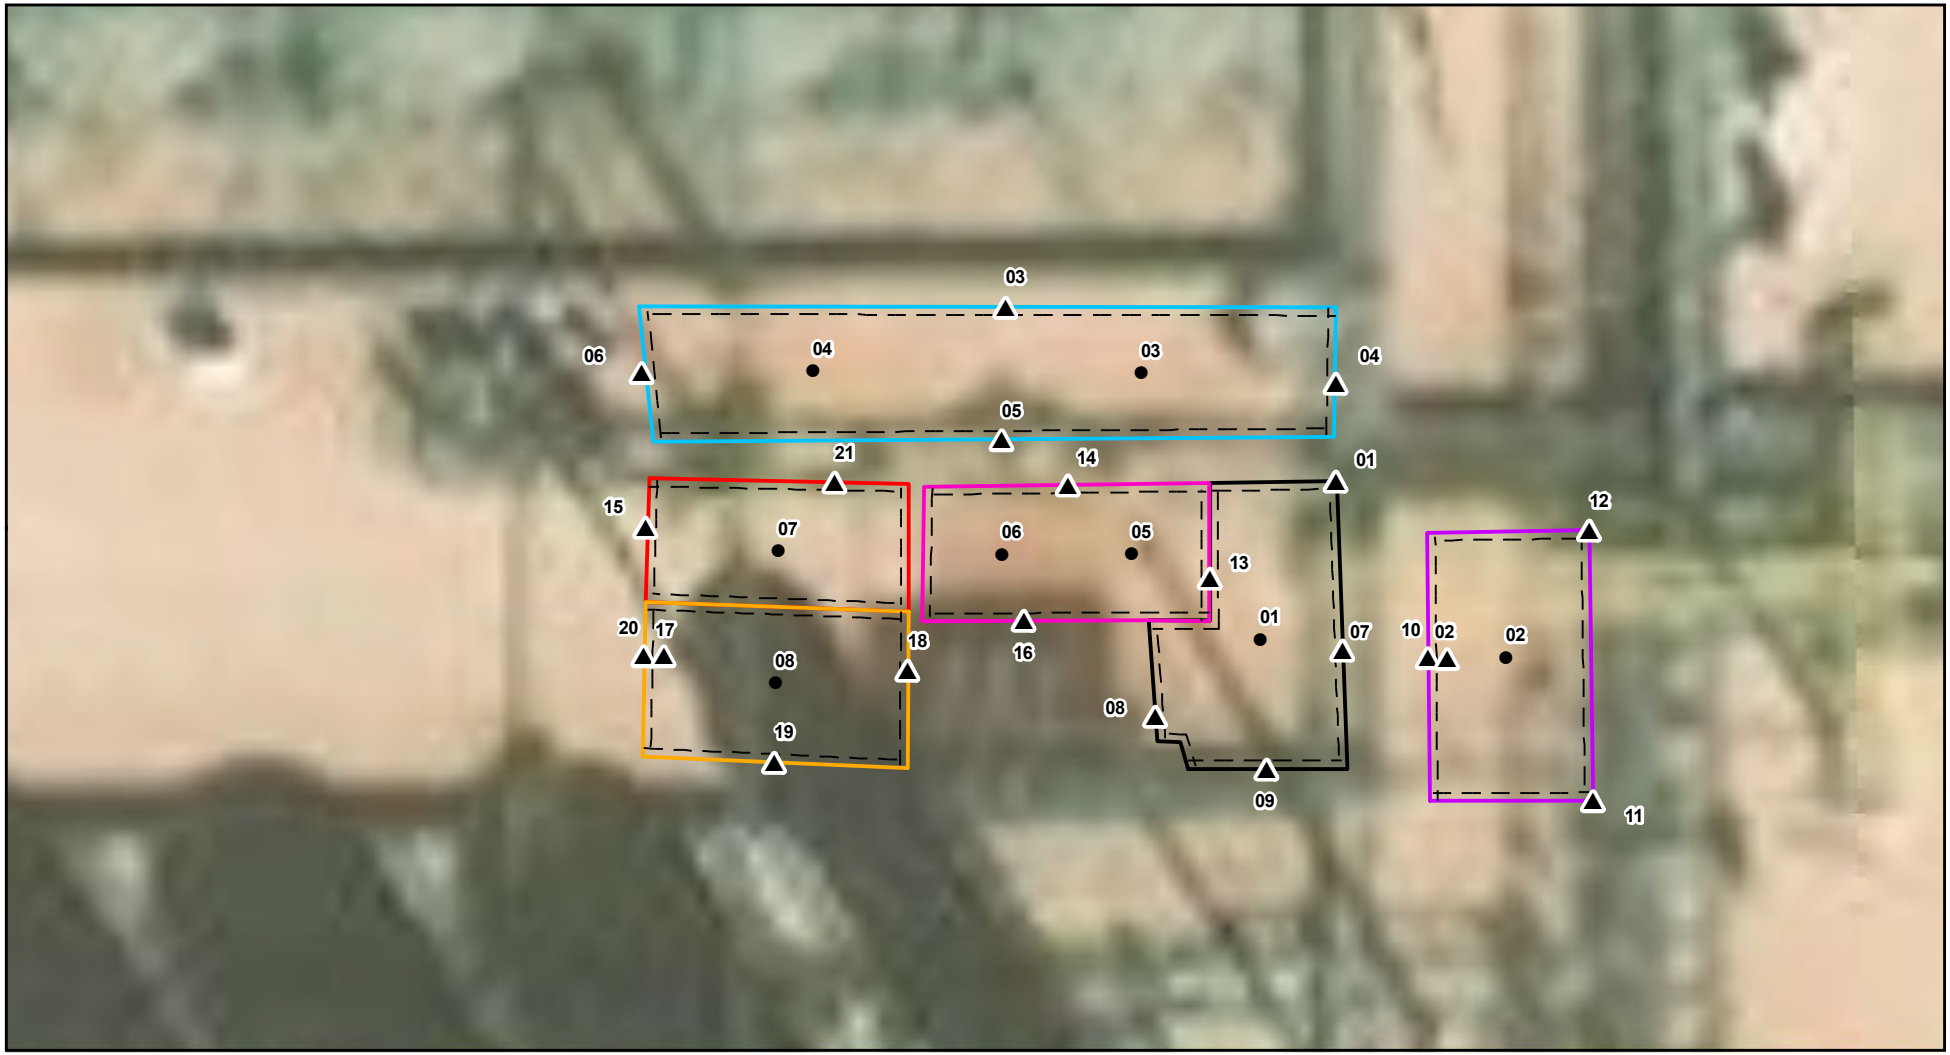
I am reviewing the reports for NAPP2401043023 PLU 29 BIG SINKS WEST TB and the following reason for rejection was not addressed: In addition, WS24-02 and WS24-17 are missing both from Figure 2 and Table 4. Can you update the table and figure to address these?
