Cottonwood CONSULTING

RE: Mudge A #002
2025 Biannual Monitoring Report

Mudge A #002
OVM Reading Results
Simcoe LLC

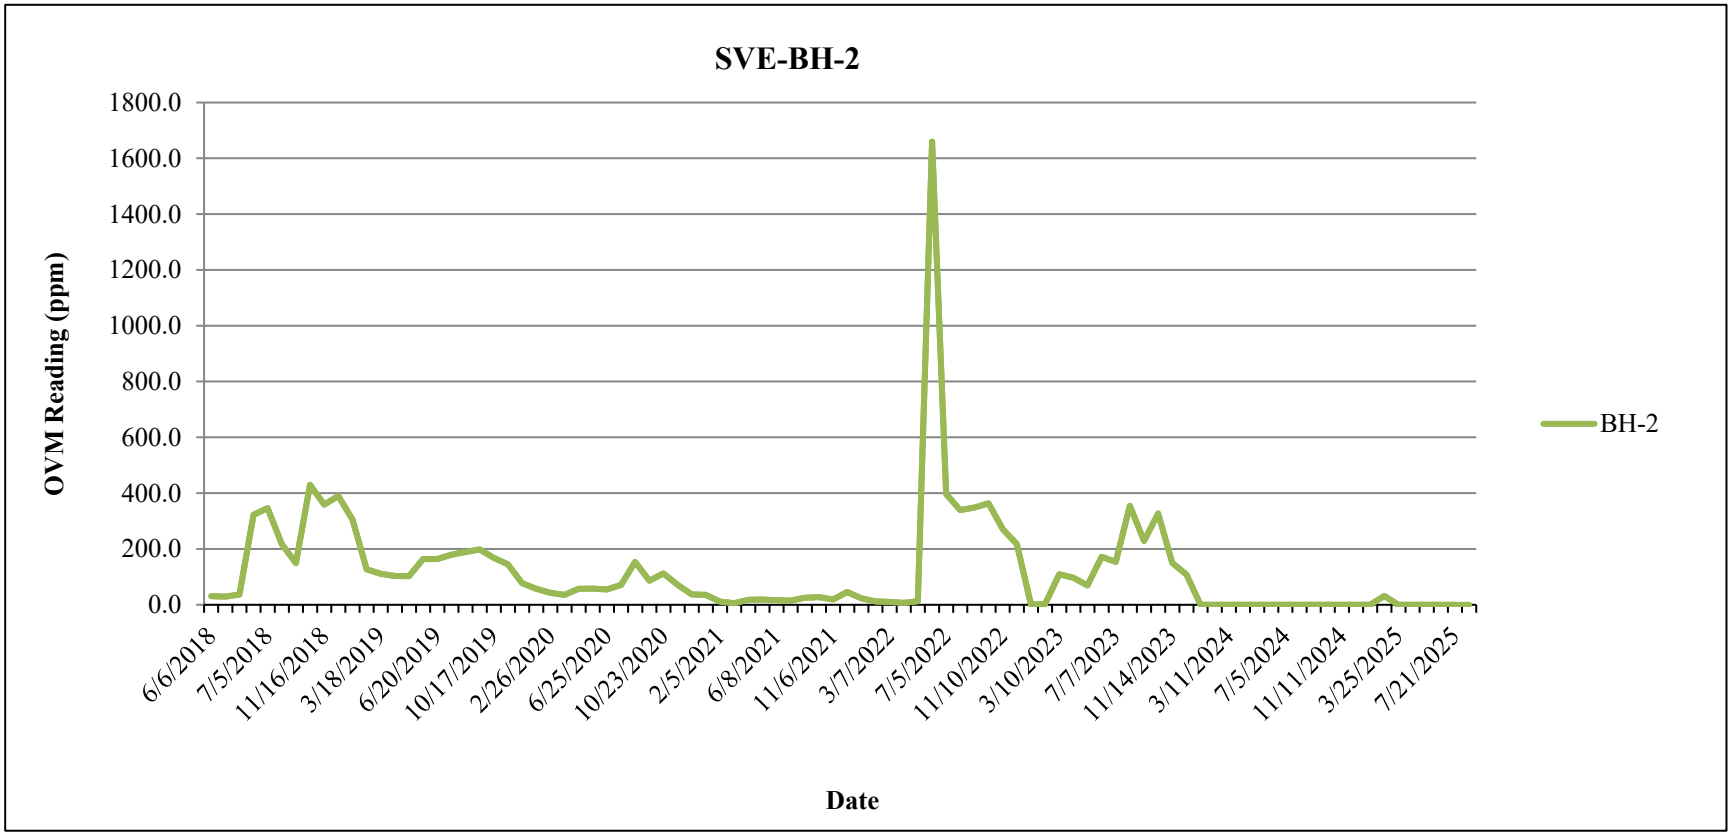
FIGURE 1

It appears that the SVE system has reduced OVM readings in SVE point BH-2. Benzene, toluene,

ethylbenzene, and total xylenes were not detected in the gas sample collected from the SVE system. See Figure 1 for OVM reading results, Attachment 1 for a summary of the SVE System Monitoring Data, and Attachment 2 for the gas sample laboratory report.

Simcoe will continue to conduct regular monitoring and sampling at the Mudge A #002 SVE system. In the future, Simcoe may advance subsurface soil borings to verify closure standards are met.
