Closure Report
Yukon Gold 31 CTB 2 (04.29.2026)
Incident ID: nAPP2612430390
Unit H, Sec 31, T23S, R30E
Eddy County, New Mexico
32.262993°, -103.913058°

Produced Water Release
Point of Release: Dump Line Developed Pinhole Leak
Release Date: 04.29.2026
Volume Released: 8 Barrels of Produced Water
Volume Recovered: 7 Barrels of Produced Water

Re: Closure Report
Yukon Gold 31 CTB 2 (04.29.2026)
Devon Energy Production Company
Incident ID: nAPP2612430390
Site Location: Unit H, S31, T23S, R30E
(Lat 32.262993°, Long -103.913058°)
Eddy County, New Mexico

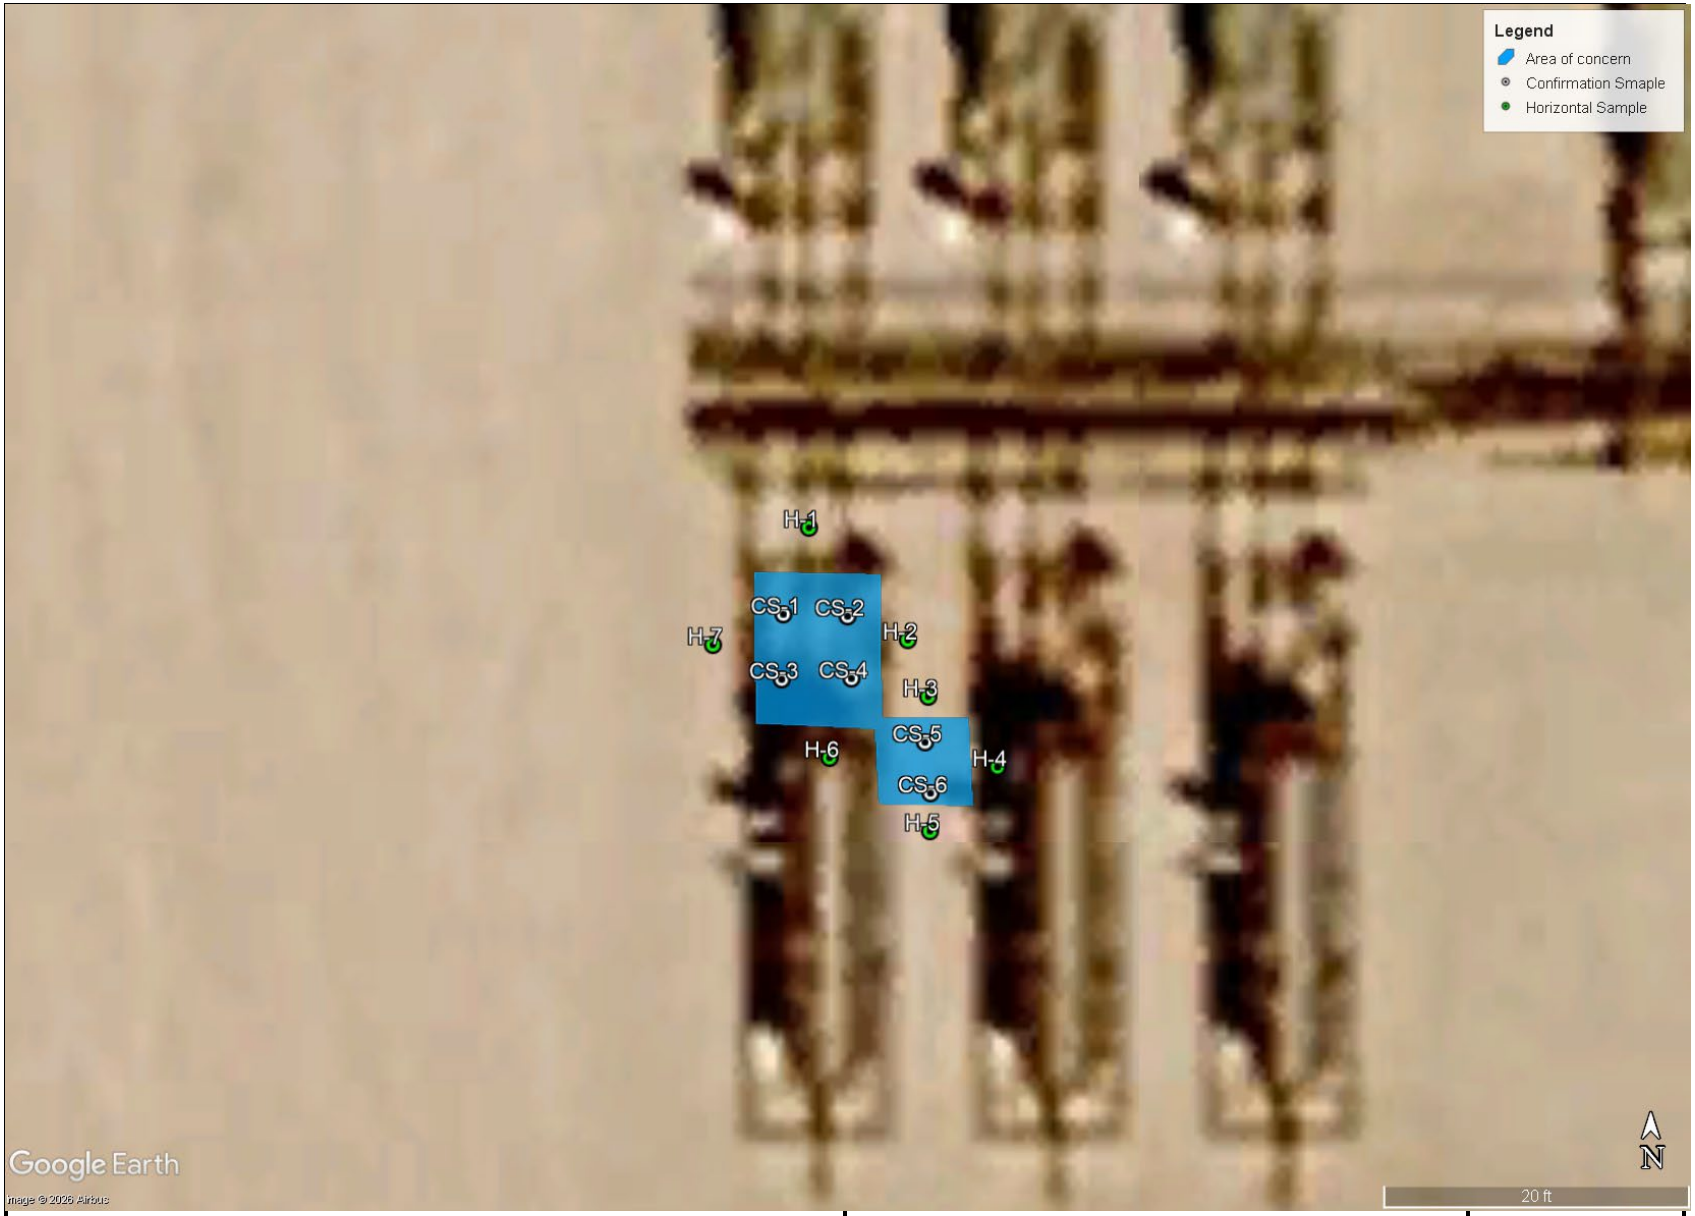
EXCAVATION DEPTH MAP DEVON ENERGY PRODUCTION COMPANY YUKON GOLD 31 CTB 2 (04.29.2026) EDDY COUNTY, NEW MEXICO 32.262993°, -103.913058°	CARMONA RESOURCES	FIGURE 3

Based on the initial C-141 obtained from the New Mexico Oil Conservation Division (NMOCD), the release was discovered on April 29, 2026, due to a dump line developing a pinhole leak, allowing fluids to reach the surface of the pad. It resulted in the release of eight (8) barrels of produced water, with seven (7) barrels of produced water recovered. The spill boundaries are shown in Figure 3. The initial C-141 form is attached in Appendix C.

Once the remediation activities were completed, the excavated areas were backfilled with clean material to surface grade. Approximately 200 square feet of contamination was remediated, resulting in approximately 4 cubic yards of material excavated and transported offsite for proper disposal. The backfill material was sourced from Northern Delaware Basin Landfill and was collected for laboratory analysis on May 26, 2026, before being utilized. Laboratory data can be found in Table 1.

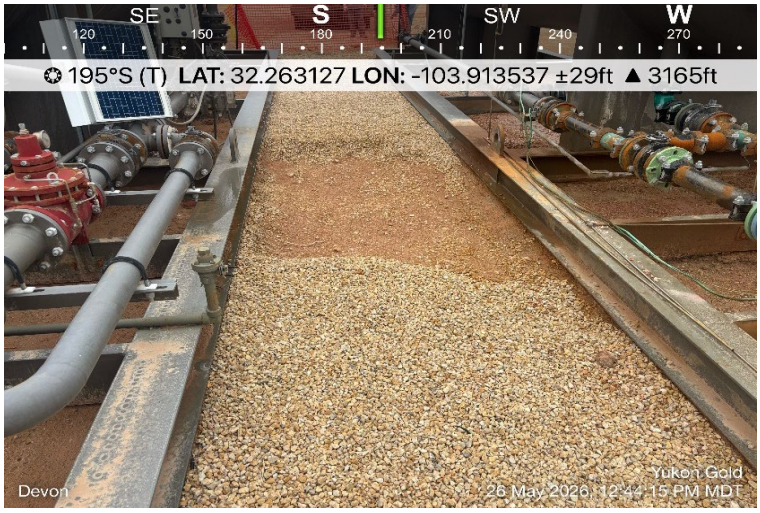
Description:
View South area of CS-5 and CS-6.

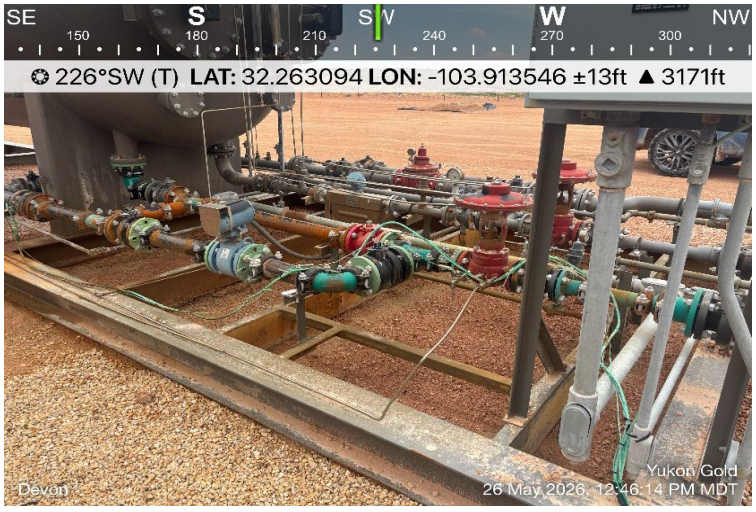
Photograph No. 3

Description:
View Southwest, area of CS-1 through CS-4.

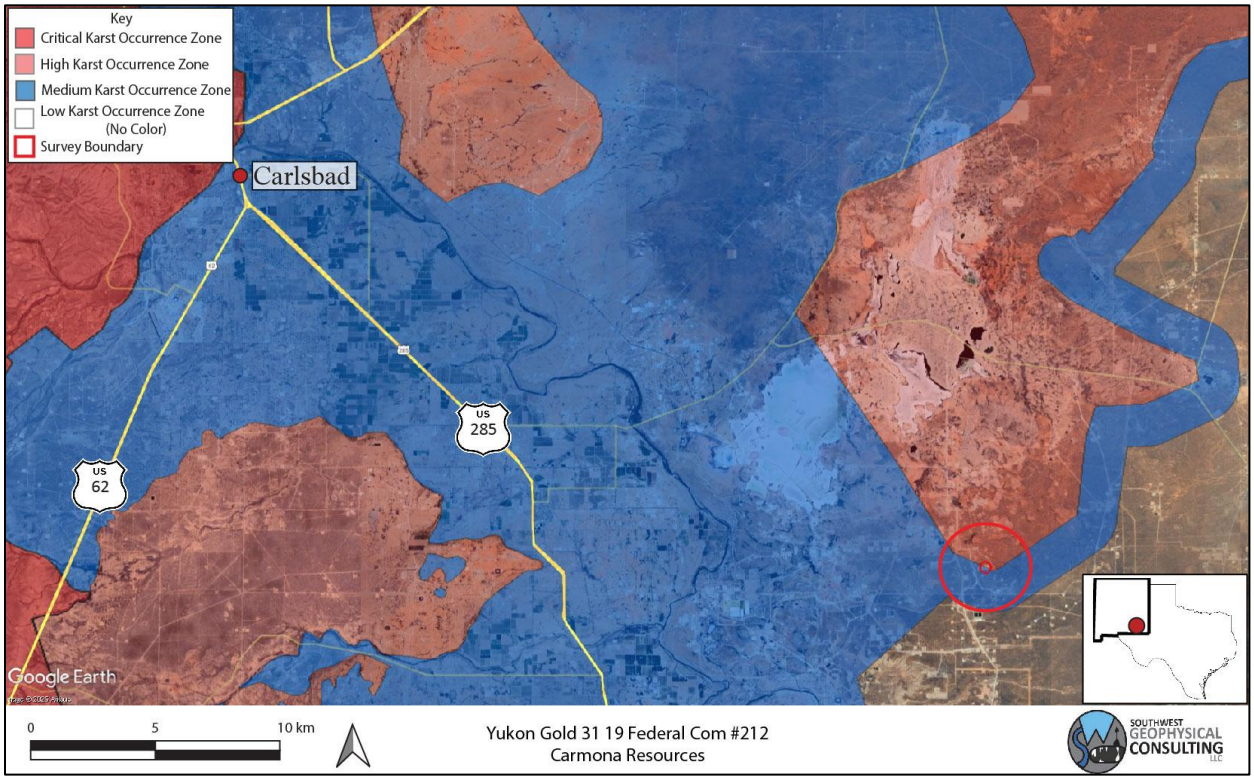
The Bureau of Land Management (BLM) categorizes all areas within the Carlsbad Field Office (CFO) zone of responsibility as having either low, medium, high, or critical cave potential based on geology, occurrence of known caves, density of karst features, and potential impacts to freshwater aquifers[4]. These designations are also recognized by the New Mexico State Land Office (NMSLO). This project occurs within both a **HIGH** karst occurrence zone (HKOZ) and a **MEDIUM** karst occurrence zone (MKOZ)[5] (**Figure 1**).

Figure 1: Karst occurrence zone overview. Background image credit: Google Earth. Image date: August 21, 2024. Image datum: WGS-84.

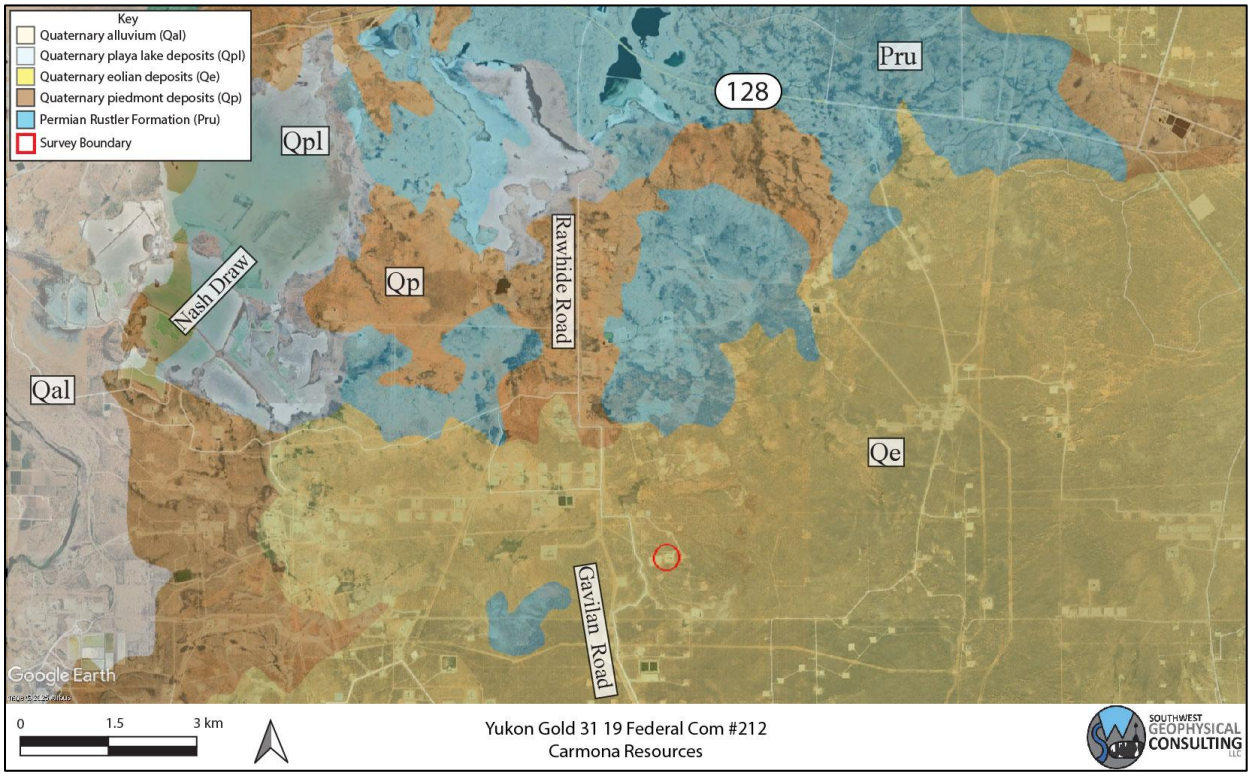
The site for the YG31 survey is located east of Nash Draw at an elevation of 967 meters (3,173 feet), ± 15 meters (49.2 feet). This region is entirely underlain by the Permian Rustler Formation (Pru). The area is mantled by thin gypsiferous soils (gypsite), Quaternary eolian deposits (Qe), and piedmont gravels (Qp)[11] up to 5 meters in depth (**Figure 3**).

The Pru overlies the Permian Salado Formation (Psl), a layer of extremely soluble halite which can readily dissolve to create caves, sinkholes, and other karst features; however, due to its extremely soluble nature, only non-soluble silt and sand remain from the dissolution of this layer at the surface[12]. The Rustler Formation may be subject to collapse if a void has developed beneath it in the Salado Formation[13].

Figure 3: Geology overview. Geology map credit: The Digital Geologic Map of New Mexico in ARC/INFO Format. Background image credit: Google Earth. Image date: August 21, 2024. Image datum: WGS-84.

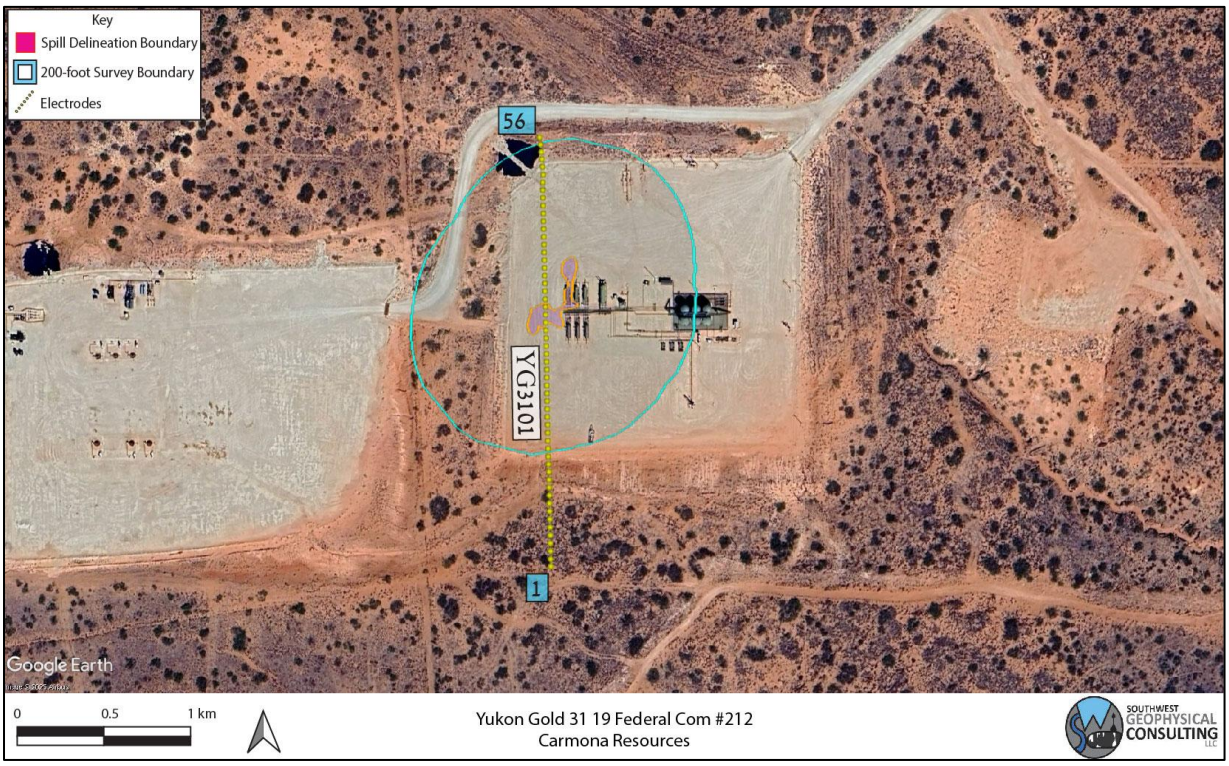
For this survey, an Advanced Geosciences Inc. (AGI) SuperSting™ Wifi R8 with a multi-electrode switchbox, a 56-electrode array of 40-centimeter-long electrodes, and a tablet controller were used to image the subsurface. This survey consisted of one resistivity line in a dipole-dipole strong-gradient configuration laid out south to north. The single line consisted of 56 electrodes at 4-meter spacing, resulting in a 220-meter-long array (**Figure 5**, **Table 1**). A preconfigured command file was used to run the data collection (DDSG56). This electrode configuration provided a depth of investigation of 44 meters (144 feet) and a resolution of 2.0 to 2.5 meters (6.6 to 8.2 feet) within the first 5 to 8 meters (16 to 26 feet) from the surface. A Leica GS18 GPS was used to record electrode locations and elevations.

Figure 5: Geophysical survey overview. One survey line was conducted with 56 electrodes each at 4-meter spacing (yellow dots denoted with blue numbers). Background image credit: Google Earth. Image date: August 21, 2024. Image datum: WGS-84.

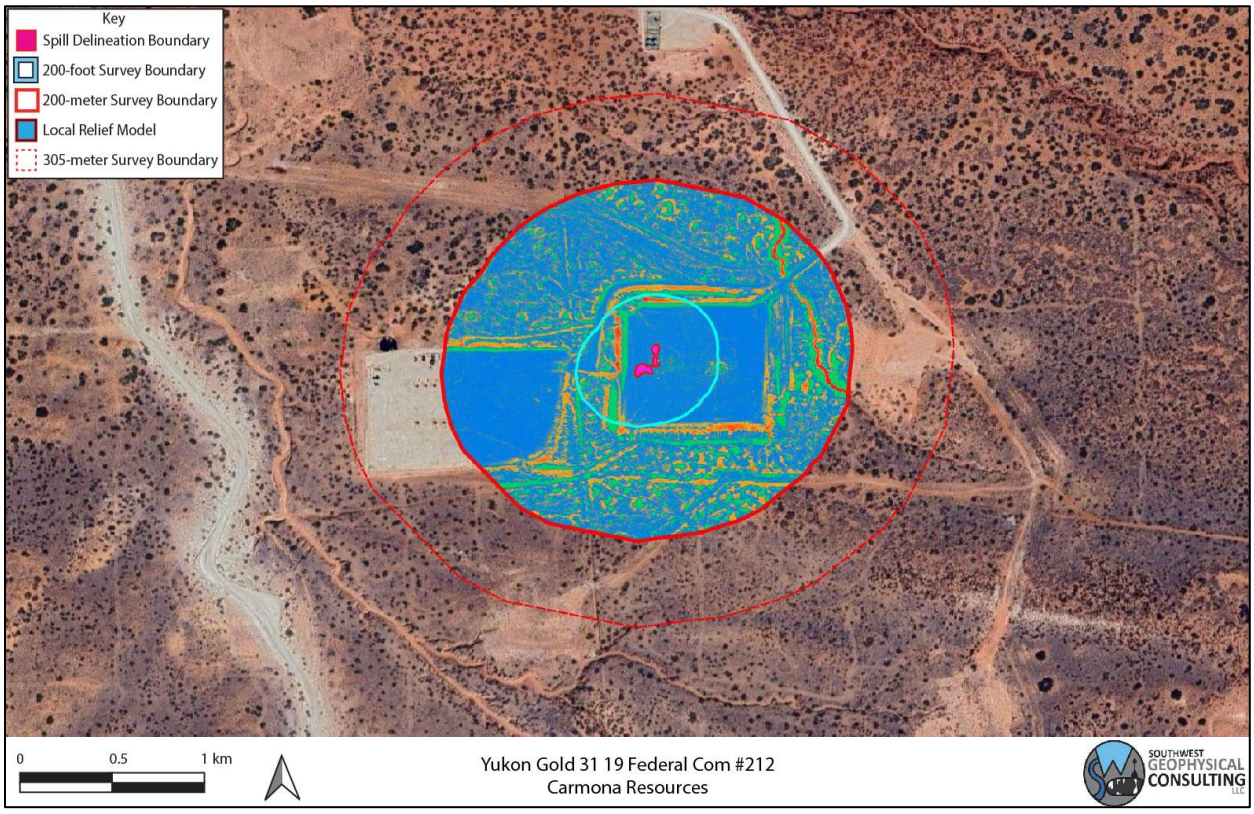
Figure 6: Aerial karst survey results. Background image credit: Google Earth. Image date: March 20, 2023. Image datum: WGS-84.

The desk study and surface karst survey showed no surface karst features within the 200-foot (61-meter)[1] survey area surrounding the spill delineation boundary (**Figure 6**). No springs exist within the 1,000-foot (305-meter)[1] survey boundary.

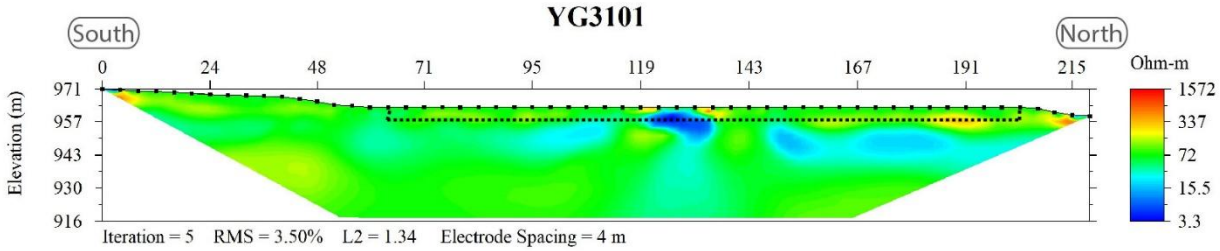
Figure 7: 2D inverted resistivity sections. Reds and oranges indicate higher resistivity values. Yellows and greens are medium-resistivity values. Blues are low-resistivity values. Please note that the color scale is relative. The dashed black line indicates the location of the well pad.

The results of this study indicate a moderately well-layered geologic system with resistivities between 3.3 and 1,572 Ohm-m (**Figure 7**). Please keep in mind when viewing the 2D inverted resistivity sections that color maps can be widely different for each view. Always check the color map located on the right side of the image when viewing the 2D images to ensure you understand the range of resistivities presented. Distances along the top and depths along the left side are in meters. The color map along the right side is in Ohm-m. Due to the nature of the survey, shallower zones have higher resolution between electrodes than deeper zones; therefore, small features at depth will not be visible.

No anomalies consistent with air-filled subsurface voids are found within the YG31 survey area. However, small solutionally enlarged voids or fractures at or near the resolution limit of the survey (1.5 – 2.0 meters) may be present. Slightly higher-than-average resistivity areas less than 10 meters beneath the surface are interpreted as dry caliche or gypsite soils. Due to their low resistivity values when compared with significant subsurface voids, these features should not be a concern during remediation efforts. Areas of moderate resistivity (yellows, and greens) near the surface are interpreted as dry gypsite soils and gypsum bedrock of the Rustler Formation[17] (**Figure 7** and **Figure 8**).

The low-resistivity area between 3.3 – 15 Ohm-m is interpreted to represent fluid from the brine release. Other low resistivity areas between 15 and 50 may represent surface-to-subsurface hydrologic pathways, or a layer of either clays and halite lenses or moist or saturated layers within the Rustler Formation. (**Figure 7**).
