WELL API NO.
30-025-38576 and 30-025-42139

7. Lease Name or Unit Agreement Name
Linam AGI

2. Name of Operator
DCP Operating Company, LP

Report for the Month ending February 28, 2025 Pursuant to Workover C-103 for Linam AGI #1 and AGI #2

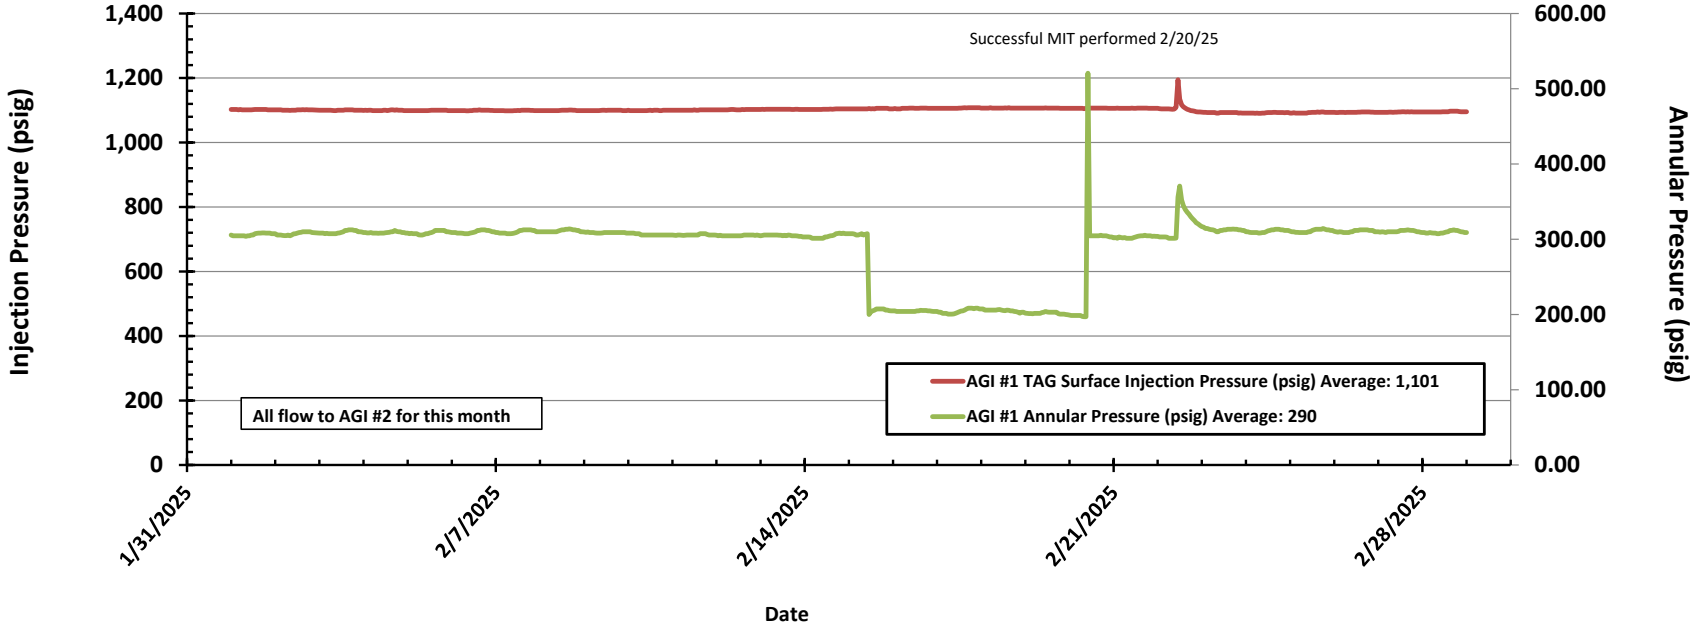
Figure #2: Linam AGI #1 Surface TAG Injection Pressure and Annular Pressure

All flow this month was directed to AGI #2. Injection parameters being monitored for AGI #1 (currently static) were as follows (Figures 1, 2, 3, 4): Average Injection Rate: 0 scf/hr, Average TAG Injection Pressure: 1,101 psig, Average TAG Temperature: 60°F, Average Annulus Pressure: 290 psig, Average Pressure Differential: 810 psig. Bottom hole (BH) sensors provided the average BH pressure for the entire period of 4,057 psig and BH temperature of 138 °F (Figures 8 and 9). The BH pressure quickly responded to the switchover to AGI #2. This is a very good indication of the continued resilience of the injection zone and the excess capacity available for TAG at current injection rates. AGI #1 performed a successful MIT on 2/20/2025, exhibiting no mechanical integrity issues.

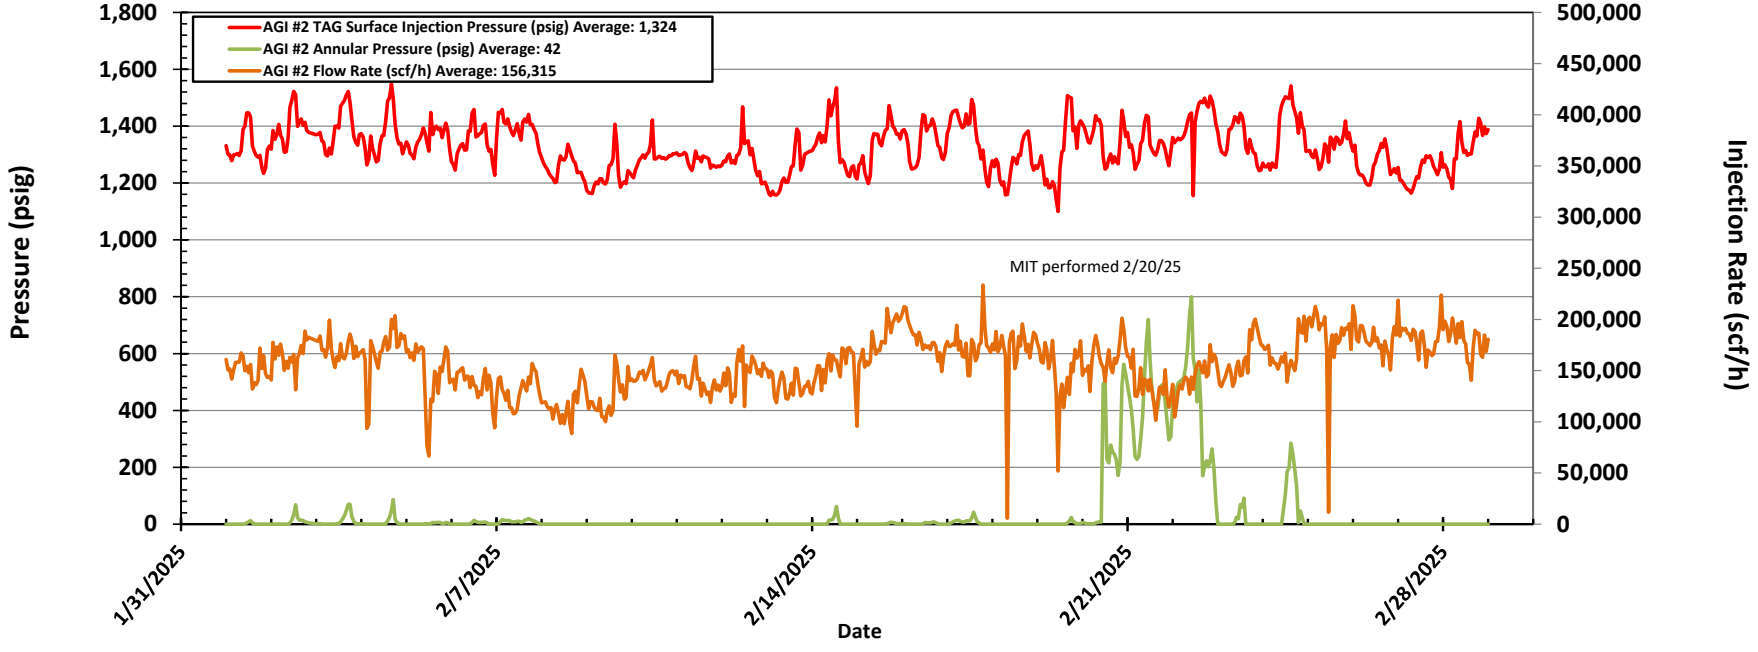
Figure #5: Linam AGI #2 Injection Pressure, Rate and Casing Annulus Pressure

The recorded injection parameters for AGI #2 for the month were: Average Injection Rate 156,315 scf/hr (AGI #2 was the only well used this month), Average Injection Pressure: 1,324 psig, Average TAG Temperature: 98°F, Average Annulus Pressure: 42 psig (minor leak detected in surface flange), average Pressure Differential: 1,283 psig (Figures 5, 6, 7). The AGI #2 well was unable to perform a satisfactory MIT on 2/20/2025. Annular pressure decreases over 10% were observed after three attempts, and it was determined that there is a possible leak on the main annular space valve, where the wellhead showed signs of possible leakage. Based on these findings, it was determined all flow should be directed to AGI #1 beginning March 1, while the wellhead valves are inspected and repaired as needed on AGI #2. Another MIT will be scheduled for AGI #2 in the near future to ensure the well can continue to permanently sequester TAG.

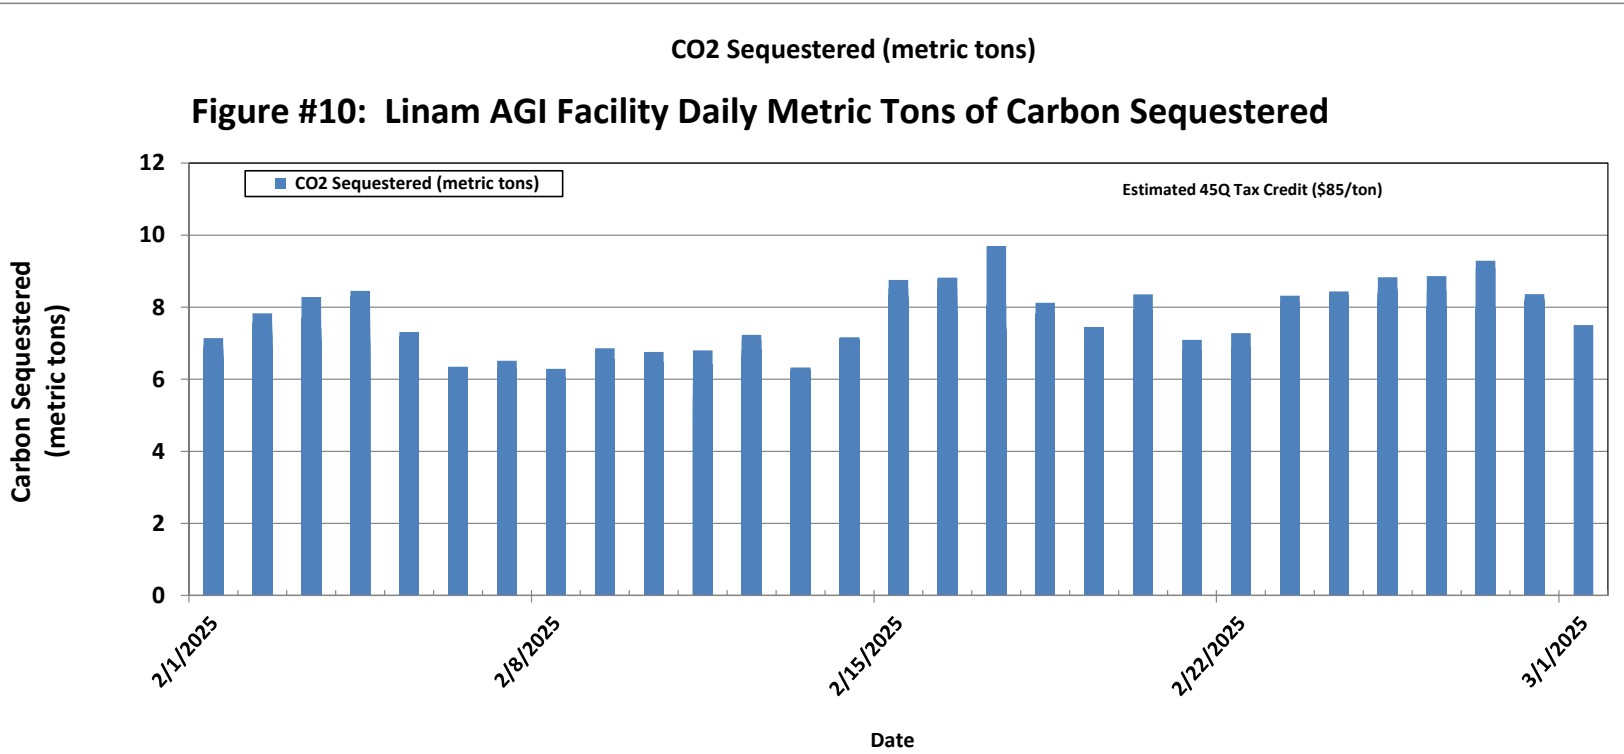
The Linam AGI #1 and AGI #2 wells are serving as a safe, effective, and environmentally friendly system to dispose of, and permanently sequester, Class II wastes consisting of H_2S and CO_2. The Linam AGI Facility permanently sequestered 4,346 Metric Tons of CO_2 for this month (Figure 10). The two wells provide the required redundancy to the plant that allows for operation with disposal to either or both wells. I hereby certify that the information above is true and complete to the best of my knowledge and belief.

CO2 Sequestered (metric tons)
Figure #10: Linam AGI Facility Daily Metric Tons of Carbon Sequestered
CO2 Sequestered (metric tons)
Estimated 45Q Tax Credit ($85/ton)
Carbon Sequestered (metric tons)
12
10
8
6
4
2
0
2/1/2025
2/8/2025
2/15/2025
2/22/2025
3/1/2025
Date
