STAGE 2 WORKPLANS

Pride Energy
State South Four Lakes #14
Stage 2 Abatement Plan

R.T. Hicks Consultants, Ltd.

RE: Pride Energy South Four Lakes #14
NMOCD #AP-077

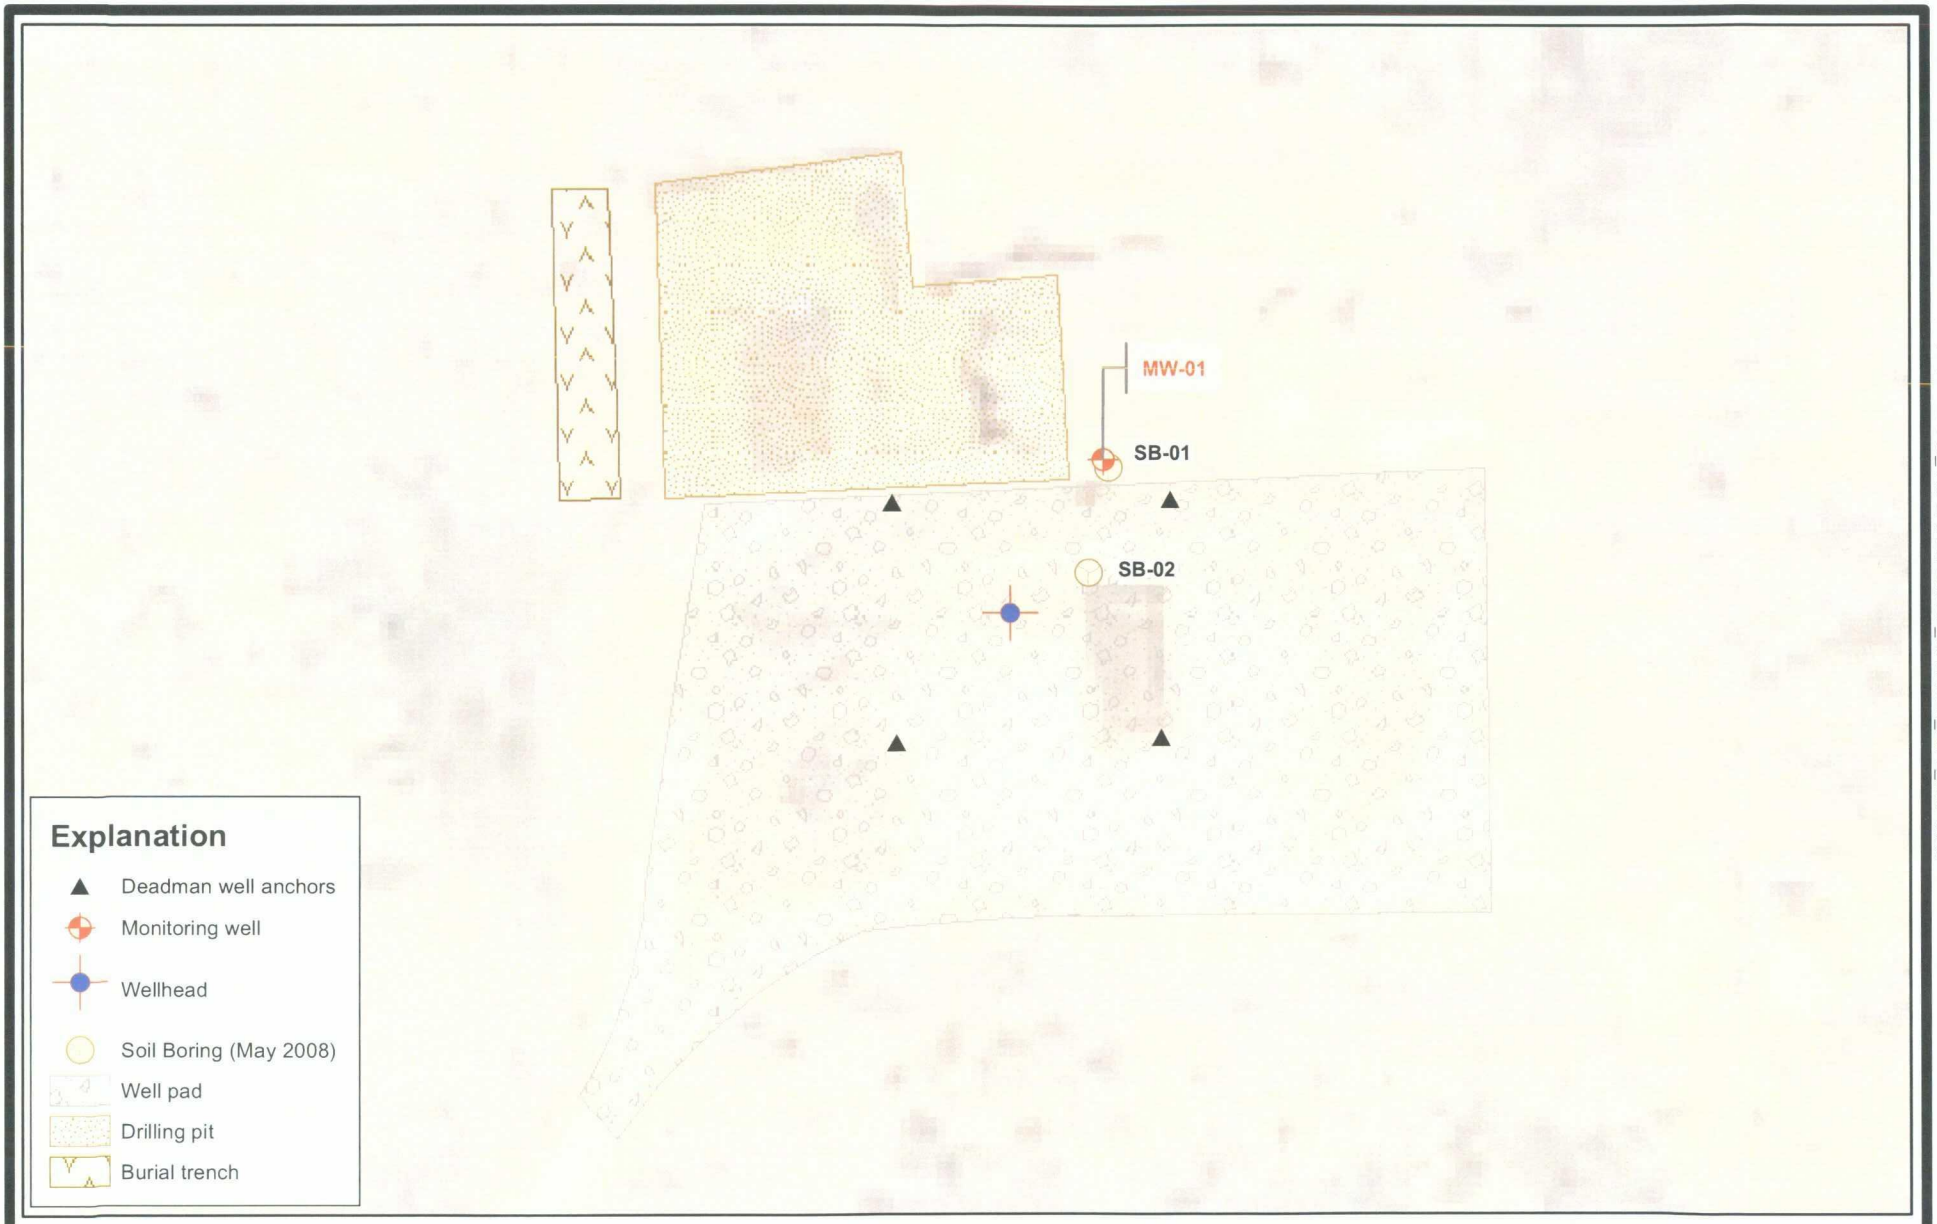
R.T. Hicks Consultants, Ltd 901 Rio Grande Blvd NW Suite F-142 Albuquerque, NM 87104 Ph: 505.266.5004	Site Map	Plate 1
	Pride Energy: South Four Lakes #14	September 2008

On May 13, 2008, Hicks Consultants mobilized to the site to perform soil boring activities. Hicks Consultants selected Atkins Engineering (Atkins), from Roswell, NM, as the drilling contractor. Using a Foremost Mobile 58 drilling rig and a 7 ¼- inch O.D. hollow stem auger, we installed two soil borings at the site (see Plate 1).

After examination of historic air photos and a close examination of the site, we modified the location of the soil borings shown in Plate 6 of the Stage 1 Abatement Plan. The first boring was drilled adjacent to MW-1 (see Plate 1), and is basically the same location as the proposed boring SB-1 shown on Plate 6 of the Stage 1 Abatement Plan. We drilled the second boring midway between the

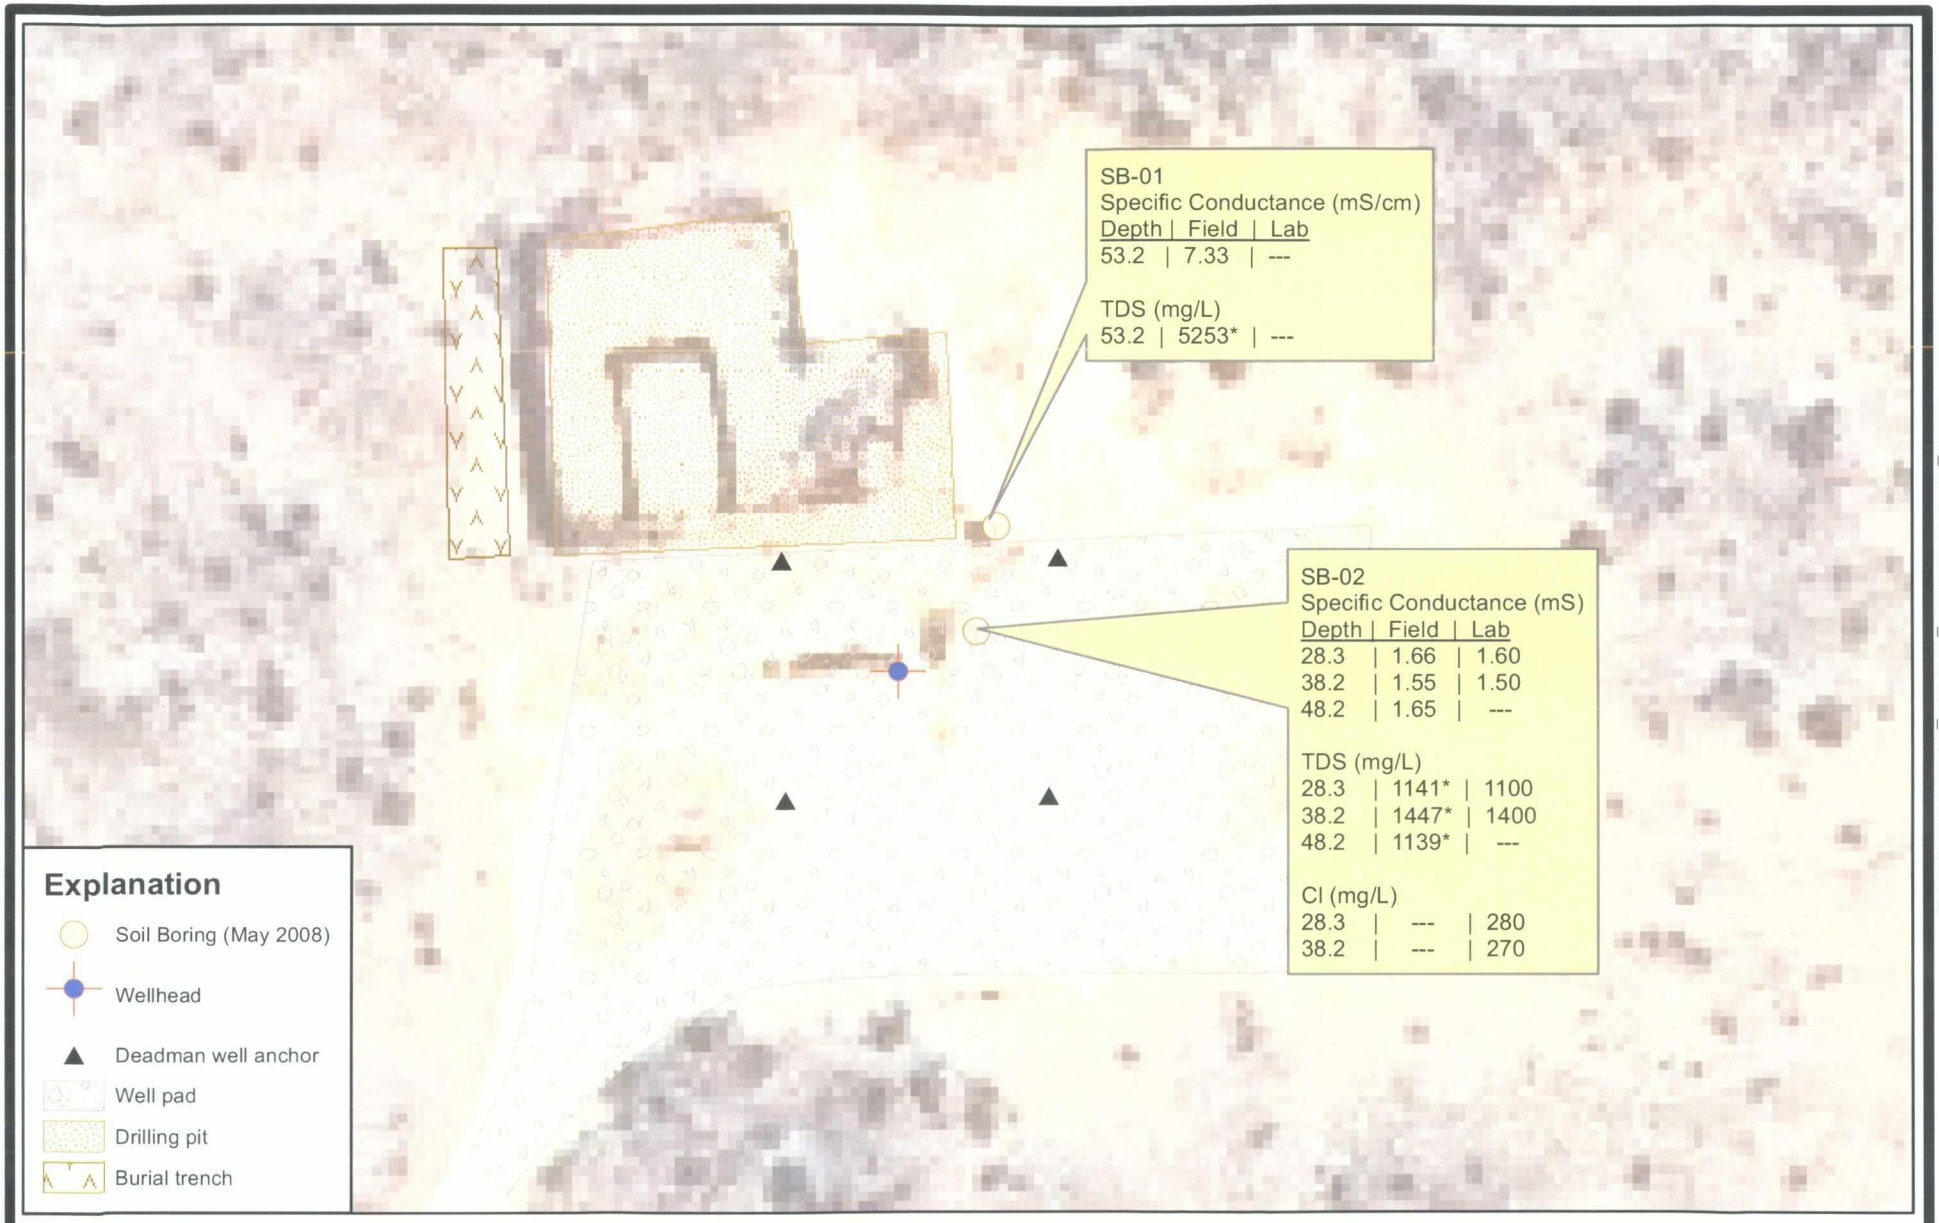
Data collected to date indicates a highly localized area of impaired ground water beneath the site. Data from the Elke Environmental report shows that chloride above 1,000 mg/kg exists in the vadose zone below the former drilling pit (1961 and 2004). The source of the chloride in the vadose zone at the Elke Environmental boring TP-5 is probably leakage from the Pride drilling pit. The other borings conducted by Elke Environmental are 10 times lower in chloride concentration and have relatively low moisture content; the source of this chloride is probably the Humble drilling pit (1961). The source of the chloride detected in SB-2 is probably leakage from the Humble drilling pit. Because MW-1 is located within the footprint of the 1962 drilling pit, the source of chloride in ground water at this location is probably the Humble pit.

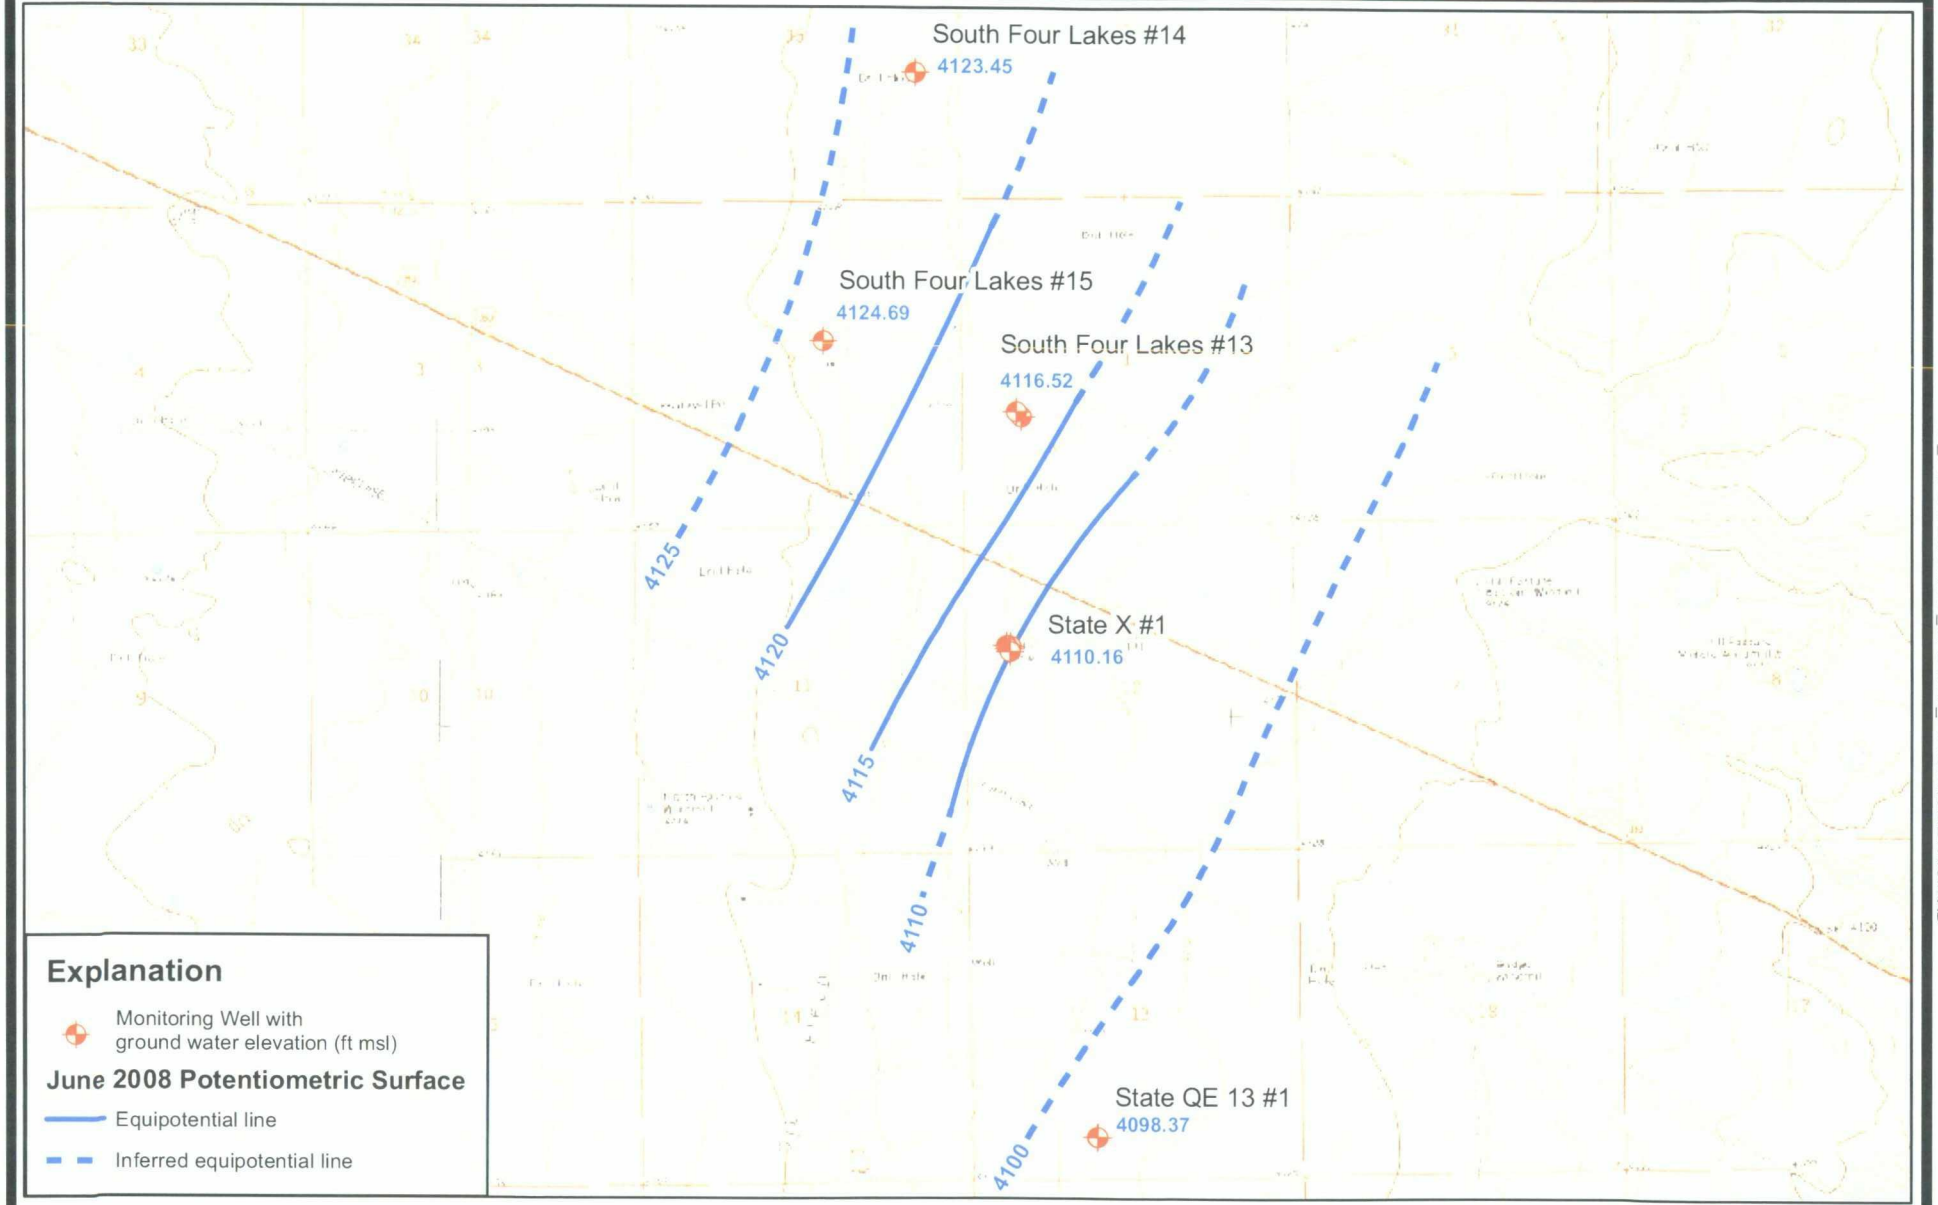
Potentiometric Surface (June 2008)	Plate 6
Pride Energy: South Four Lakes #14	September 2008

Although MW-01 is the only monitoring well at the site, data from nearby monitoring wells and data from USGS allow a reasonable assessment of the water table elevation in the area. Plate 6 shows ground water gauging data collected at four nearby Pride Energy sites and a water table elevation map. Ground water flows east-southeast at a gradient of approximately 0.002. Depth to water at the site is approximately 25-feet bgs. Plate 6 agrees with regional data[1] from USGS gauging stations for 1996.

Regional ground water data suggest a southeast ground water flow direction in much of the South Four Lakes area. Data from the gauging of the newly-installed monitor wells at the various sites in the area now suggest an east-southeast direction of ground water flow at the South Four Lakes #14 site (Plate 6).

The lithologic data presented in Plates 4 and 5 show that the upper portion of the aquifer above the quartzite is composed of fine sand. The hydraulic conductivity of fine sand could be as low as 0.1 ft/day or as high as 10 ft/day. Plate 6 shows that the hydraulic gradient in the area of the site is 0.0015. Assuming a porosity of 25% for fine sand, a hydraulic conductivity of 1 ft/day, and use of Darcy's equation, the average linear velocity of ground water at the site is 2 feet/year. In the absence of site-specific hydraulic testing, this calculation must be considered an estimate.

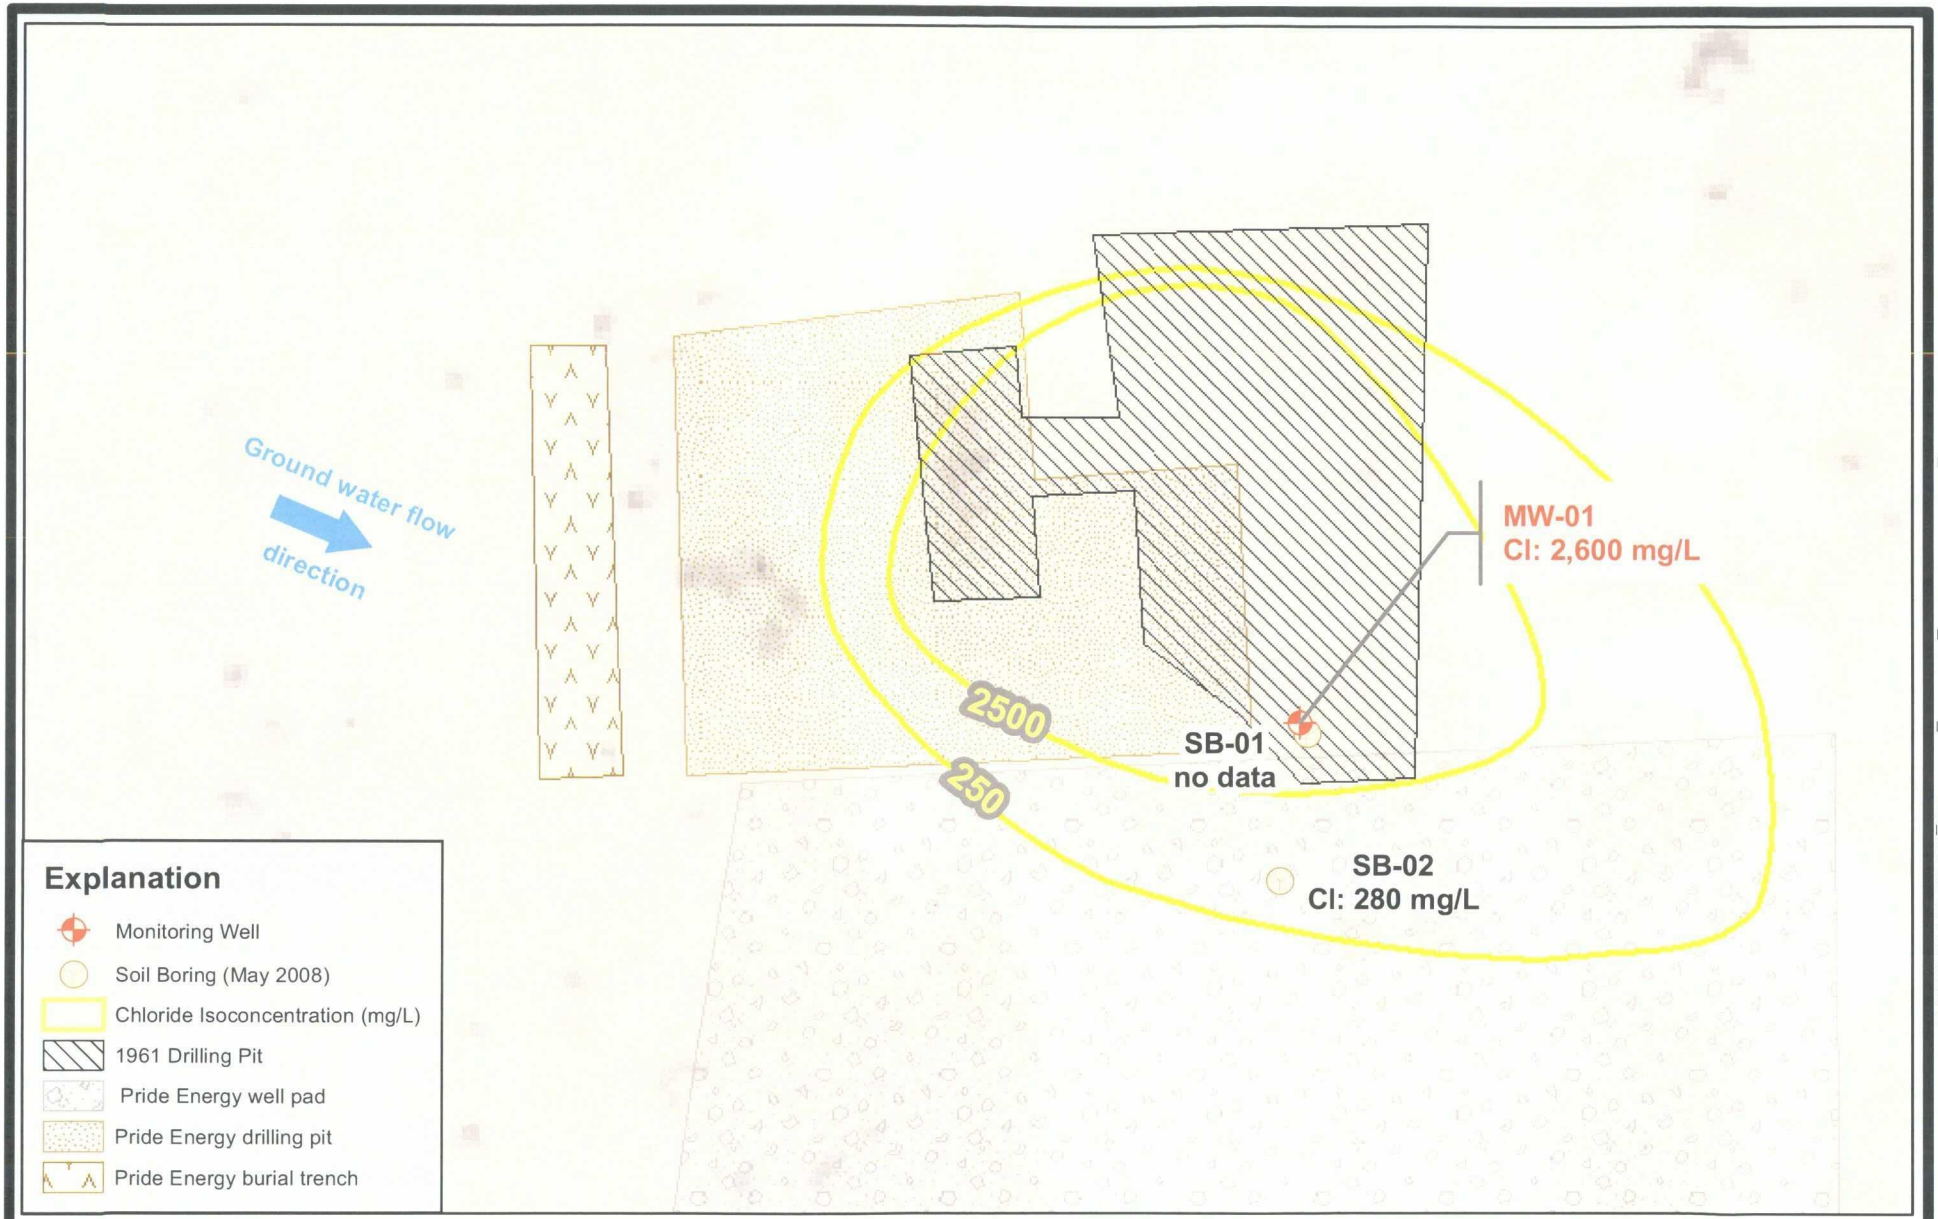
Potential Extent of Chloride Impacted Ground Water

Plate 7 shows our estimate of the extent of chloride impact from the release(s) from the drilling pit area. The distance from the edge of the 1962 reserve pit to the down gradient 250 mg/L chloride isoconcentration line is about 95 feet. We believe that the maximum extent of chloride impact (where chloride concentration exceeds background) could be 200 feet down gradient from the edge of the 1962 pit. The distance from the edge of the 2004-05 Pride Energy drilling pit to the down gradient of chloride impact is about 245 feet.

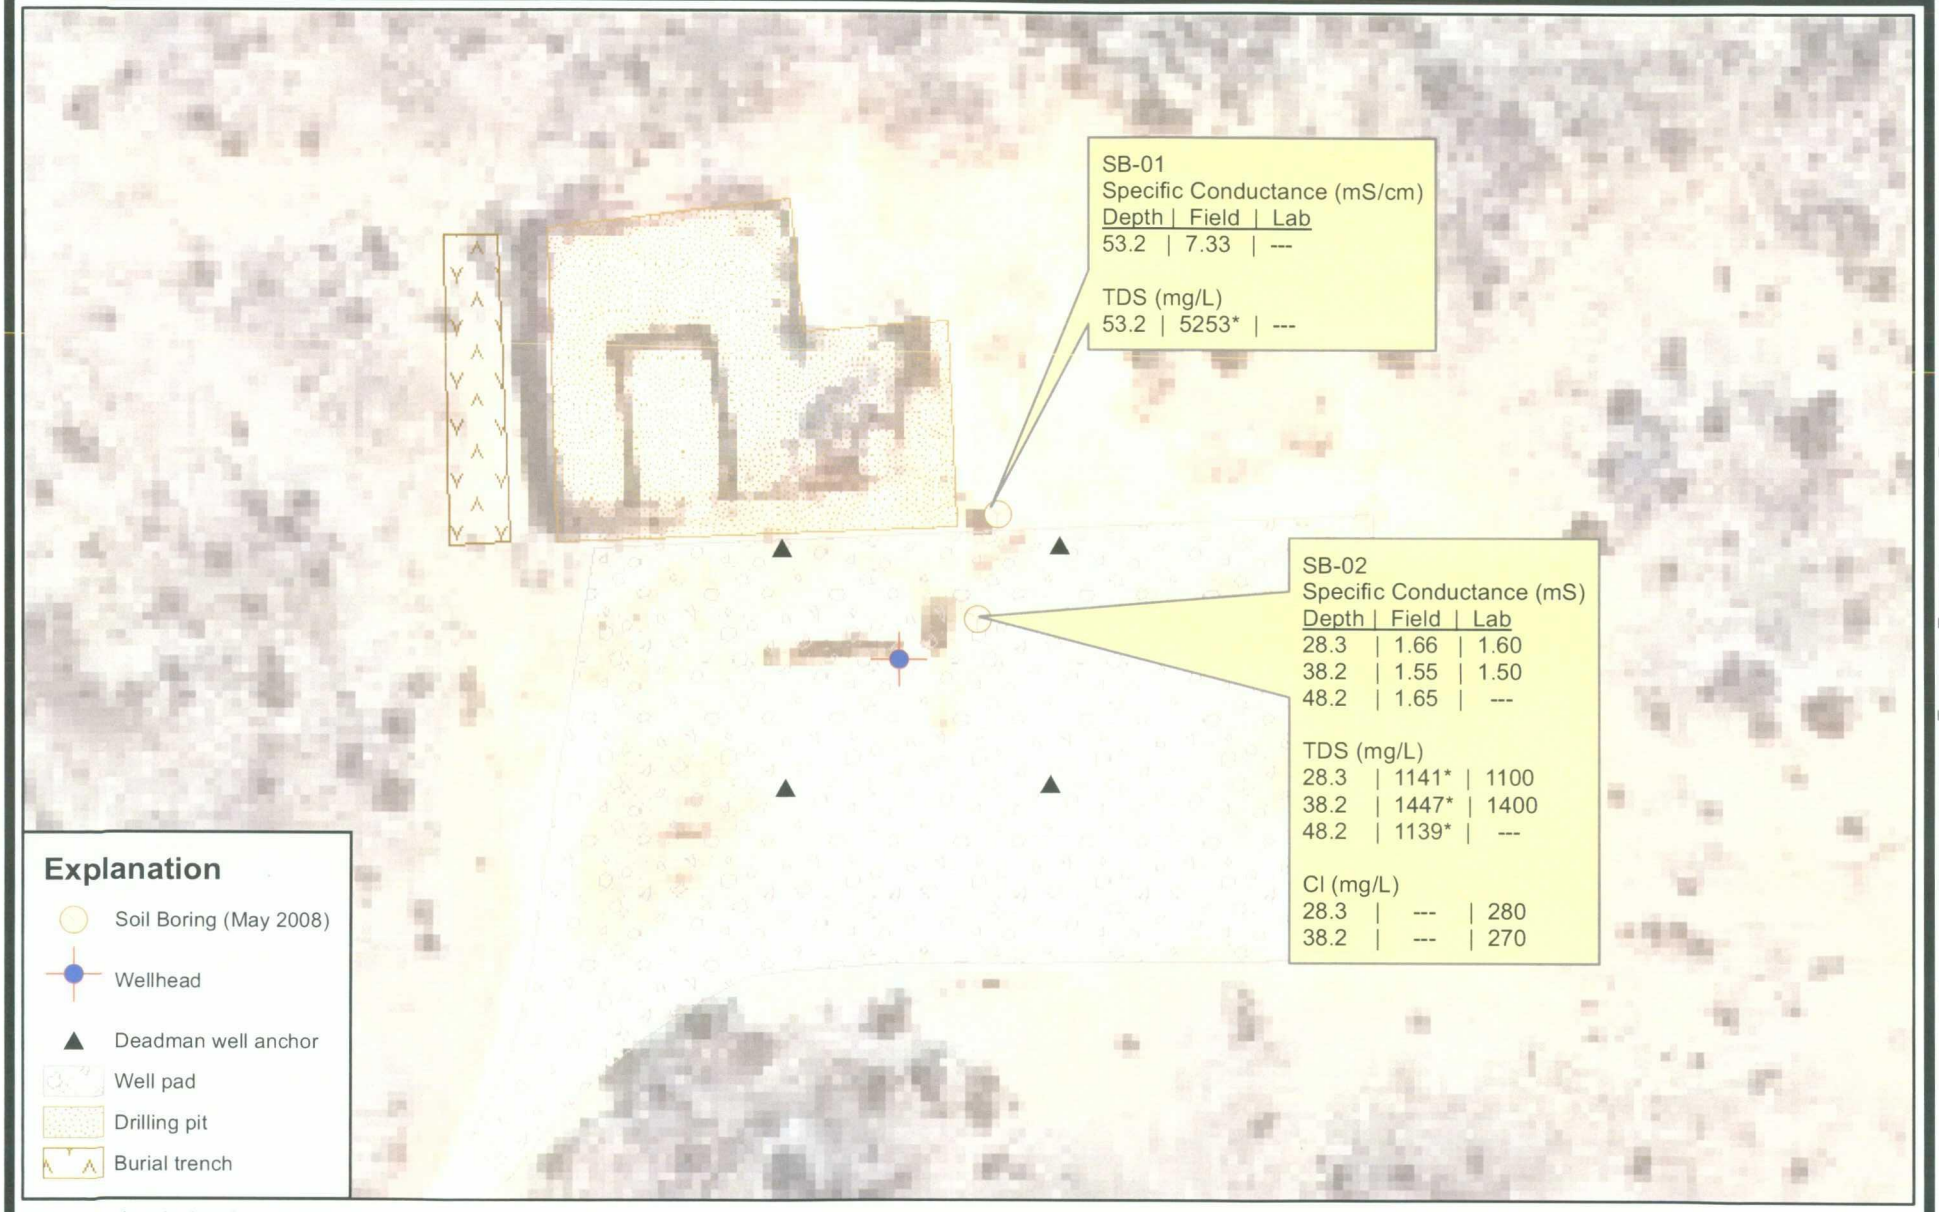
R.T. Hicks Consultants, Ltd 901 Rio Grande Blvd NW Suite F-142 Albuquerque, NM 87104 Ph: 505.266.5004	Chemistry of Ground Water During Soil Boring Activities (May 2008) Pride Energy: South Four Lakes #14	Plate 5 September 2008

SB-01 shows the highest SC measurement; 7.33 mS/cm at 53.2 feet bgs. SC measurements at SB-02 remained relatively consistent with increasing depth ranging from 1.55 to 1.65 mS/cm (see Plate 5 and Table 2).

Plate 5 shows the soil boring data spatially. Included on Plate 5 is laboratory and field data. Field TDS values were calculated from field SC measurements by correlating the ratio between lab measured conductivity and lab analyzed TDS concentrations (a 0.72 factor, see Table3). Maximum
