R. T. HICKS CONSULTANTS, LTD.

September 10, 2009

RE: Seven Produced Fluid Releases at sites operated by Marks and Garner Production Ltd, Company in Eddy County, NM as follows:

Site Name (type)	Location (T-R-Sec.-Unit)	OCD Reference No.
Levers Fed. No. 7 (battery)	T-16-S, R-29-E, Sec 33 (J)	2RP-304
Levers No. 3Y (well)	T-16-S, R-29-E, Sec 33 (N)	2RP-305
Red 12 Fed. No. 1 (battery)	T-16-S, R-29-E, Sec 33 (O)	2RP-306
Cave State No. 4 (well)	T-17-S, R-29-E, Sec 4 (F)	2RP-307
Red 12 State No. 2 (battery)	T-17-S, R-29-E, Sec 4 (H)	2RP-308
Red 12 State No. 3 (battery)	T-17-S, R-29-E, Sec 5 (J)	2RP-309
Red 12 State No. 4 (battery)	T-17-S, R-29-E, Sec 5 (O)	2RP-310

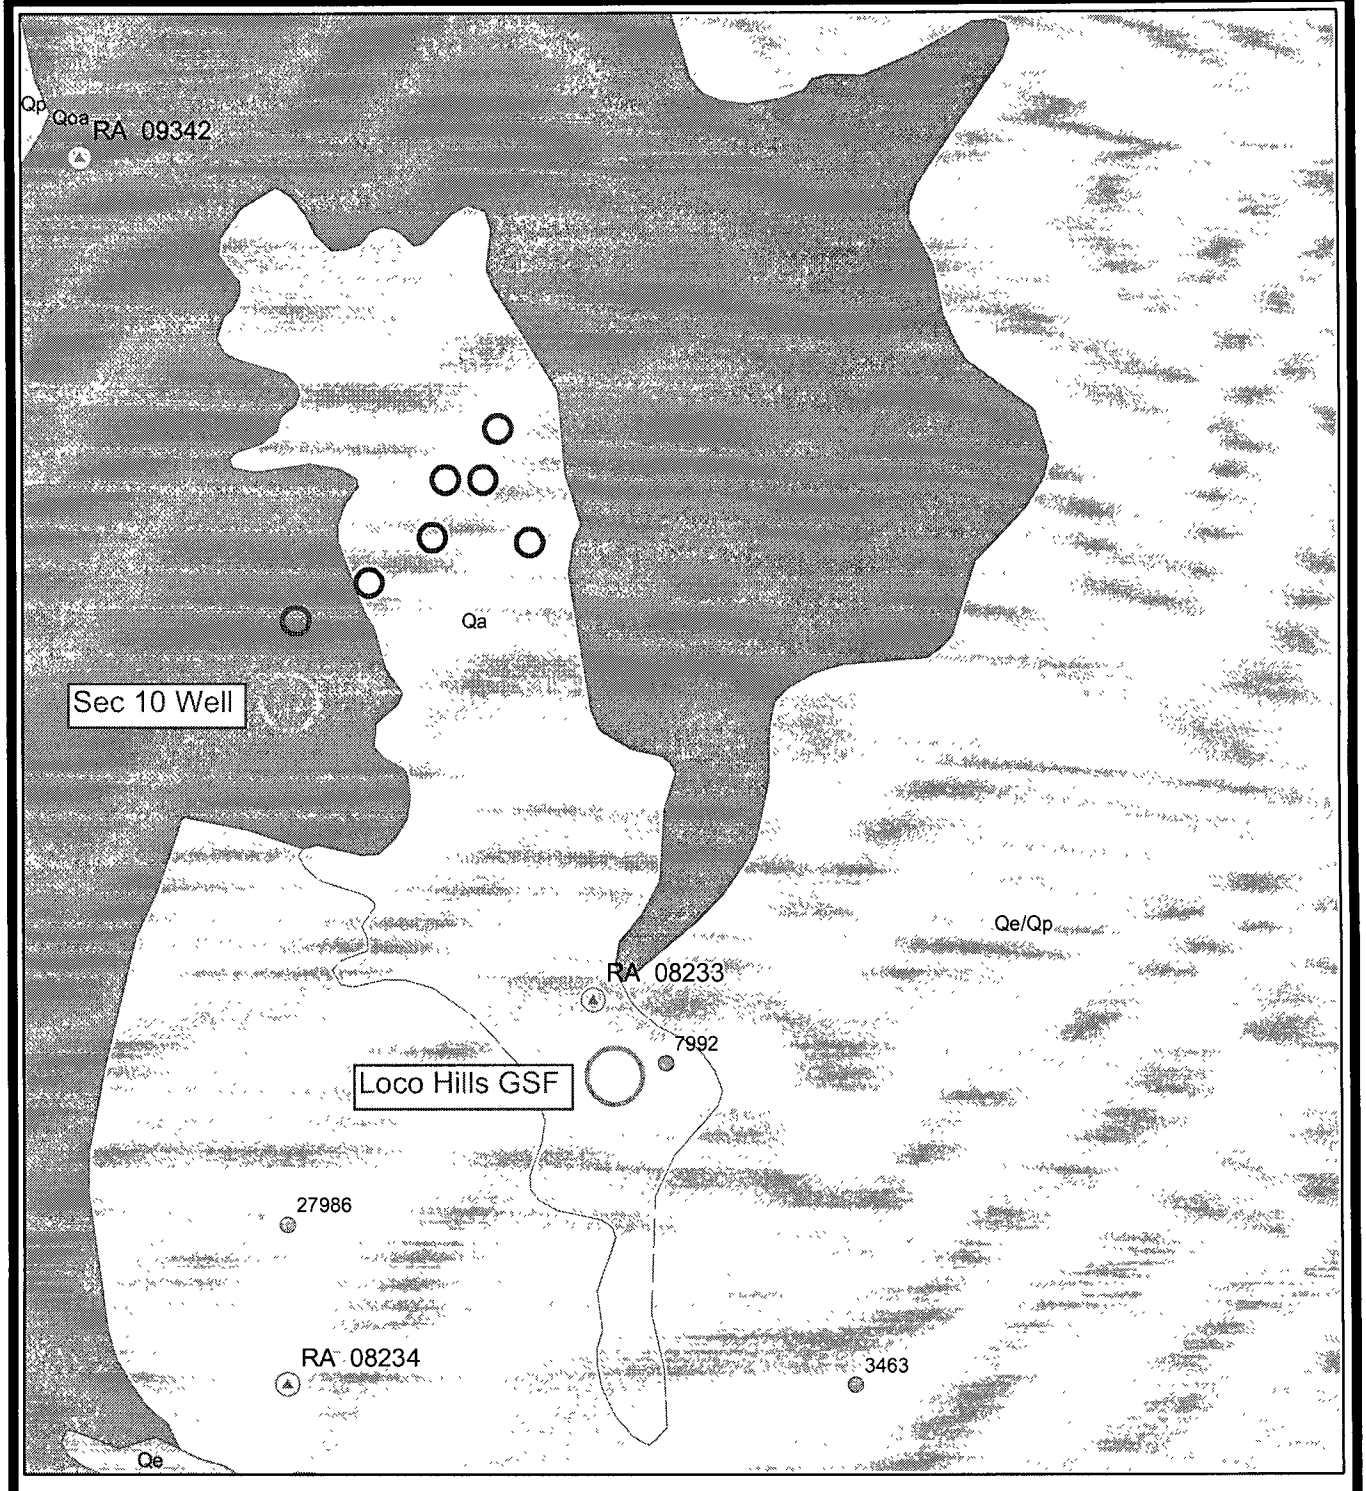
R.T. Hicks Consultants, Ltd 901 Rio Grande Blvd NW Suite F-142 Albuquerque, NM 87104 Ph: 505.266.5004	Geologic Map Showing Nearby Wells	Plate 1b
	Marks and Garner	Sept 2009

Depth to Ground Water and Ground Water Quality
Plate 1b shows the location of the Marks & Garner sites (red circles) that are the subject of investigations in support of gaining compliance with Part 29 of the NMOCD Rules. Also shown on Plate 1b are:

The geologic map shows that Quaternary Alluvium fills the valley of Bear Grass Draw. Quaternary eolian and pediment deposits dominate the southern portion of the area shown in Plate 1b and Quaternary Older Alluvium comprises the majority of the northern portion.

Plate 1b shows two other wells from the PTTC database south of the Loco Hills Gas Storage Facility. According to the PTTC database, both of these wells are screened below the alluvial cover in the Triassic Dockham group or the Rustler. These two aquifers are confined in this area.

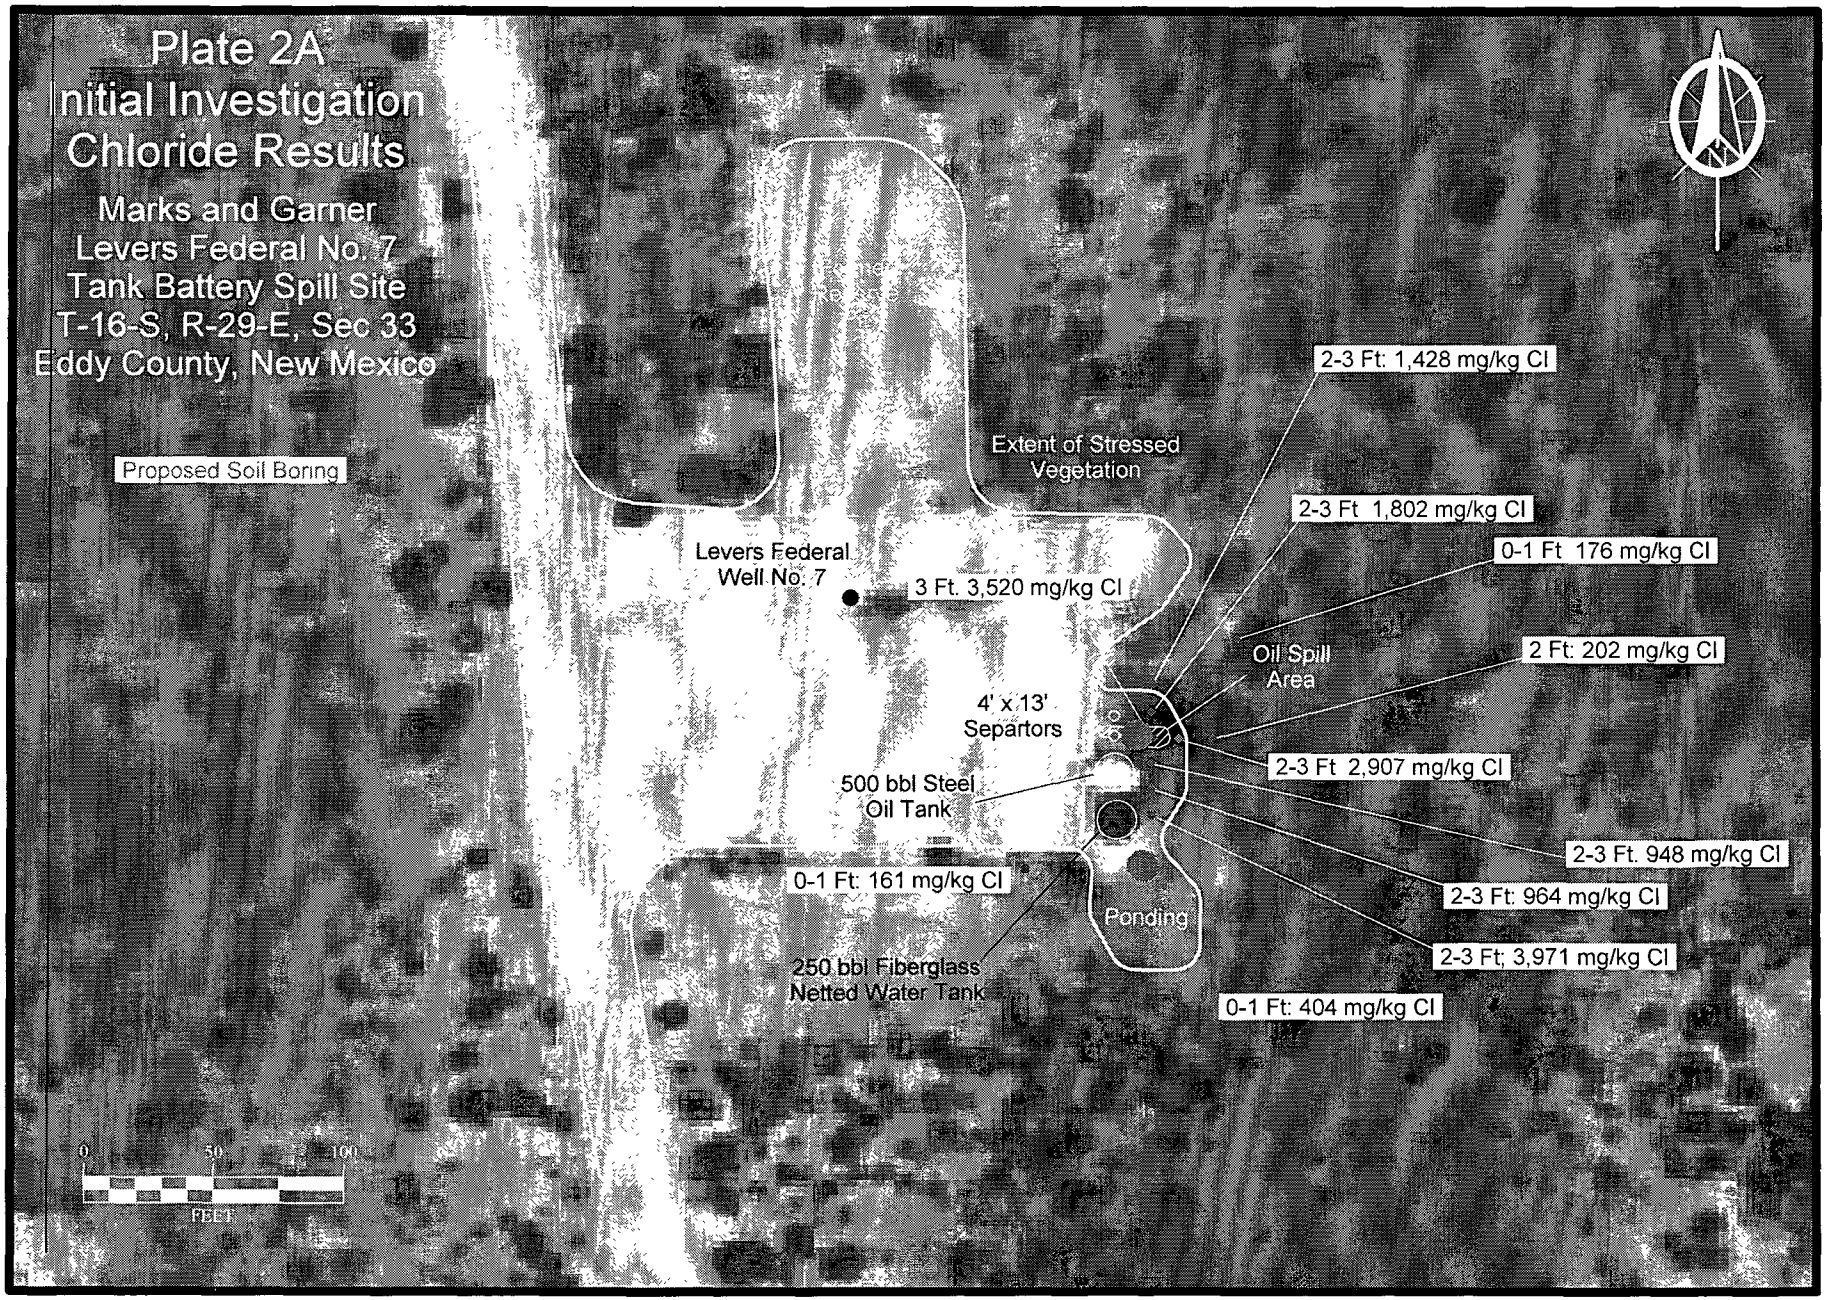
Sample Location	Depth (feet)	Sample Date	Field Cl (mg/kg)	Lab Cl (mg/kg)	PID (ppm)	Benzene (mg/kg)	Toluene (mg/kg)	Ethylbenzene (mg/kg)	Xylenes (mg/kg)	BTEX (mg/kg)	C_{6-12} (mg/kg)	C_{12-28} (mg/kg)	C_{28-35} (mg/kg)
Center Oil Spill	0 5	6/23/09	--	--	10	<0 0011	<0 0022	0 0015	<0 0011	<0 006	<16 4	461	61 6
	1 0	6/23/09	--	--	0	--	--	--	--	--	--	--	--
	3 0	6/23/09	--	3,520	0	<0 0011	<0 0022	<0 0011	<0 0011	<0 006	<16 7	20 9	<16 7
10-Ft North	2-3	8/27/09	**1,802**	--	0	--	--	--	--	--	--	--	--
20-Ft North	2-3	8/27/09	**1,428**	--	0	--	--	--	--	--	--	--	--
10-Ft South	2-3	8/27/09	**948**	--	0	--	--	--	--	--	--	--	--
20-Ft South	2-3	8/27/09	**964**	--	0	--	--	--	--	--	--	--	--
30-Ft South	2-3	8/27/09	**3,971**		0	--	--	--	--	--	--	--	--
10-Ft East	2-3	8/27/09	**2,907**	--	0	--	--	--	--	--	--	--	--
20-Ft East	2	8/27/09	202	--	0	--	--	--	--	--	--	--	--
50-Ft Northeast	0-1	8/28/09	176	--	0	--	--	--	--	--	--	--	--

70-Ft Southeast	0-1	8/28/09	161	--	0	--	--	--	--	--	--	--	--
100-Ft Southeast	0-1	8/28/09	**404**	--	0	--	--	--	--	--	--	--	--
NMOCD 1993 Guideline RRALs			250*	--		10	--	--	--	50		5,000

Plate 2A
nitial Investigation
Chloride Results
Marks and Garner
Levers Federal No. 7
Tank Battery Spill Site
T-16-S, R-29-E, Sec 33
Eddy County, New Mexico
Proposed Soil Boring
Extent of Stressed Vegetation
Levers Federal Well No. 7
3 Ft. 3,520 mg/kg Cl
2-3 Ft: 1,428 mg/kg Cl
2-3 Ft 1,802 mg/kg Cl
0-1 Ft 176 mg/kg Cl
Oil Spill Area
2 Ft: 202 mg/kg Cl
4' x 13' Separtors
2-3 Ft 2,907 mg/kg Cl
500 bbl Steel Oil Tank
2-3 Ft. 948 mg/kg Cl
0-1 Ft: 161 mg/kg Cl
2-3 Ft: 964 mg/kg Cl
Ponding
2-3 Ft; 3,971 mg/kg Cl
250 bbl Fiberglass Netted Water Tank
0-1 Ft: 404 mg/kg Cl
0
50
100
FEET

Hicks Consultants recommends that a hollow-stem auger be used to complete the vertical delineation of hydrocarbon- and chloride-impacted soil at each site according to the attached plates. We anticipate that a drilling rig will be available in mid to late October 2009 and a final report for each site, including recommendations for remedial actions, will be submitted to the NMOCD by the end of 2009. In the final report we will provide remediation action levels for soil and underlying sediment based upon criteria in NMOCD Rules, science-based evaluation of the sampling data and physical setting.

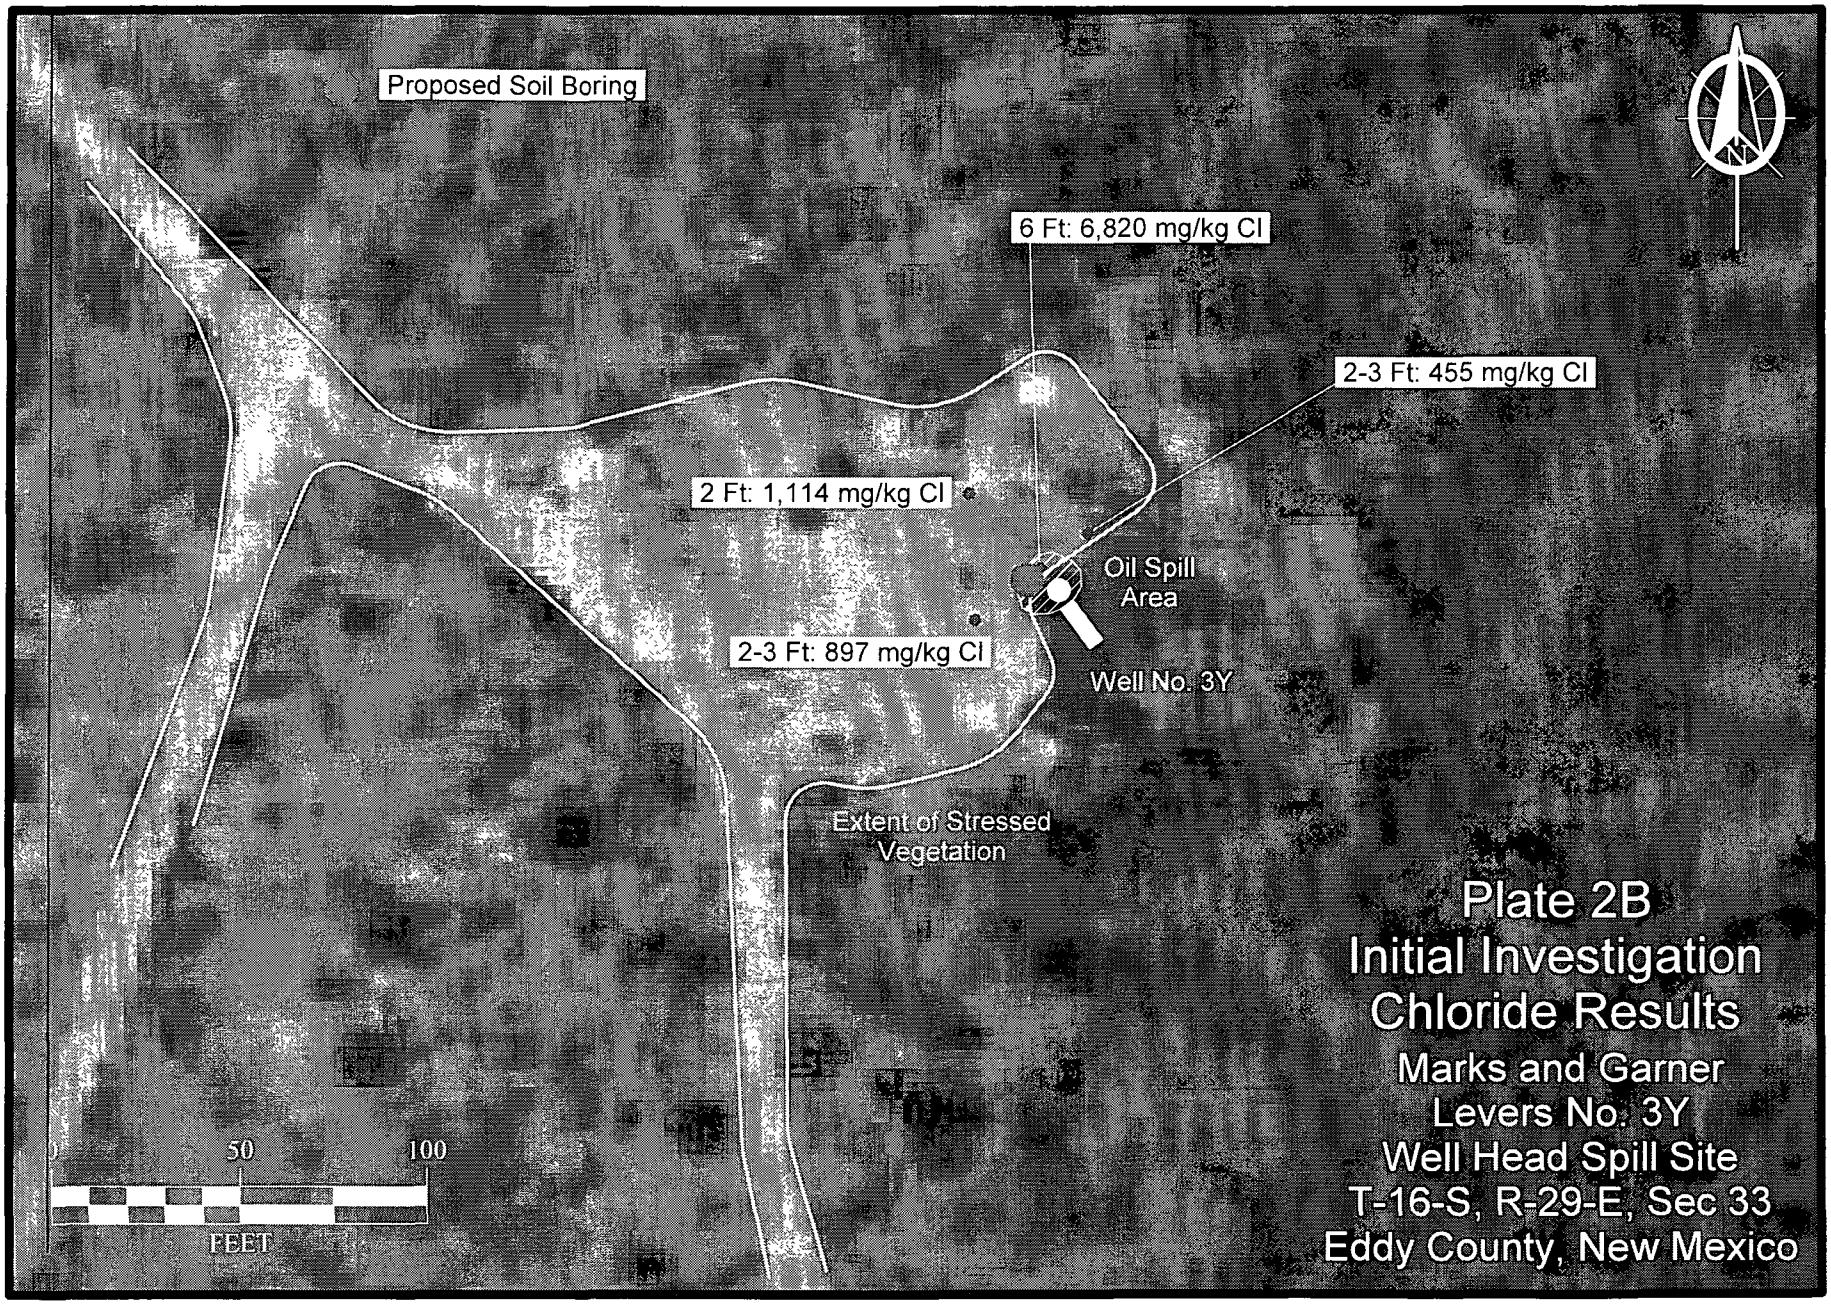
Proposed Soil Boring
6 Ft: 6,820 mg/kg Cl
2-3 Ft: 455 mg/kg Cl
2 Ft: 1,114 mg/kg Cl
Oil Spill Area
2-3 Ft: 897 mg/kg Cl
Well No. 3Y
Extent of Stressed Vegetation
0
50
100
FEET
Plate 2B
Initial Investigation
Chloride Results
Marks and Garner
Levers No. 3Y
Well Head Spill Site
T-16-S, R-29-E, Sec 33
Eddy County, New Mexico

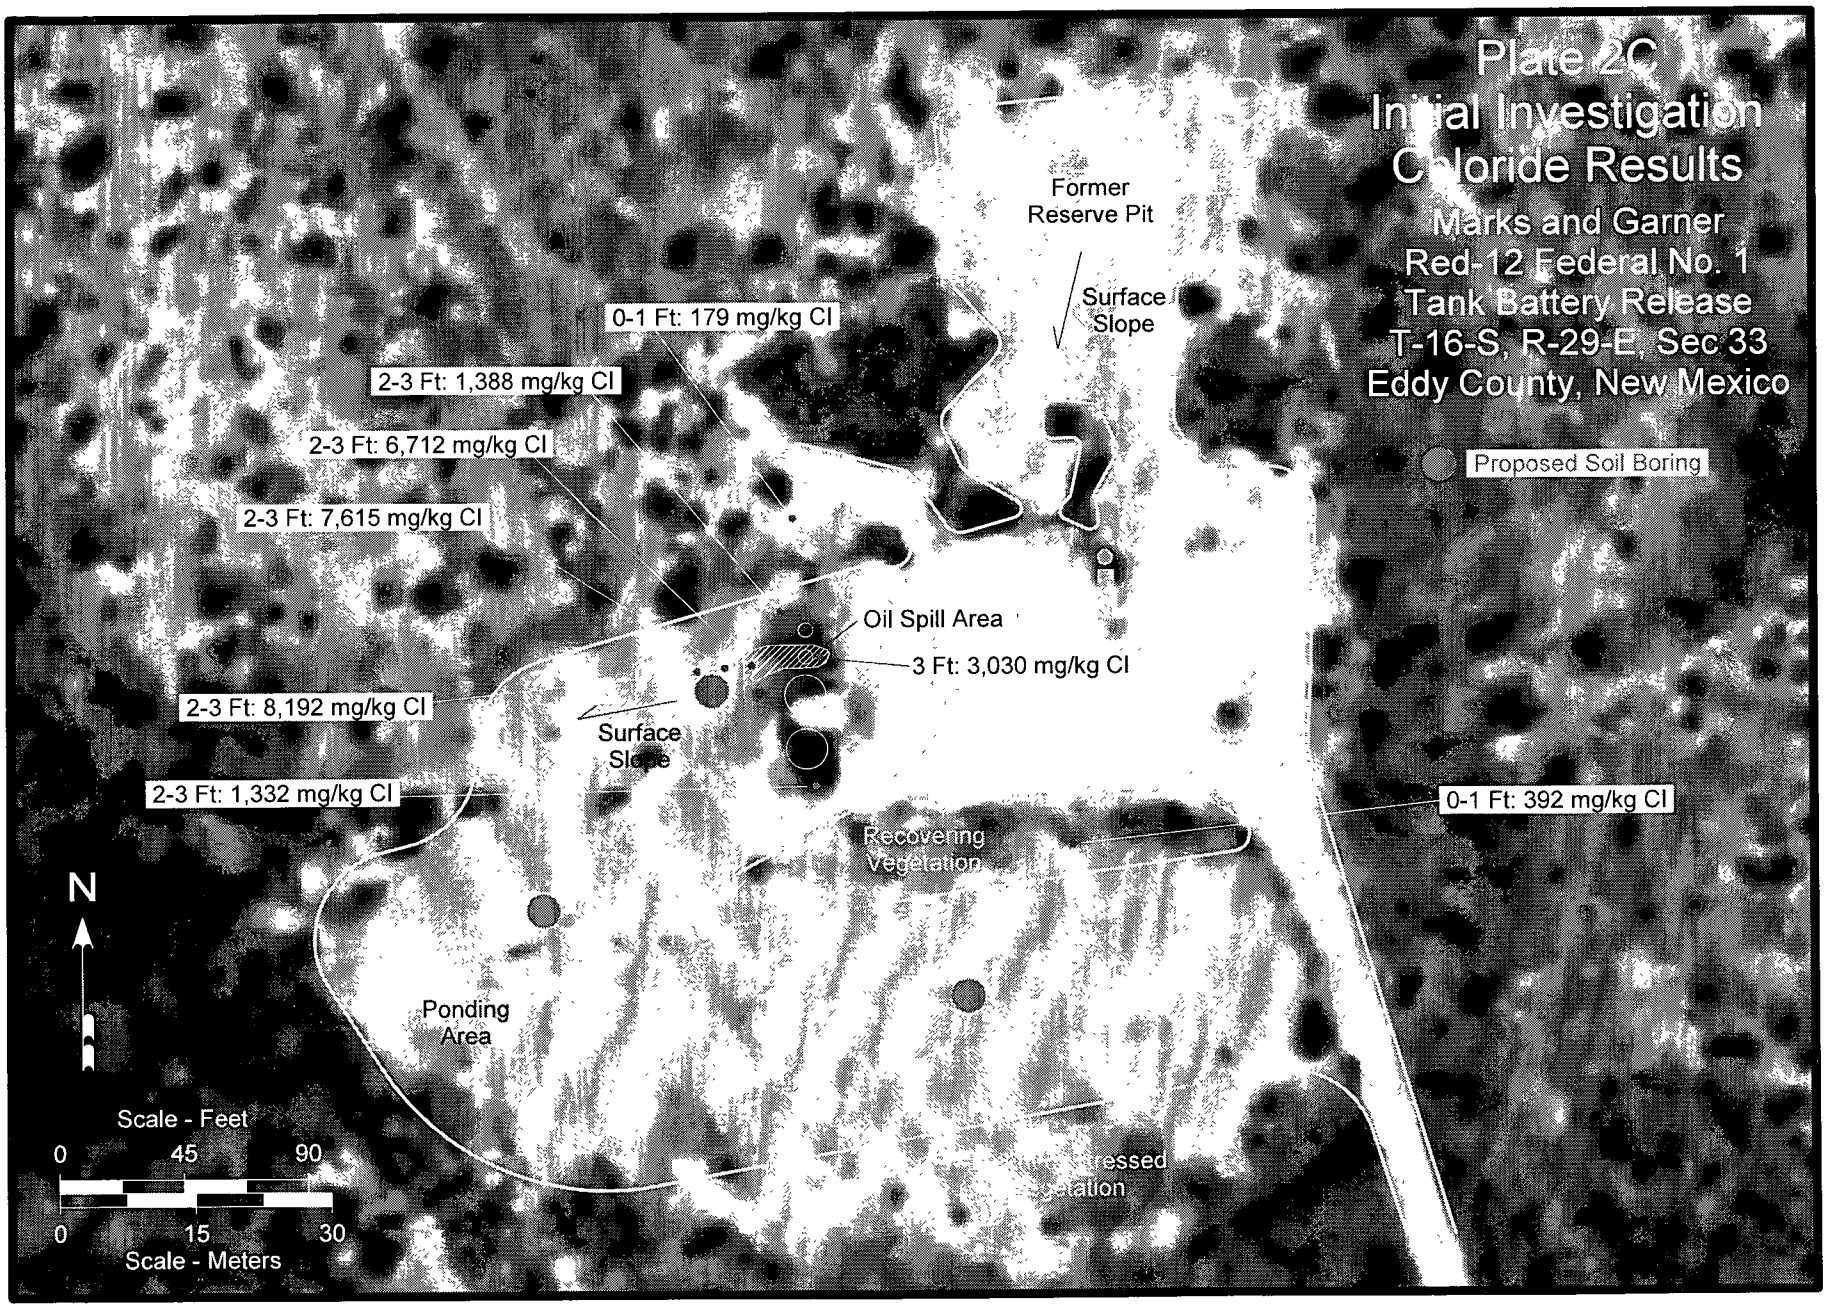
Plate 2C
Initial Investigation
Chloride Results
Marks and Garner
Red-12 Federal No. 1
Tank Battery Release
T-16-S, R-29-E, Sec 33
Eddy County, New Mexico
Former
Reserve Pit
Surface
Slope
Proposed Soil Boring
0-1 Ft: 179 mg/kg Cl
2-3 Ft: 1,388 mg/kg Cl
2-3 Ft: 6,712 mg/kg Cl
2-3 Ft: 7,615 mg/kg Cl
Oil Spill Area
3 Ft: 3,030 mg/kg Cl
2-3 Ft: 8,192 mg/kg Cl
Surface
Slope
2-3 Ft: 1,332 mg/kg Cl
0-1 Ft: 392 mg/kg Cl
Recovering
Vegetation
N
Ponding
Area
Scale - Feet
0
45
90
0
15
30
Scale - Meters

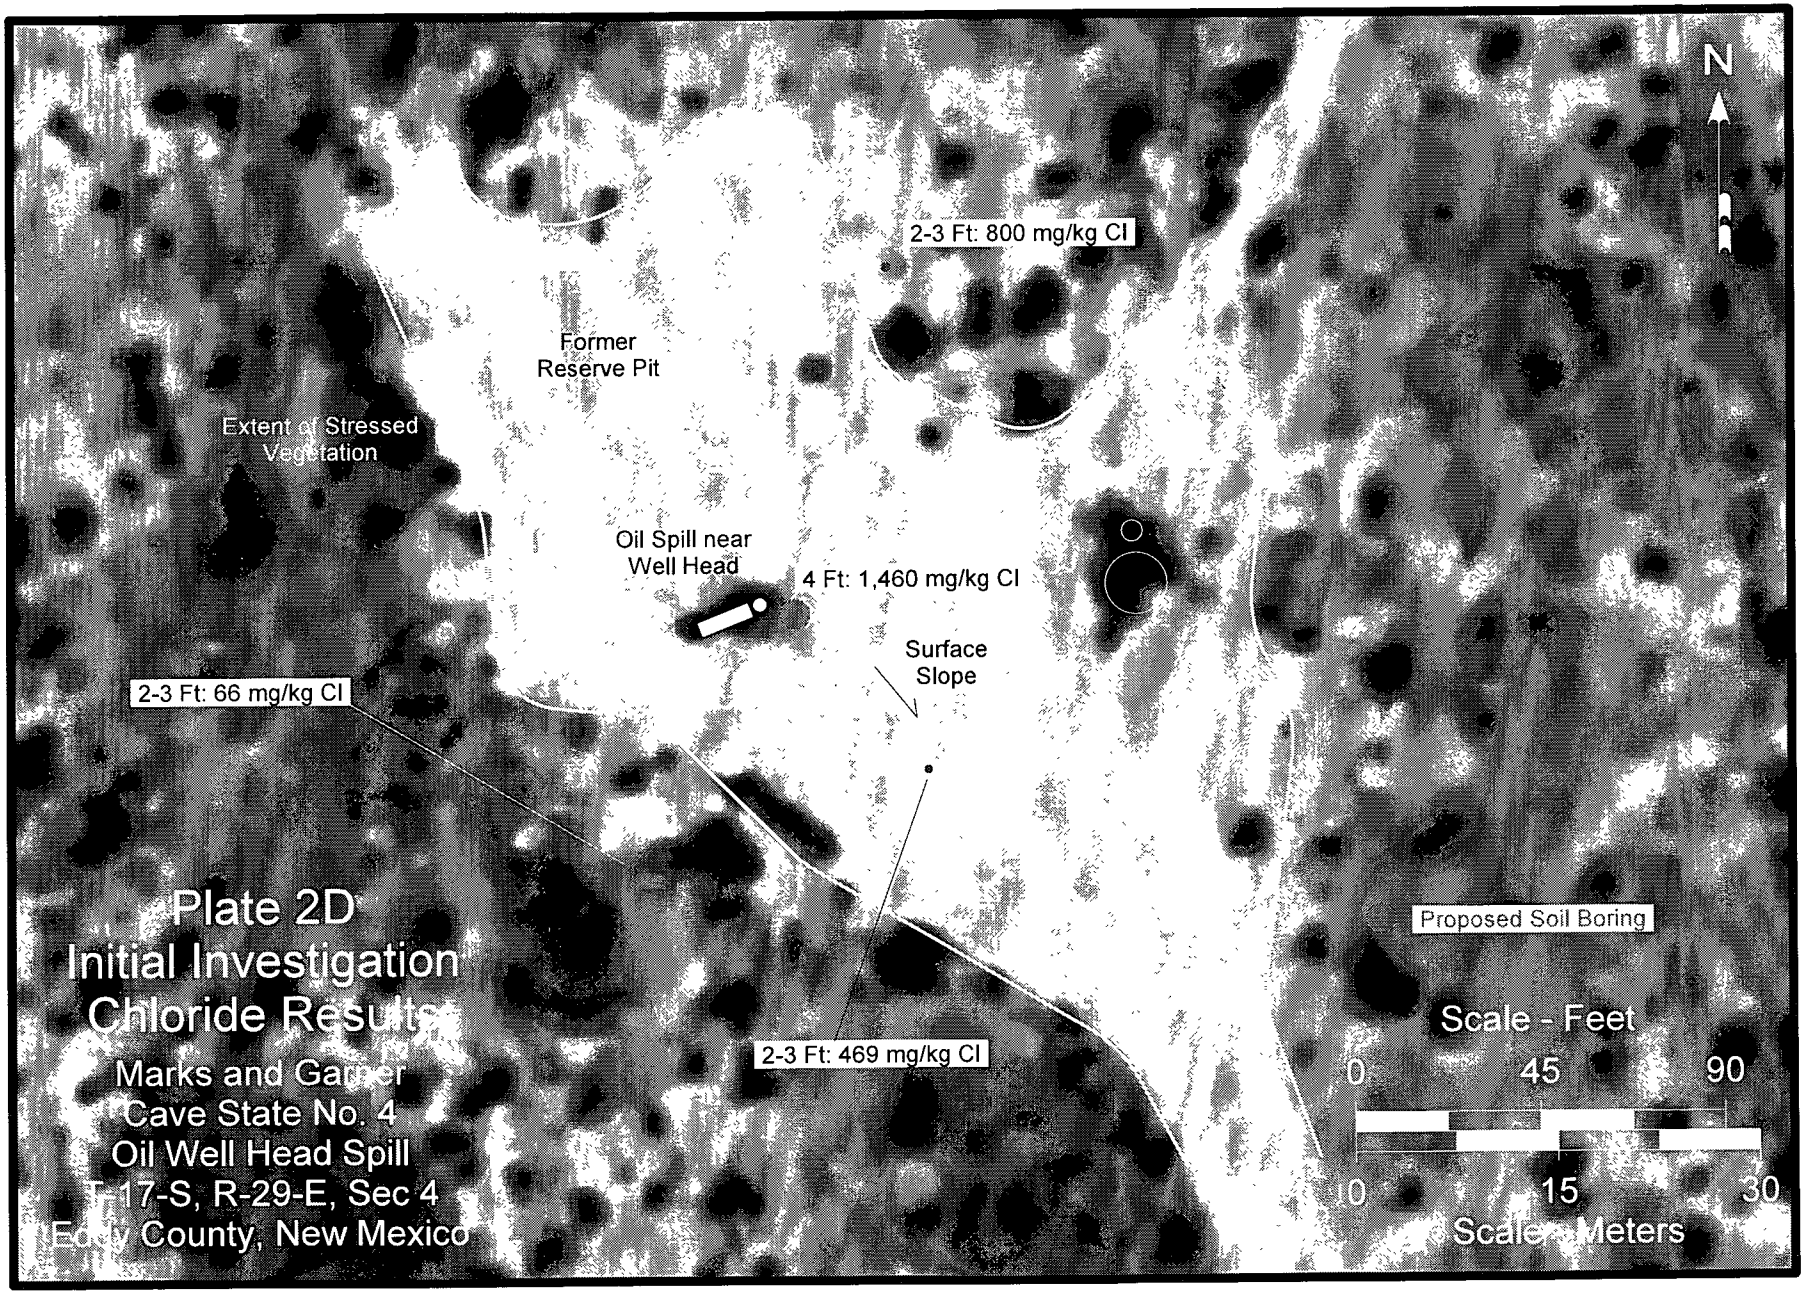
N
2-3 Ft: 800 mg/kg Cl
Former
Reserve Pit
Extent of Stressed
Vegetation
Oil Spill near
Well Head
4 Ft: 1,460 mg/kg Cl
Surface
Slope
2-3 Ft: 66 mg/kg Cl
Plate 2D
Initial Investigation
Chloride Results
Marks and Garner
Cave State No. 4
Oil Well Head Spill
T-17-S, R-29-E, Sec 4
Eddy County, New Mexico
2-3 Ft: 469 mg/kg Cl
Proposed Soil Boring
Scale - Feet
0
45
90
10
15
30
Scale - Meters

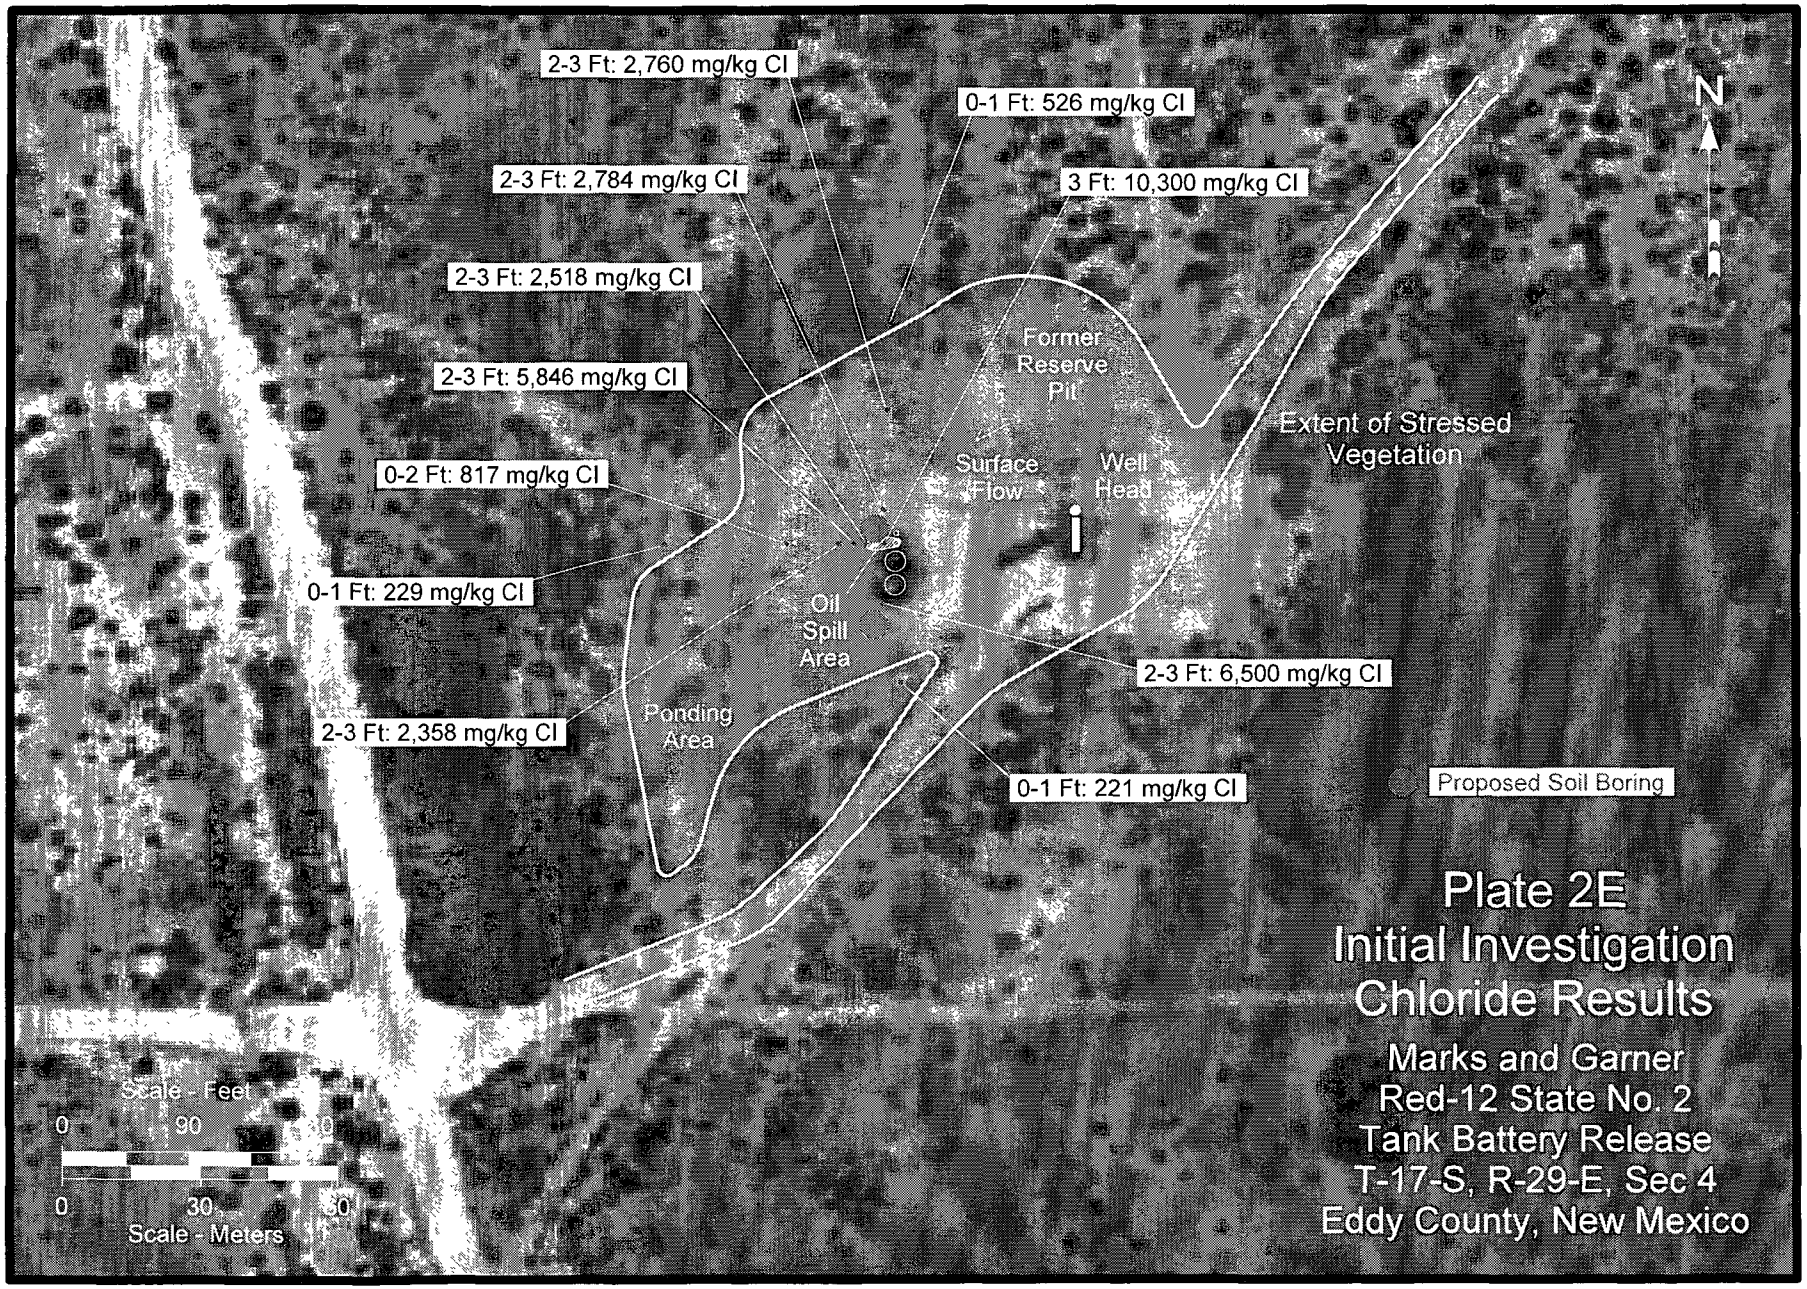
Sample Location	Depth (feet)	Sample Date	Field Cl (mg/kg)	Lab Cl (mg/kg)	PID (ppm)	Benzene (mg/kg)	Toluene (mg/kg)	Ethylbenzene (mg/kg)	Xylenes (mg/kg)	BTEX (mg/kg)	C_{6-12} (mg/kg)	C_{12-28} (mg/kg)	C_{28-35} (mg/kg)
Center Oil Spill	0 5	6/23/09	--	--	10	<0 0011	<0 0023	0 0099	0 0186	0 032	340	**20,500**	1,360
	1 0	6/23/09	--	--	6	--	--	--	--	--	--	--	--
	3 0	6/23/09	--	**10,300**	0	<0 0011	<0 0022	<0 0011	<0 0011	<0 006	<16 2	58 6	<16 2
10-Ft West	2-3	8/27/09	**2,518**	--	0	--	--	--	--	--	--	--	--
20-Ft West	2-3	8/27/09	**5,846**		0	--	--	--	--	--	--	--	--
30-FT West	2-3	8/27/09	**2,358**	--	0	--	--	--	--	--	--	--	--
20-Ft North	2-3	8/27/09	**2,784**	--	0	--	--	--	--	--	--	--	--
40-Ft South	2-3	8/27/09	**6,500**	--	0	--	--	--	--	--	--	--	--
100-Ft South	0-1	8/28/09	221	--	0	--	--	--	--	--	--	--	--
100-Ft North	2-3	8/28/09	**2,760**		0	--	--	--	--	--	--	--	--
160-Ft North	0-1	8/28/09	**526**	--	0	--	--	--	--	--	--	--	--

70-Ft West	0-2	8/28/09	**817**		0	--	--	--	--	--	--	--	--
160-Ft West	0-1	8/28/09	229	--	0	--	--	--	--	--	--	--	--
NMOCD 1993 Guideline RRALs			**250***		--	**10**	--	--	--	**50**		**5,000**

2-3 Ft: 2,760 mg/kg Cl
0-1 Ft: 526 mg/kg Cl
2-3 Ft: 2,784 mg/kg Cl
3 Ft: 10,300 mg/kg Cl
2-3 Ft: 2,518 mg/kg Cl
Former Reserve Pit
2-3 Ft: 5,846 mg/kg Cl
Extent of Stressed Vegetation
0-2 Ft: 817 mg/kg Cl
Surface Flow
Well Head
0-1 Ft: 229 mg/kg Cl
Oil Spill Area
2-3 Ft: 6,500 mg/kg Cl
Ponding Area
2-3 Ft: 2,358 mg/kg Cl
0-1 Ft: 221 mg/kg Cl
Proposed Soil Boring
N
Scale - Feet
0
90
0
0
30
30
Scale - Meters
Plate 2E
Initial Investigation
Chloride Results
Marks and Garner
Red-12 State No. 2
Tank Battery Release
T-17-S, R-29-E, Sec 4
Eddy County, New Mexico

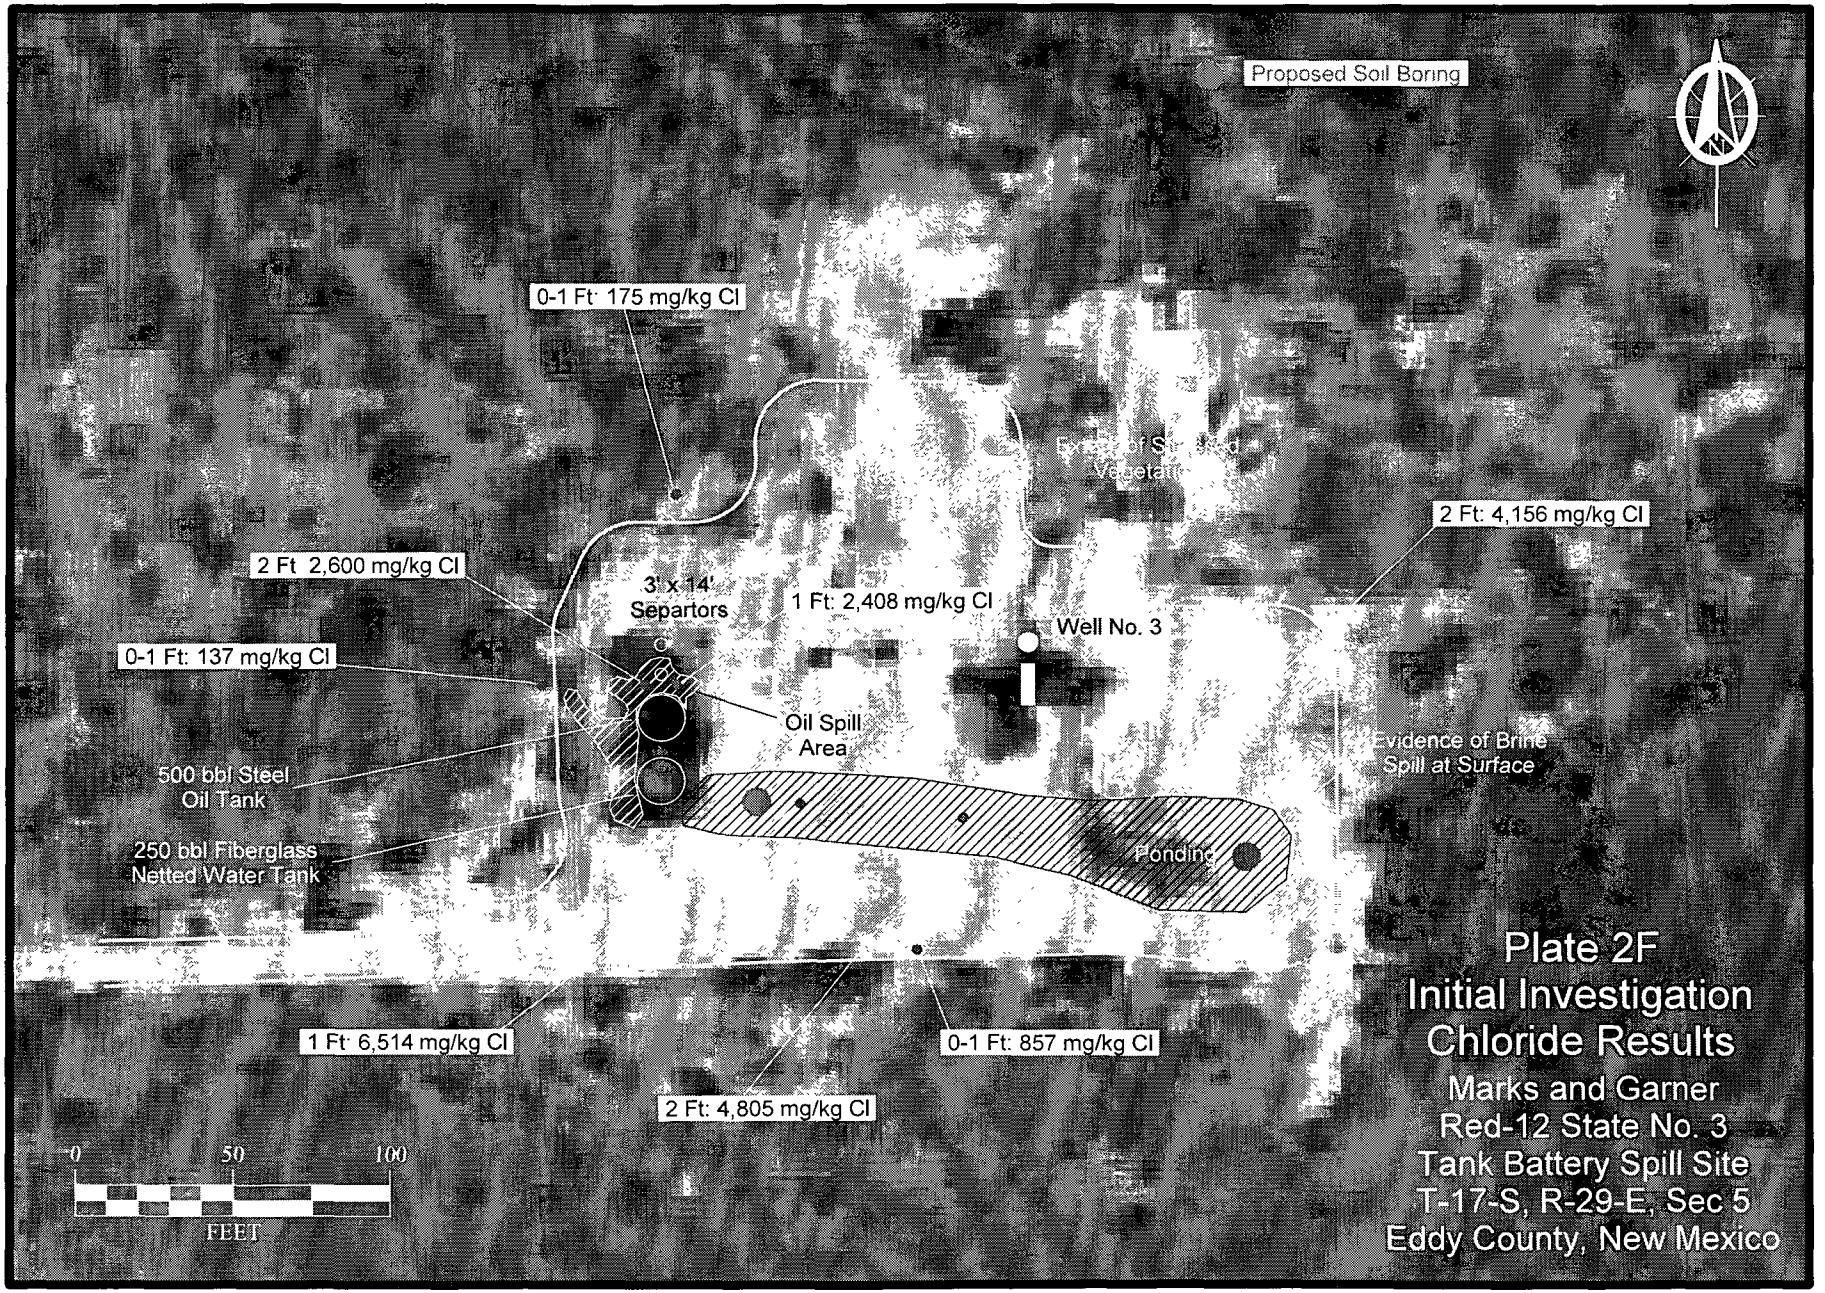
Proposed Soil Boring
0-1 Ft: 175 mg/kg Cl
2 Ft: 4,156 mg/kg Cl
2 Ft 2,600 mg/kg Cl
3' x 14'
Separtors
1 Ft: 2,408 mg/kg Cl
Well No. 3
0-1 Ft: 137 mg/kg Cl
Oil Spill
Area
Evidence of Brine
Spill at Surface
500 bbl Steel
Oil Tank
250 bbl Fiberglass
Netted Water Tank
Ponding
1 Ft: 6,514 mg/kg Cl
0-1 Ft: 857 mg/kg Cl
2 Ft: 4,805 mg/kg Cl
0
50
100
FEET
Plate 2F
Initial Investigation
Chloride Results
Marks and Garner
Red-12 State No. 3
Tank Battery Spill Site
T-17-S, R-29-E, Sec 5
Eddy County, New Mexico

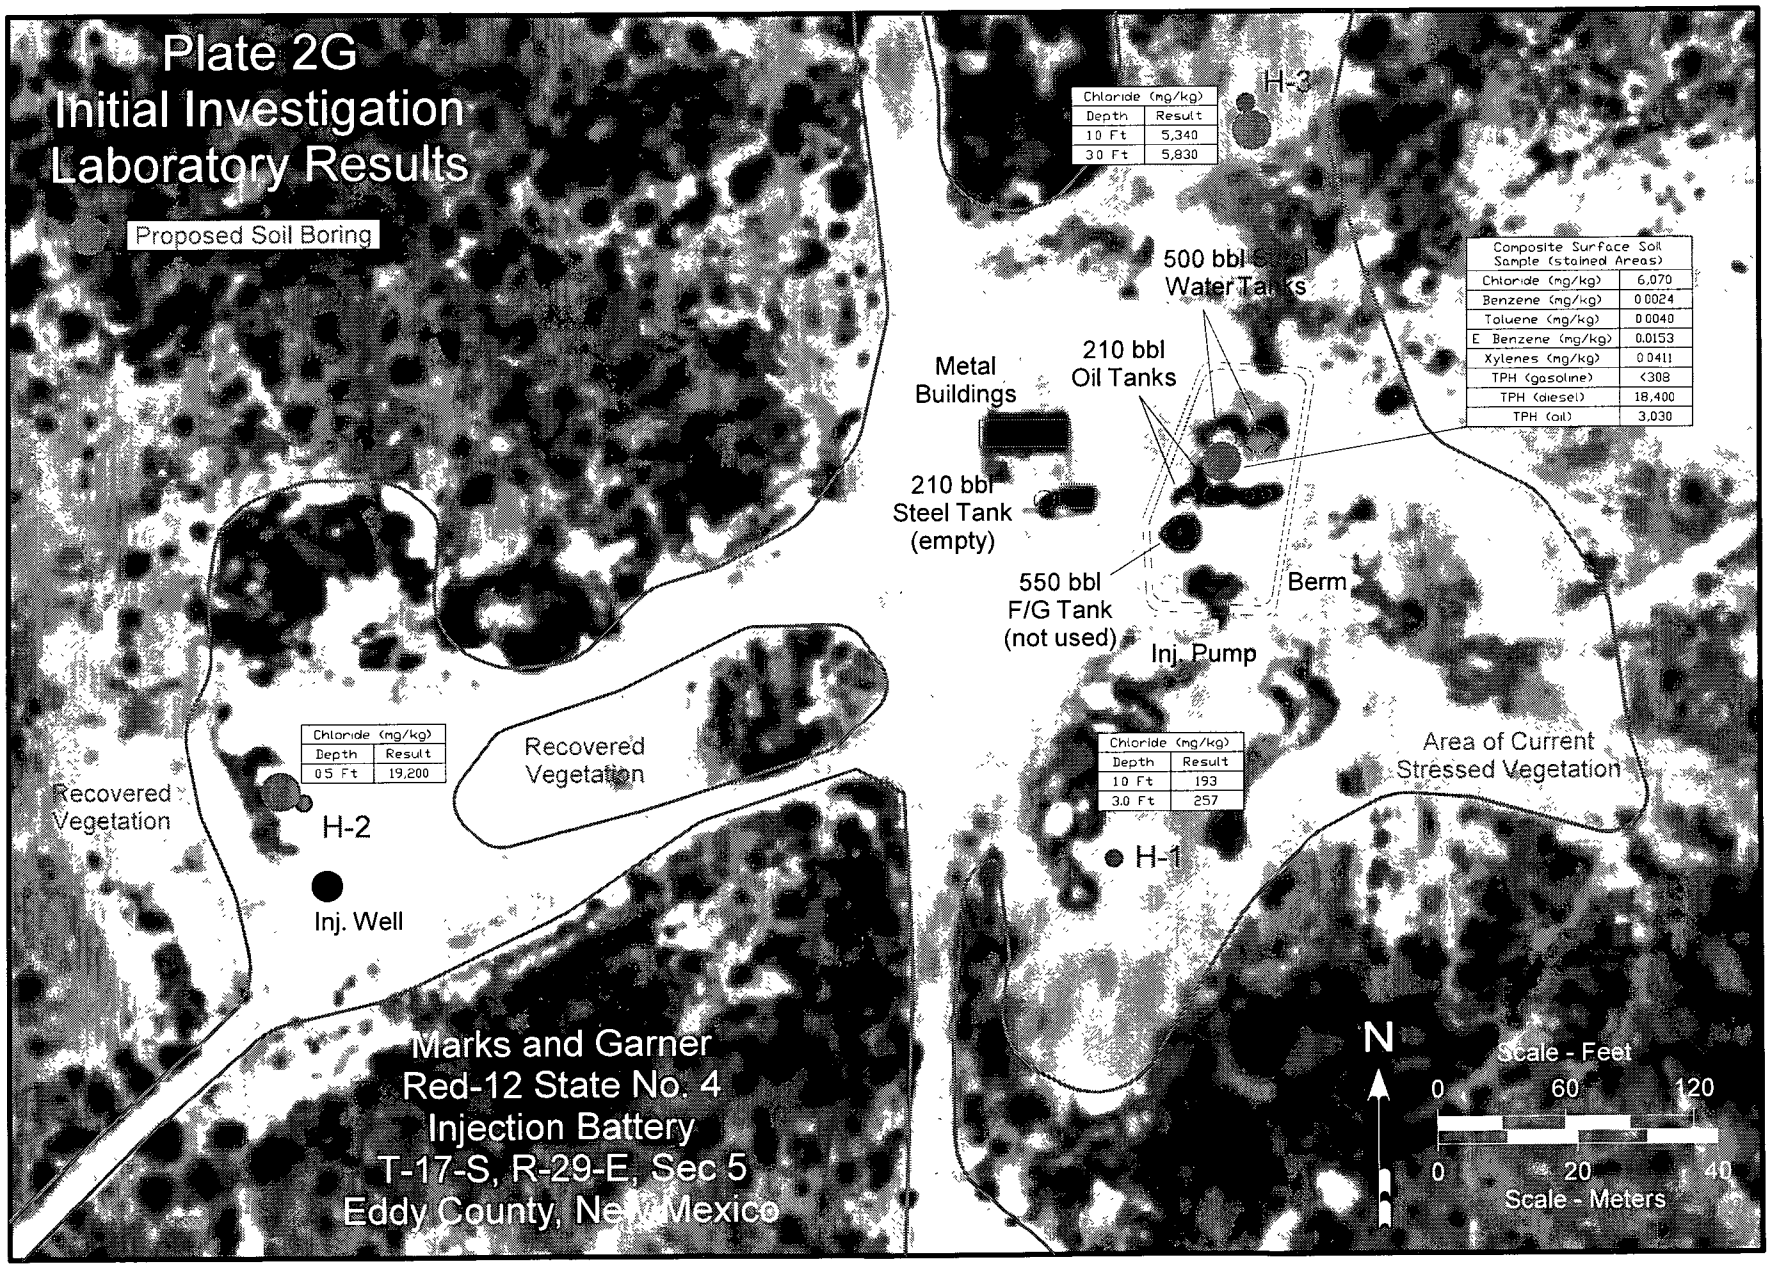
Plate 2G
Initial Investigation
Laboratory Results
Proposed Soil Boring
Chloride (mg/kg)
Depth | Result
10 Ft | 5,340
30 Ft | 5,830
H-3
500 bbl Steel Water Tanks
Composite Surface Soil Sample (stained Areas)
Chloride (mg/kg) | 6,070
Benzene (mg/kg) | 0.0024
Toluene (mg/kg) | 0.0040
E Benzene (mg/kg) | 0.0153
Xylenes (mg/kg) | 0.0411
TPH (gasoline) | <308
TPH (diesel) | 18,400
TPH (oil) | 3,030
Metal Buildings
210 bbl Oil Tanks
210 bbl Steel Tank (empty)
550 bbl F/G Tank (not used)
Berm
Inj. Pump
Chloride (mg/kg)
Depth | Result
05 Ft | 19,200
Recovered Vegetation
Recovered Vegetation
H-2
Inj. Well
Chloride (mg/kg)
Depth | Result
10 Ft | 193
30 Ft | 257
H-1
Area of Current Stressed Vegetation
Marks and Garner
Red-12 State No. 4
Injection Battery
T-17-S, R-29-E, Sec 5
Eddy County, New Mexico
N
Scale - Feet
0
60
120
0
20
40
Scale - Meters
