February 27, 2015

Re: COG Operating, LLC
Scratch State Com No. 1
Stage 1 Abatement Plan Site Investigation Report and Closure Request
Section 24, Township 18 South, Range 33 East
Lea County, New Mexico
NMOCD AP - 094

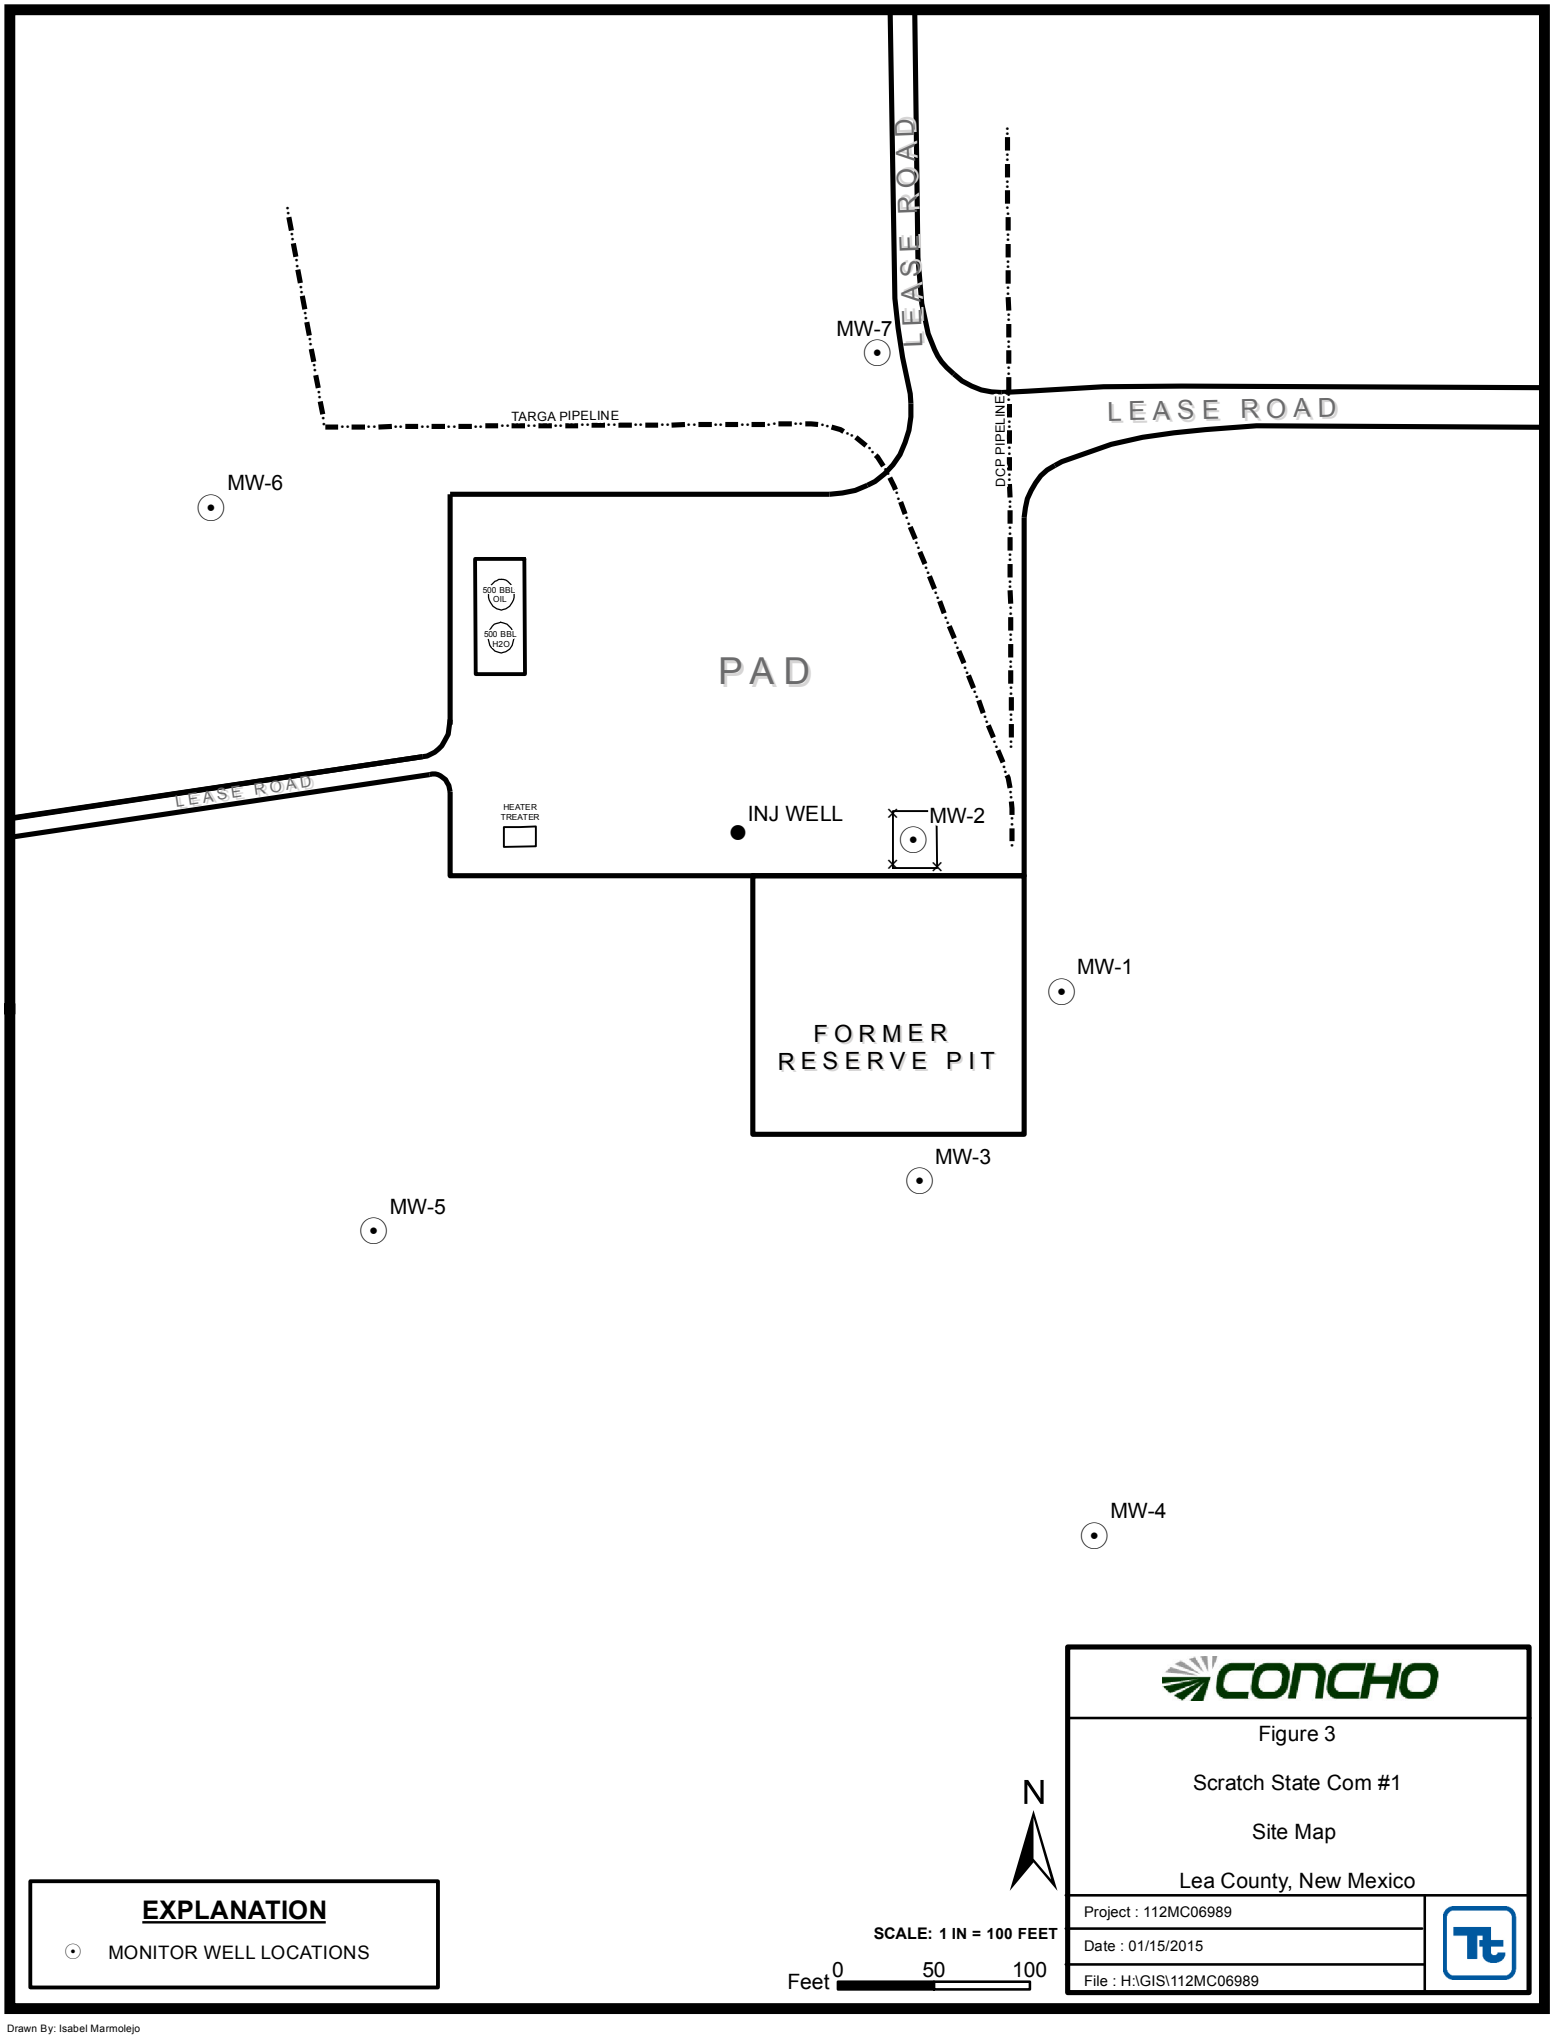
LEASE ROAD
MW-7
TARGA PIPELINE
DCP PIPELINE
LEASE ROAD
MW-6
500 BBL OIL
500 BBL H2O
PAD
LEASE ROAD
HEATER TREATER
INJ WELL
MW-2
MW-1
FORMER RESERVE PIT
MW-3
MW-5
MW-4
N
SCALE: 1 IN = 100 FEET
Feet 0 50 100
EXPLANATION
MONITOR WELL LOCATIONS
CONCHO
Figure 3
Scratch State Com #1
Site Map
Lea County, New Mexico
Project : 112MC06989
Date : 01/15/2015
File : H:\GIS\112MC06989
Drawn By: Isabel Marmolejo

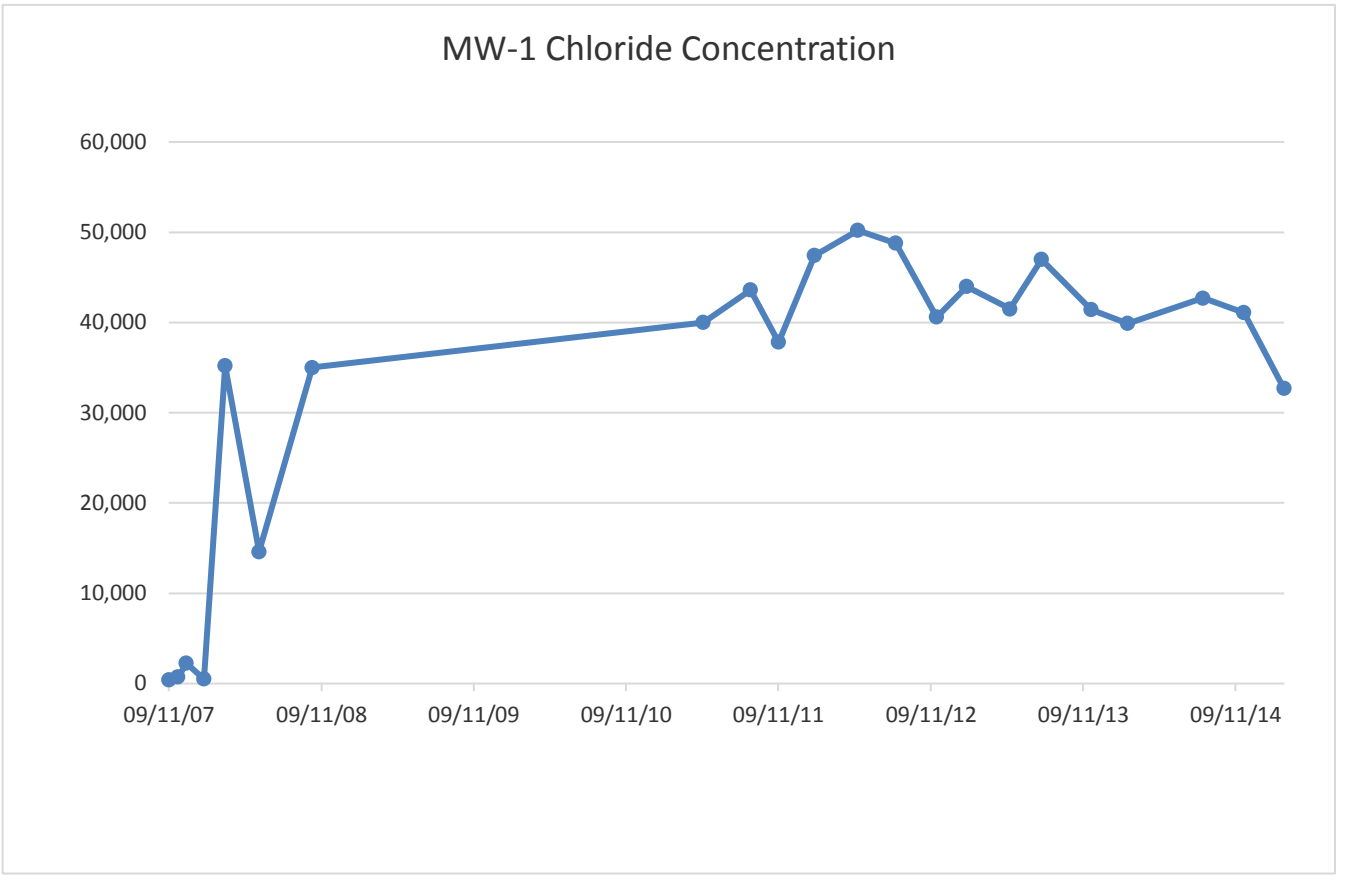
MW-1 Chloride Concentration
60,000
50,000
40,000
30,000
20,000
10,000
0
09/11/07
09/11/08
09/11/09
09/11/10
09/11/11
09/11/12
09/11/13
09/11/14

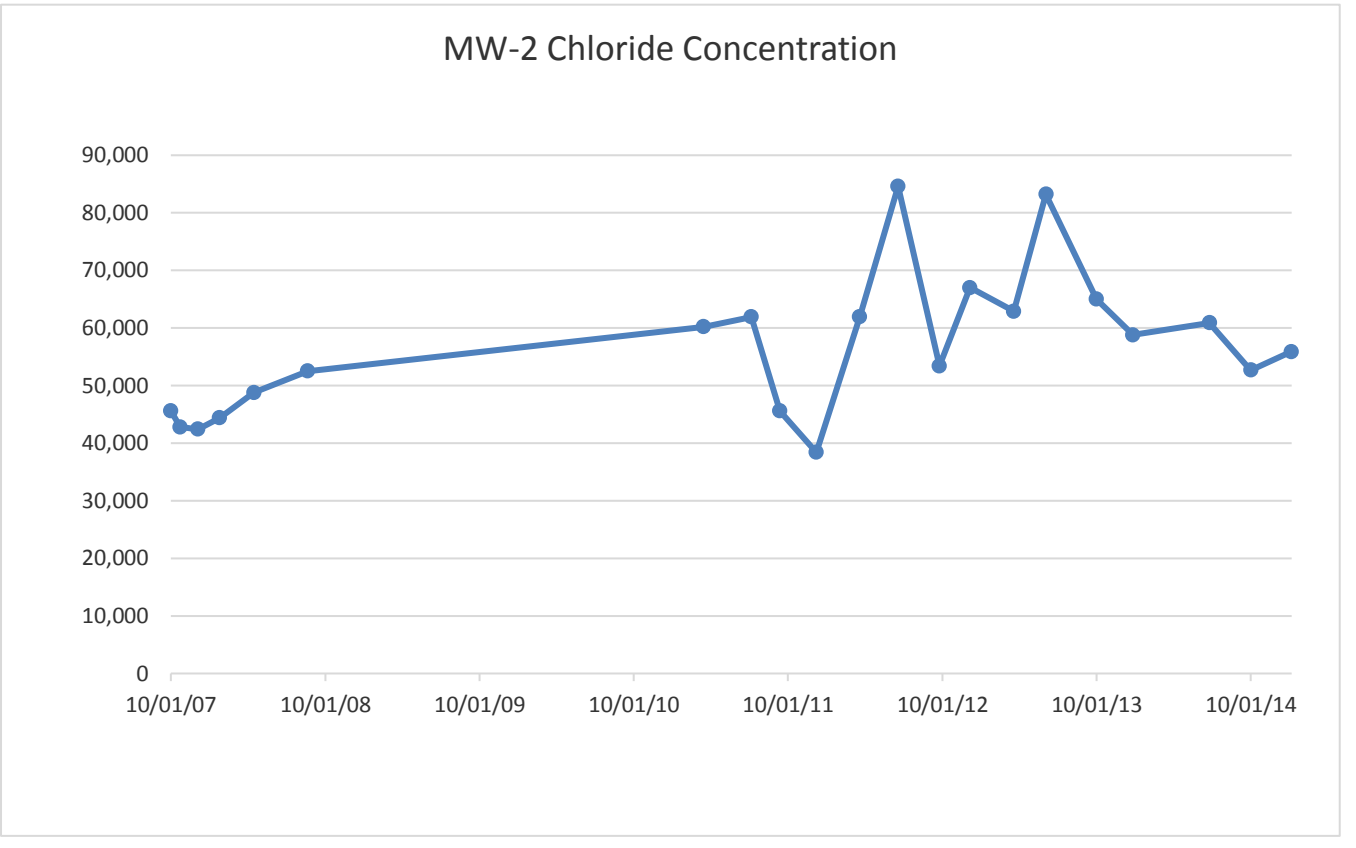
MW-2 Chloride Concentration
90,000
80,000
70,000
60,000
50,000
40,000
30,000
20,000
10,000
0
10/01/07
10/01/08
10/01/09
10/01/10
10/01/11
10/01/12
10/01/13
10/01/14

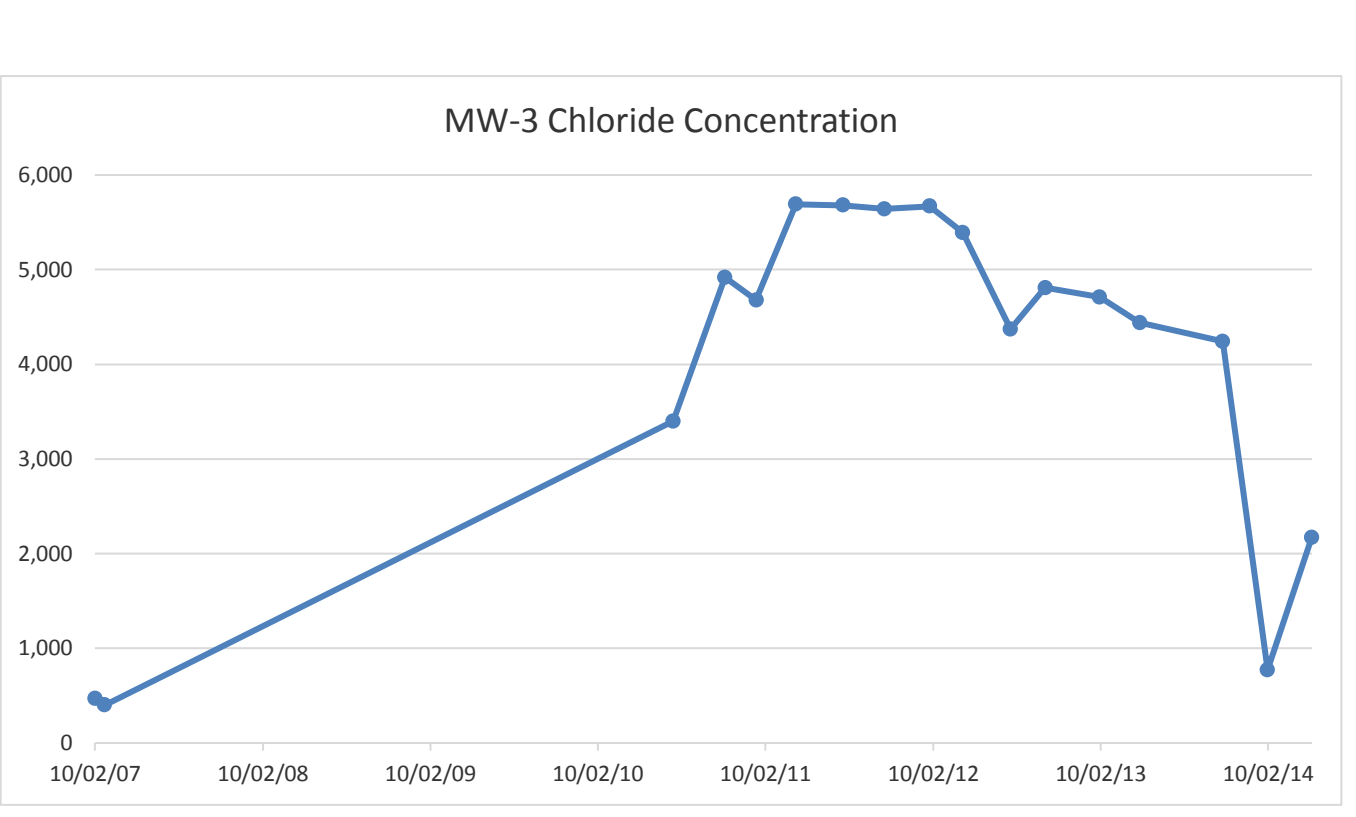
MW-3 Chloride Concentration
6,000
5,000
4,000
3,000
2,000
1,000
0
10/02/07
10/02/08
10/02/09
10/02/10
10/02/11
10/02/12
10/02/13
10/02/14
