Re: Request for Permanent Closure
Martinez Gas Com G 001
API No. 3004512172; Unit letter A, Section 24, T29N, R10W; GPS: 36.714499°, -107.829341°

GROUNDWATER REMEDIATION REPORT

MARTINEZ GC G # 1
(A) SECTION 24, T29N, R10W, NMPM
SAN JUAN COUNTY, NEW MEXICO

NOVEMBER 2015

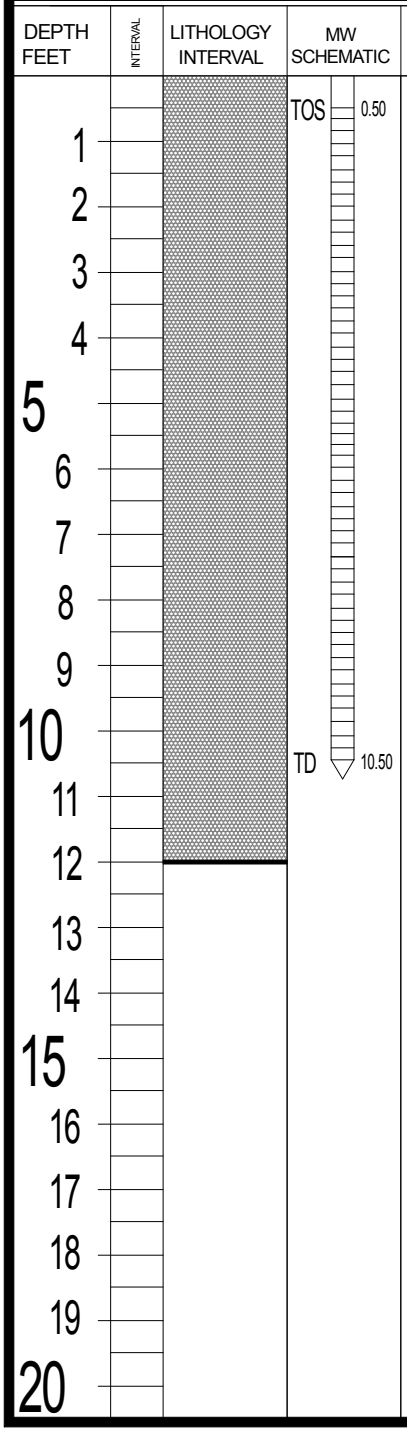
MW #1A

LIGHT MEDIUM GRAY SAND TO SILTY SAND, NON COHESIVE, FIRM, SLIGHTLY MOIST PHASING INTO SATURATED, VERY SLIGHT APPARENT HYDROCARBON ODOR DETECTED PHYSICALLY FROM AUGER CUTTINGS OF TOP HALF OF BORING (0.0 - 12.0 FT. BELOW GRADE).

Monitor well consist of 2 inch PVC piping - casing from 1.00 feet above grade to 0.50 feet below grade, 0.010 slotted screen between 0.50 to 10.50 feet below grade, sanded annular to surface, flush mount cover concreted at surface to 1.50 feet above grade, secured casing with locking cap and padlock.

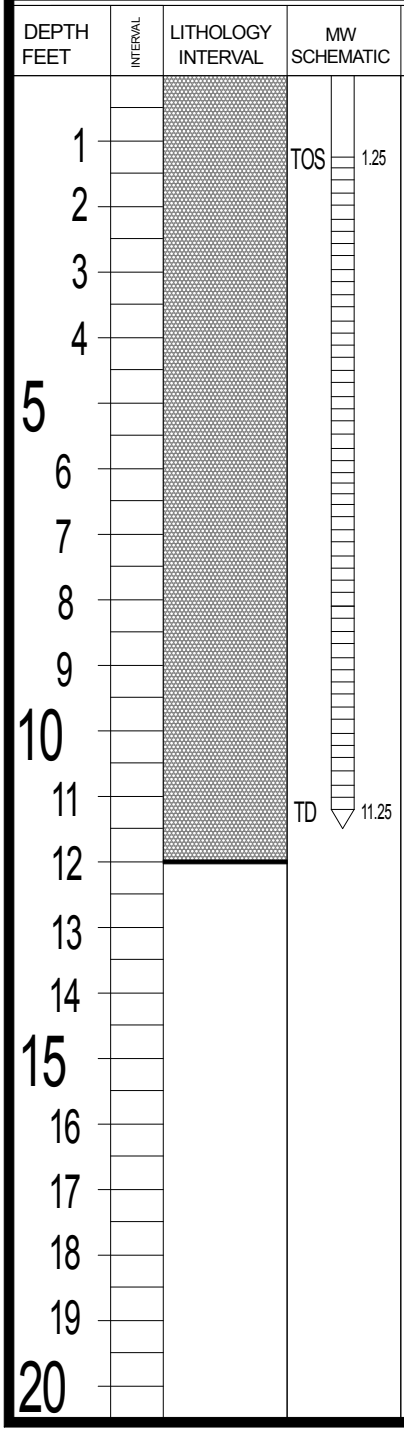
MW #2A

LIGHT MEDIUM GRAY SAND TO SILTY SAND, NON COHESIVE, FIRM, SLIGHTLY MOIST PHASING INTO SATURATED, NO APPARENT HYDROCARBON ODOR DETECTED PHYSICALLY FROM AUGER CUTTINGS (0.0 - 12.0 FT. BELOW GRADE).

Monitor well consist of 2 inch PVC piping - casing from 0.25 to 1.25 feet below grade, 0.010 slotted screen between 1.25 to 11.25 feet below grade, sanded annular to 1.00 feet below grade, bentonite chips from 0.50 to 1.00 feet below grade, flush mount cover concreted at surface, secured casing with locking cap and padlock.

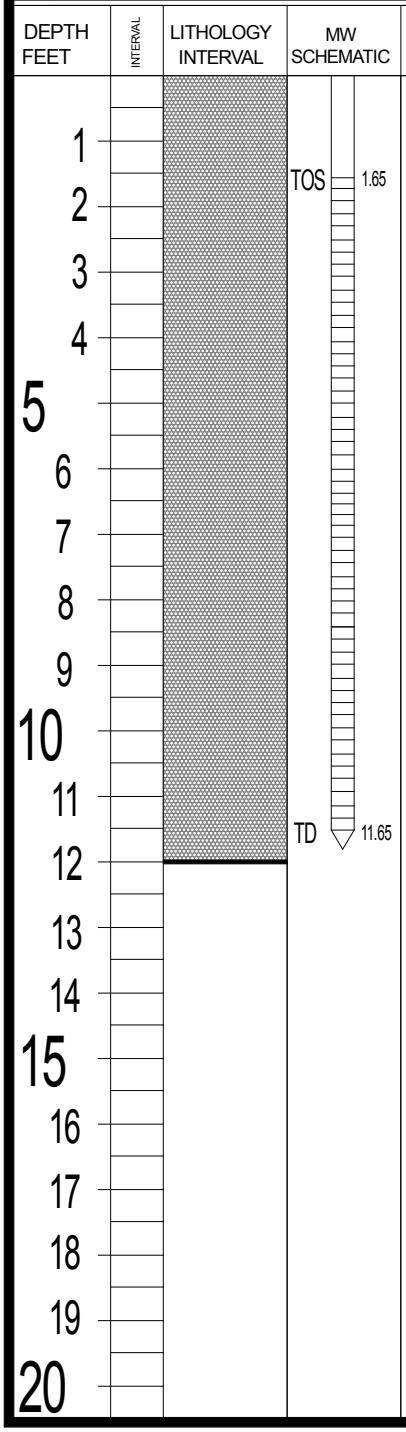
MW #3A

LIGHT MEDIUM GRAY SAND TO SILTY SAND, NON COHESIVE, FIRM, SLIGHTLY MOIST PHASING INTO SATURATED, NO APPARENT HYDROCARBON ODOR DETECTED PHYSICALLY FROM AUGER CUTTINGS (0.0 - 12.0 FT. BELOW GRADE).

Monitor well consist of 2 inch PVC piping - casing from 2.50 feet above grade to 1.65 feet below grade, 0.010 slotted screen between 1.65 to 11.65 feet below grade, sanded annular to 1.00 feet below grade, bentonite chips from grade to 1.00 feet below grade, steel well protector installed for above-grade casing, concreted at surface, and secured with padlock.

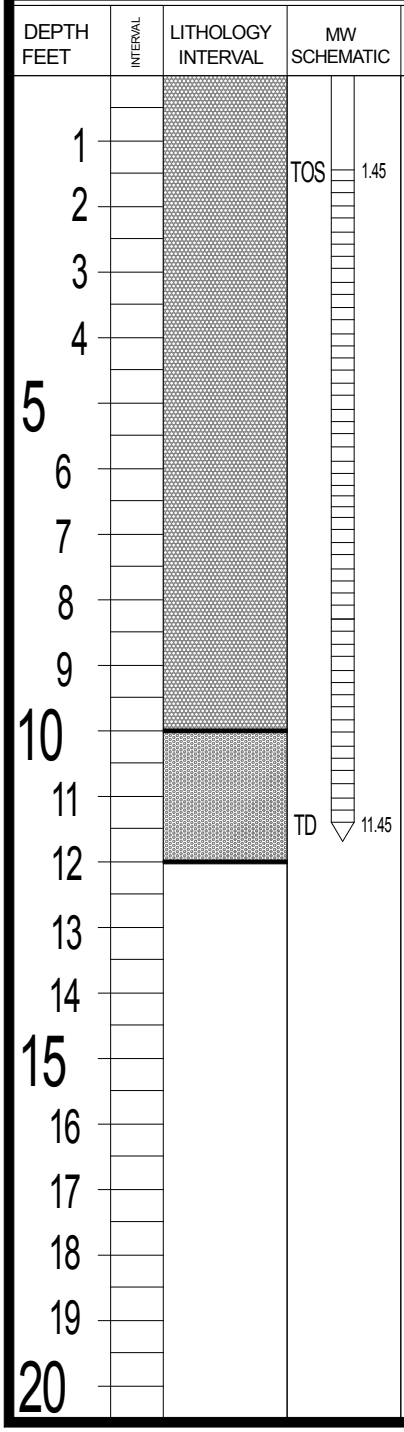
MW #4A

LIGHT MEDIUM GRAY SAND TO SILTY SAND, NON COHESIVE, FIRM, SLIGHTLY MOIST PHASING INTO SATURATED, NO APPARENT HYDROCARBON ODOR DETECTED PHYSICALLY FROM AUGER CUTTINGS (0.0 - 10.0 FT. BELOW GRADE).

SAME AS ABOVE EXCEPT WITH GRAVEL (10.0 - 12.0 FT. BELOW GRADE).

Monitor well consist of 2 inch PVC piping - casing from 2.60 feet above grade to 1.45 feet below grade, 0.010 slotted screen between 1.45 to 11.45 feet below grade, sanded annular to 1.00 feet below grade, bentonite chips from grade to 1.00 feet below grade, steel well protector installed for above-grade casing, concreted at surface, and secured with padlock.
