CONCHO

Closure Report

SRO State Com #64H
API #: 30-015-42130
RP#: 2RP-5209
GPS: 32.05748 -104.08201
Unit Letter E, Section 10, Township 26 South, Range 28 East
Eddy County, New Mexico

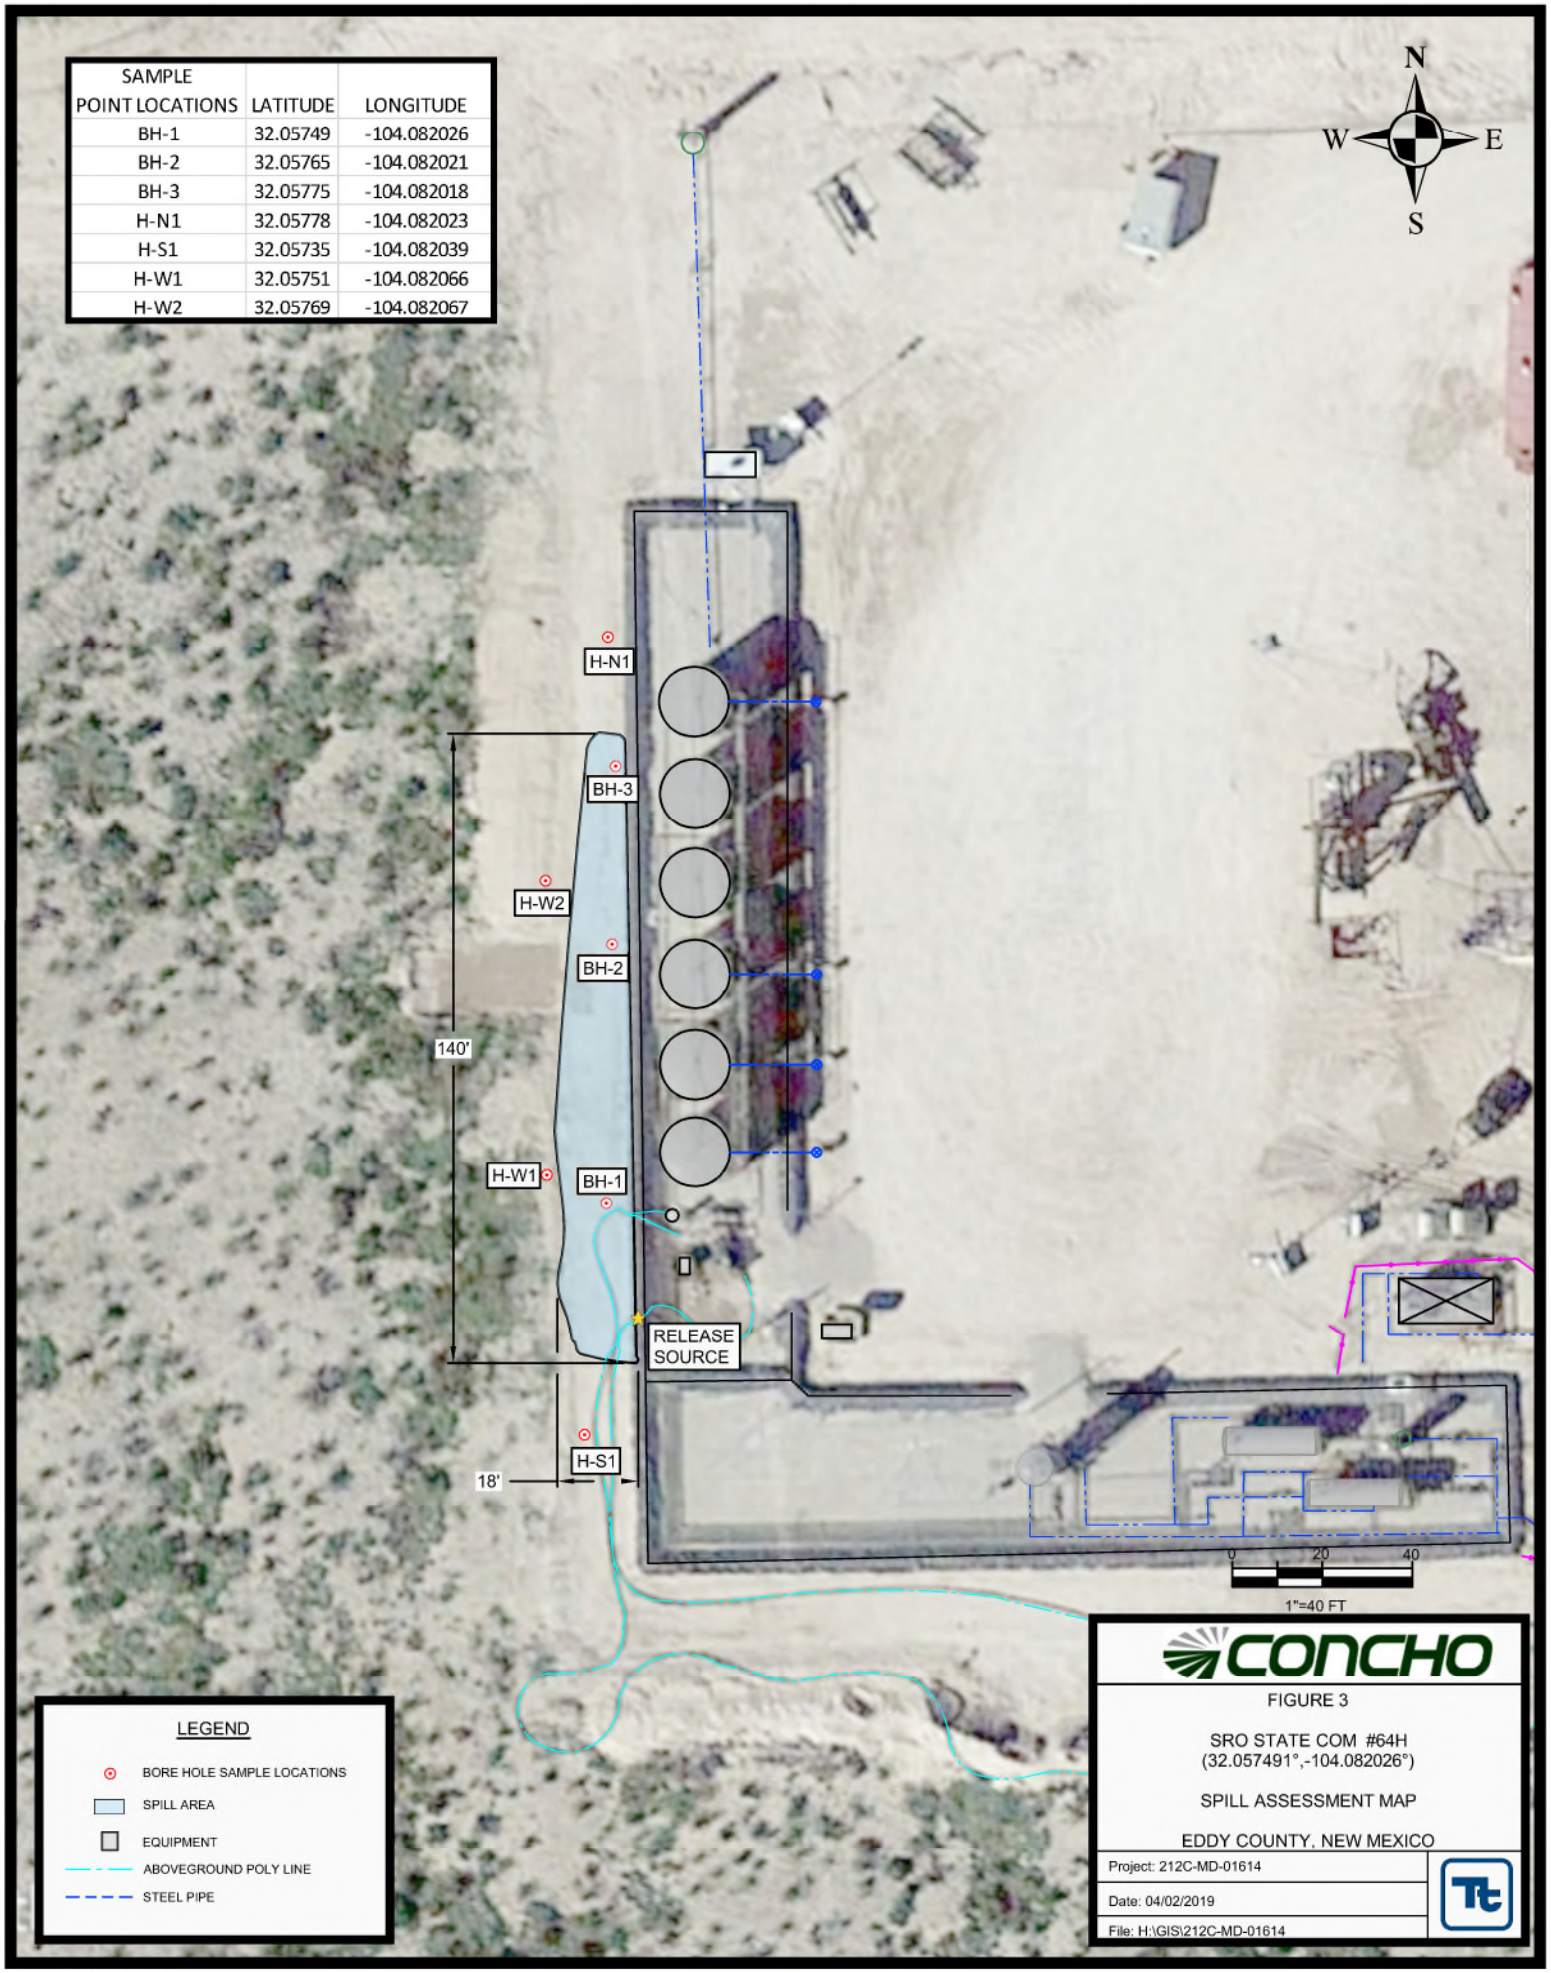
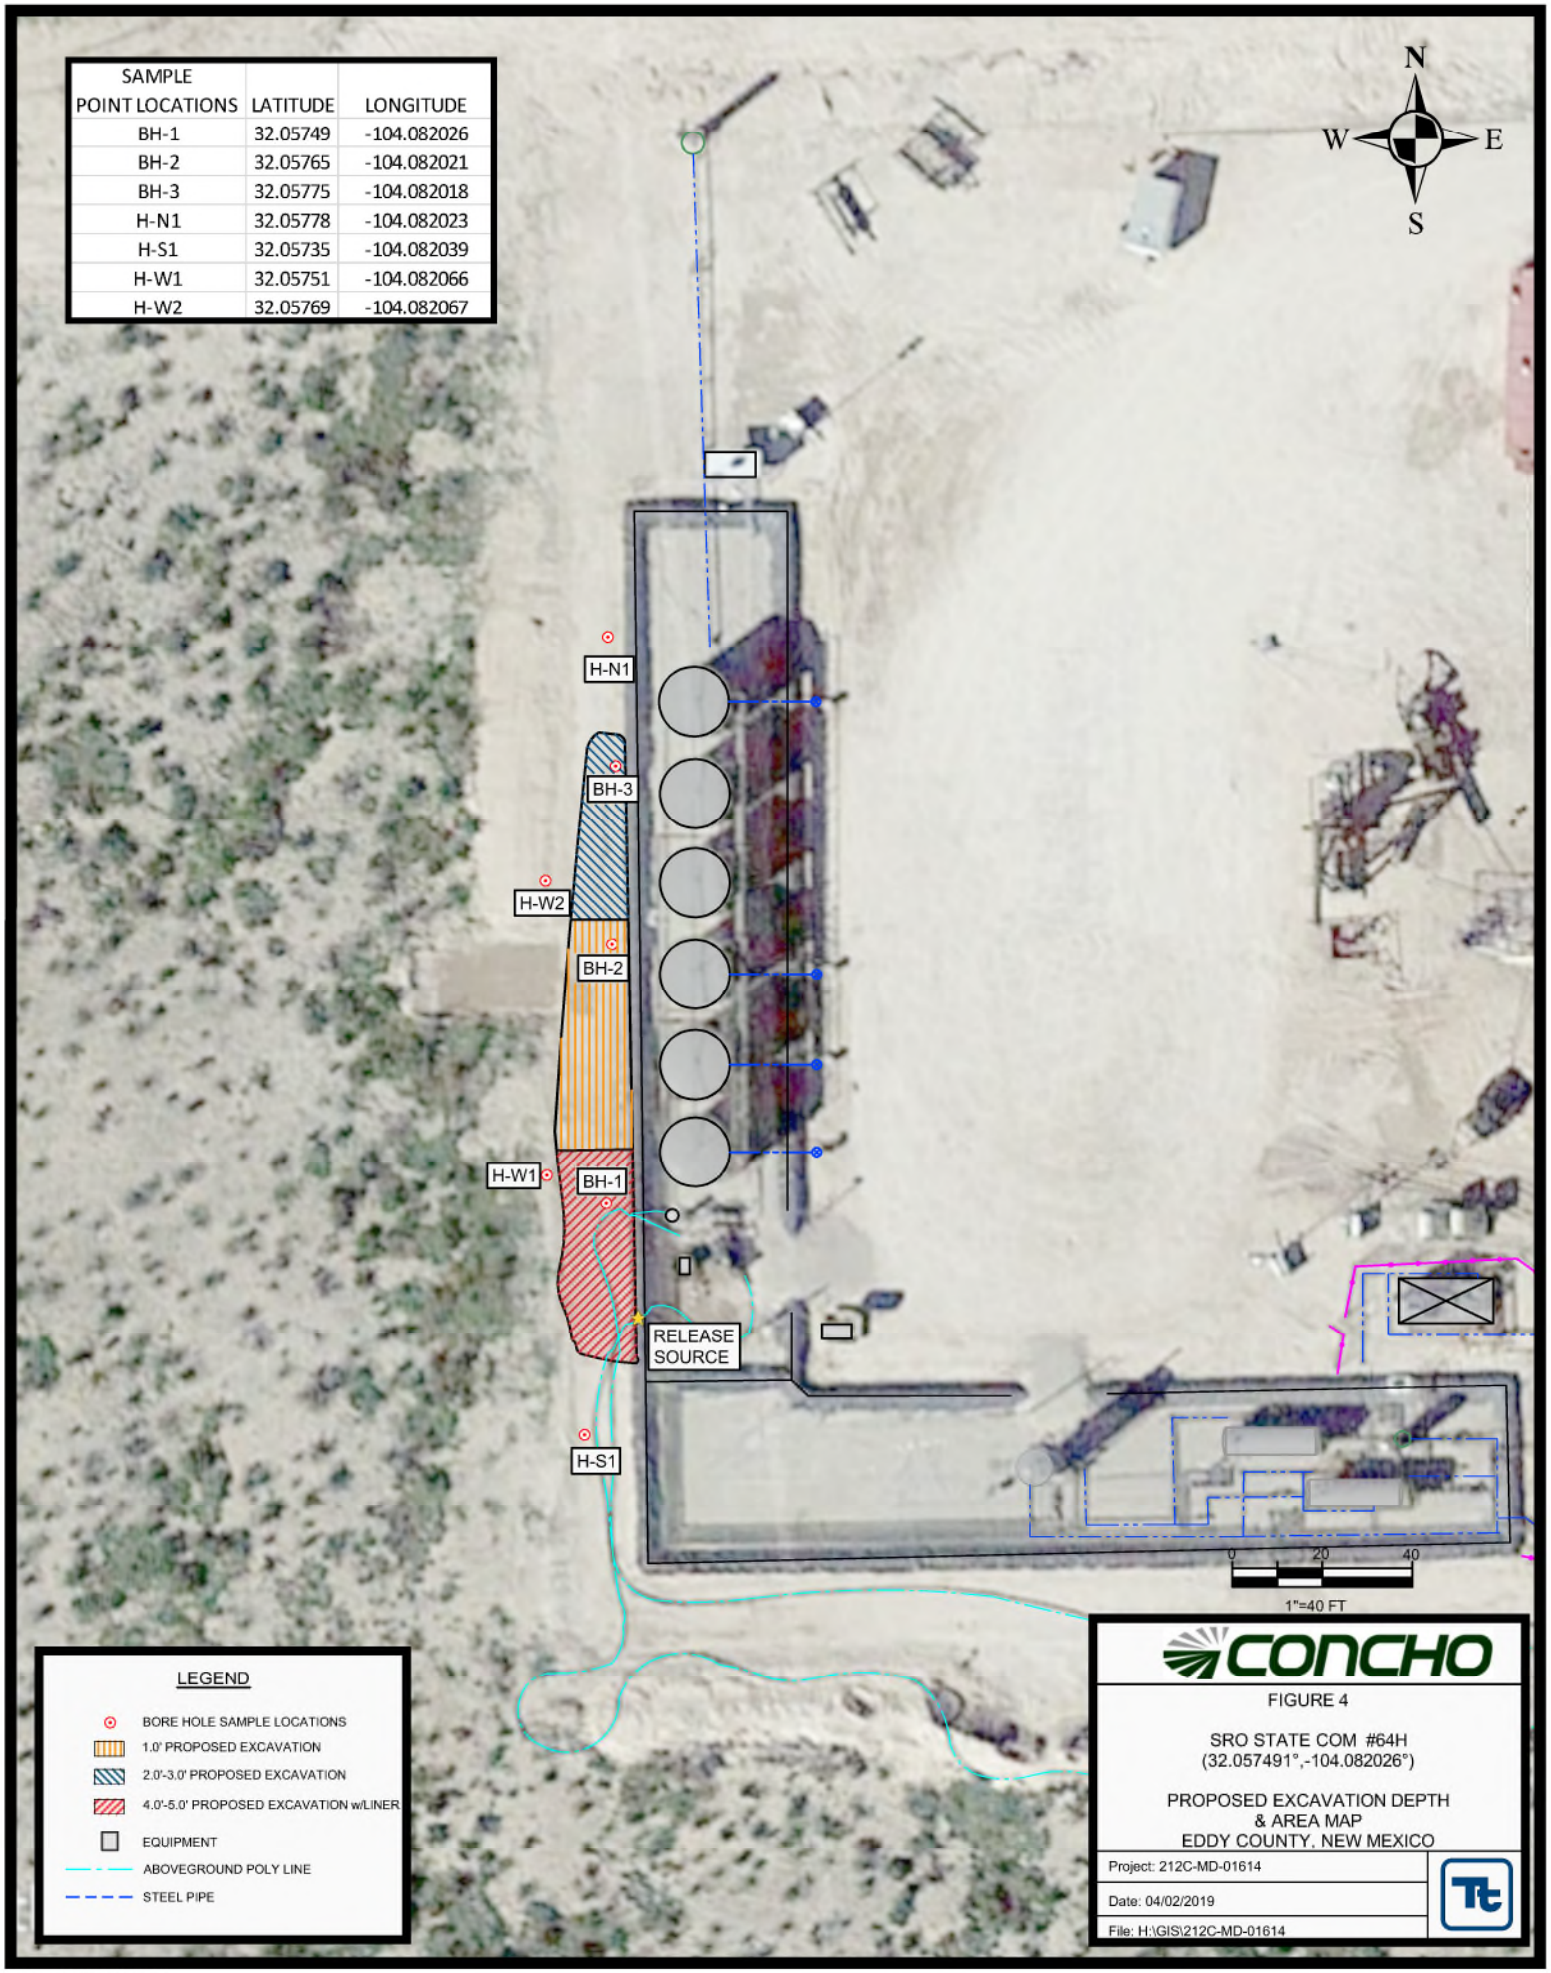
SAMPLE POINT LOCATIONS | LATITUDE | LONGITUDE
BH-1 | 32.05749 | -104.082026
BH-2 | 32.05765 | -104.082021
BH-3 | 32.05775 | -104.082018
H-N1 | 32.05778 | -104.082023
H-S1 | 32.05735 | -104.082039
H-W1 | 32.05751 | -104.082066
H-W2 | 32.05769 | -104.082067
N
W
E
S
H-N1
BH-3
H-W2
BH-2
140'
H-W1
BH-1
RELEASE SOURCE
H-S1
18'
0
20
40
1"=40 FT
LEGEND
BORE HOLE SAMPLE LOCATIONS
SPILL AREA
EQUIPMENT
ABOVEGROUND POLY LINE
STEEL PIPE
CONCHO
FIGURE 3
SRO STATE COM #64H
(32.057491°,-104.082026°)
SPILL ASSESSMENT MAP
EDDY COUNTY, NEW MEXICO
Project: 212C-MD-01614
Date: 04/02/2019
File: H:\GIS\212C-MD-01614
Drawn By: MISTI MORGAN

- BORE HOLE SAMPLE LOCATIONS
- 1.0' PROPOSED EXCAVATION
- 2.0'-3.0' PROPOSED EXCAVATION
- 4.0'-5.0' PROPOSED EXCAVATION w/LINER
- EQUIPMENT
- ABOVEGROUND POLY LINE
- STEEL PIPE
