RE: Osborn #1, CLU #302, Canada Mesa #3 Soil Contamination

Merrion Oil & Gas
CLU #302
Site Schematic

MERRION OIL & GAS
Daily Pit Closure Report

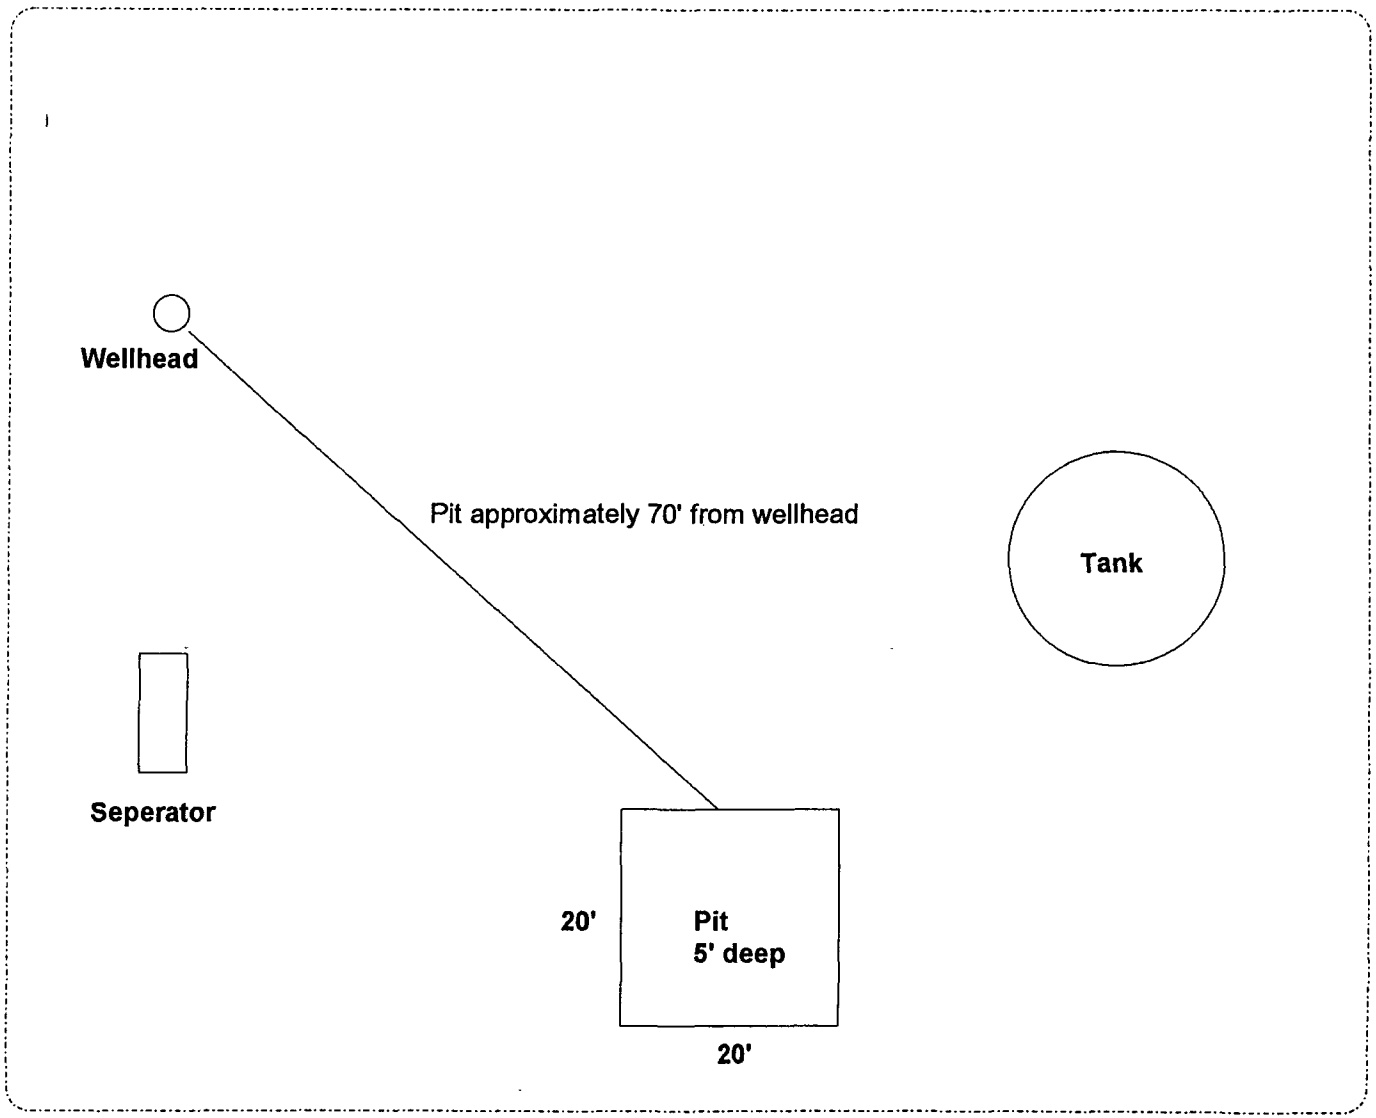
Report: Took Ground water sample from center of pit. Excavated 5' downgradiant took water sample #2 Looked clean OVM of soil tested less then 100 ppm.

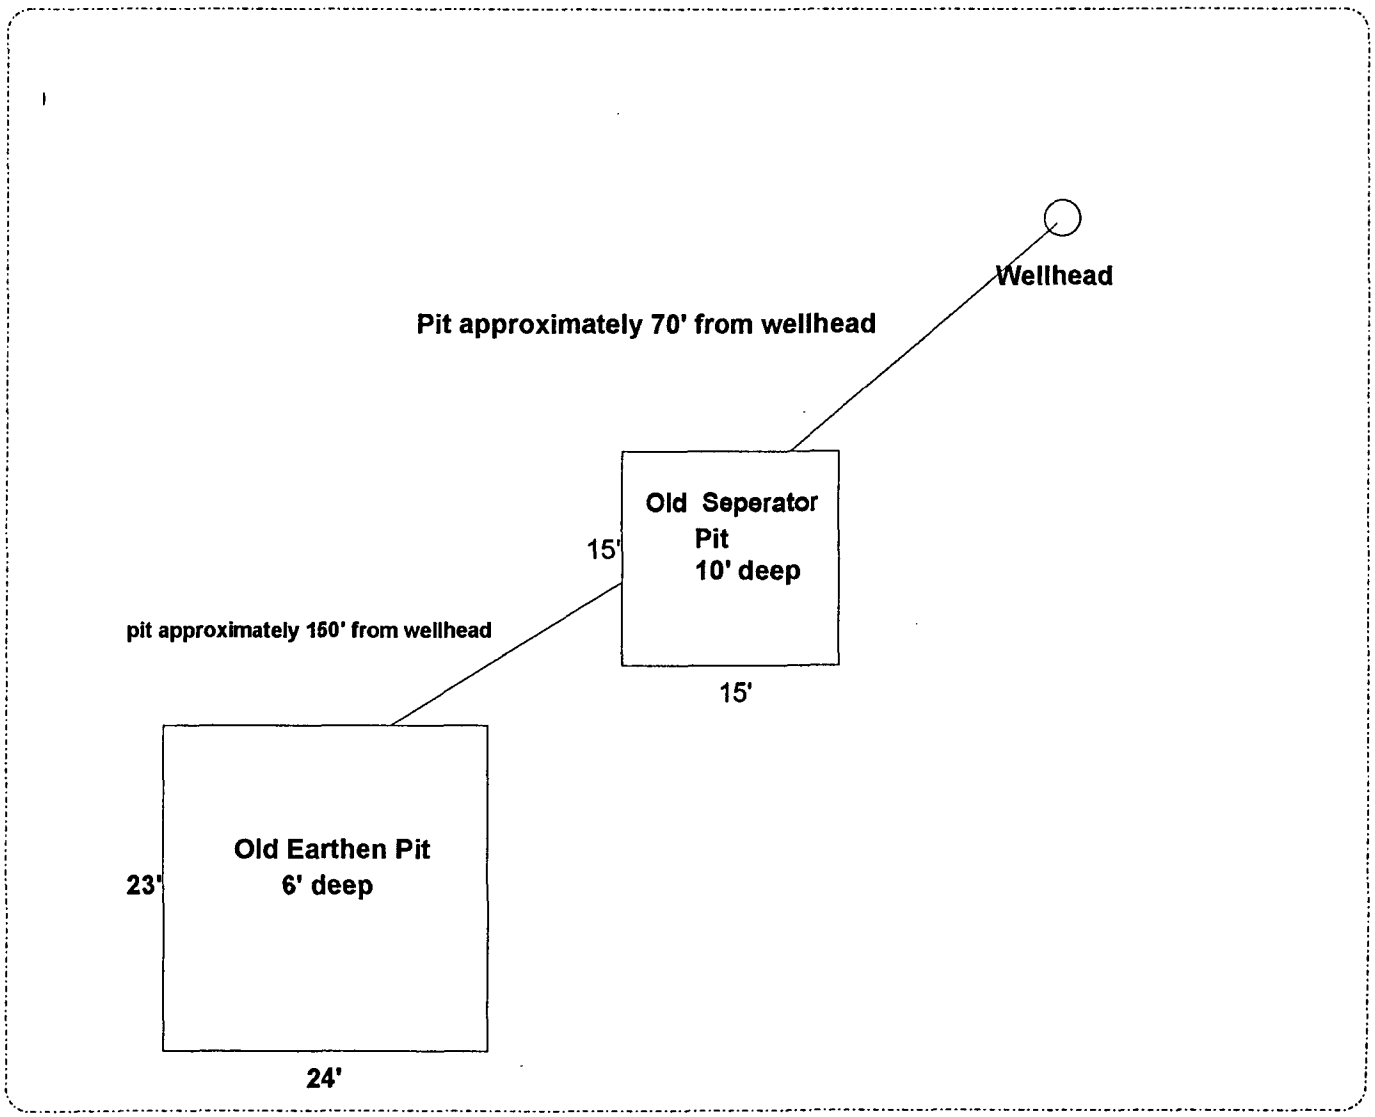
Merrion Oil & Gas
Canada Mesa #3
Site Schematic

Report: Continuing sampling. #1
Took Ground water sample at location #1.
GW sample #2 at location #2.
GW sample #3 at location #3
GW sample #4 at location #4

&
Composit soil sample at location #4
gave OVM reading of 388 ppm.

Estimate a 50' radius around pit of contamination.

4. **Canada Mesa #3:** (See attached location diagram). Over 800 cubic yards of stained soil was excavated from the large pit and composted on location. Ground water sample at location #1 showed a small amount of contamination and sample #2 showed no contamination. We estimated that the hydrocarbons hit the ground water and moved along the water surface approx. 30' in all directions from the pit. Since the water samples were not overly contaminated we feel that the water itself did not absorb the heavy hydrocarbons.
